# 1978 - 1980 Corvette: Service Bulletin: Instrument Cluster Area Squeak

**Subject:** Instrument Cluster Area Squeak

**Model and Year:** 1978 - 1980 Corvette

**Bulletin No:** 80-T-37

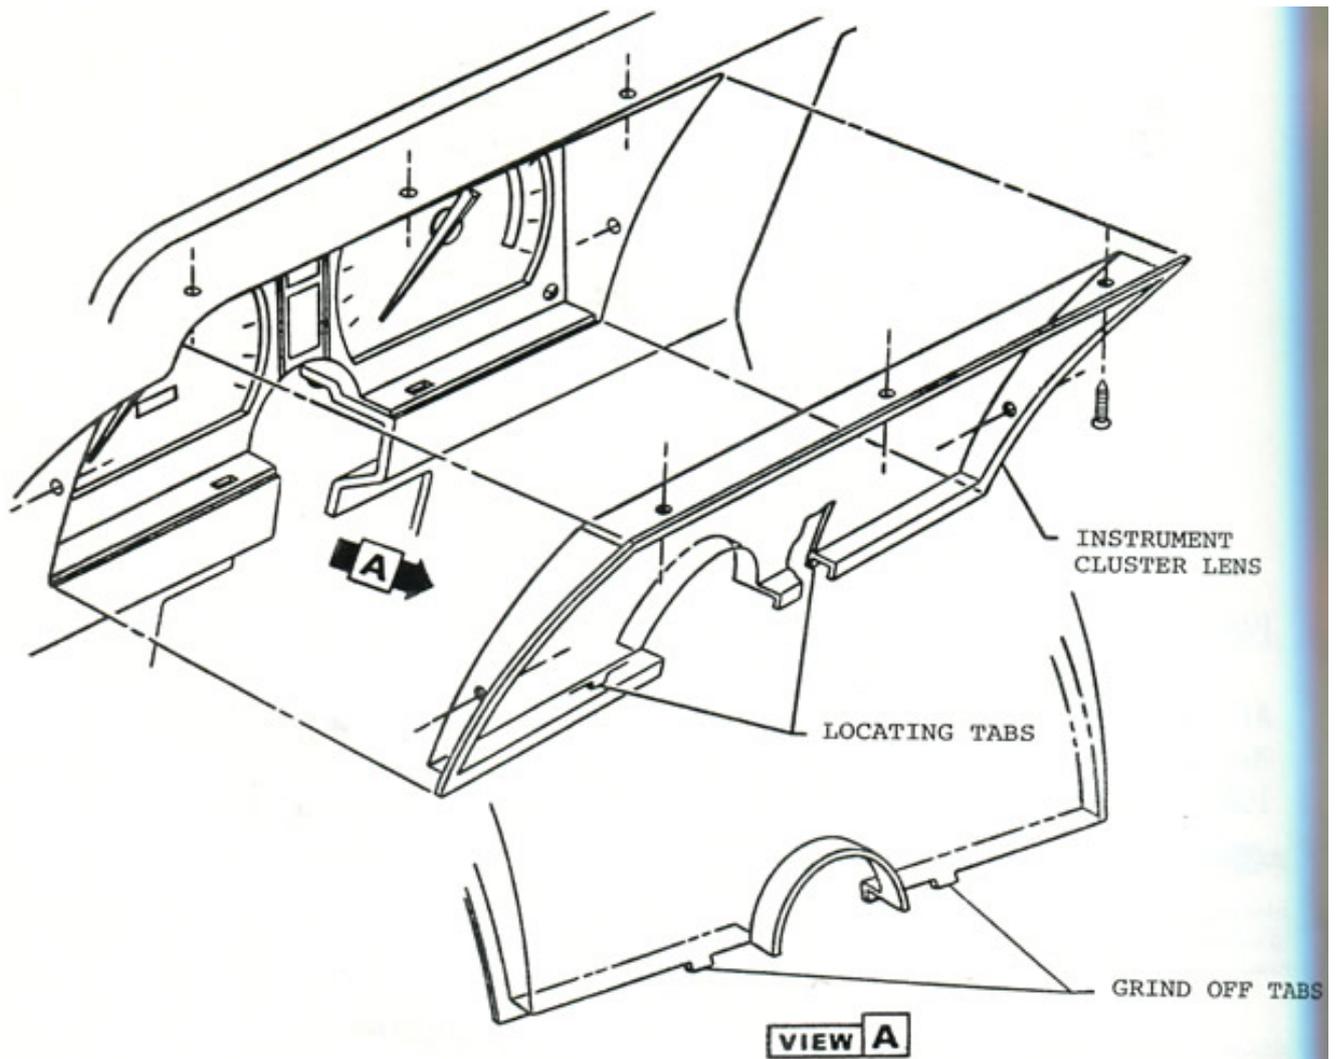
CORVETTE INSTRUMENT CLUSTER LENS  
LOCATING TABS

Lower tabs on cluster lens may rub against side of case locating holes. To verify this source, apply light hand pressure to lens.

1. Remove five (5) lens to case attaching screws and remove lens.
2. Grind off and file to a smooth surface the two (2) plastic locating tabs at bottom of lens, as illustrated on Page 2. CAUTION : The plastic lens is brittle and may crack if the tabs are snapped off rather than ground.
3. Reinstall lens to case with five (5) screws.
