# 1978 - 1980 Corvette: Service Bulletin: Instrument Cluster Area Squeak

**Source:** Chevrolet Dealer Service Technical Bulletin

**Bulletin No:** 80-T-37

**Date:** May, 1980

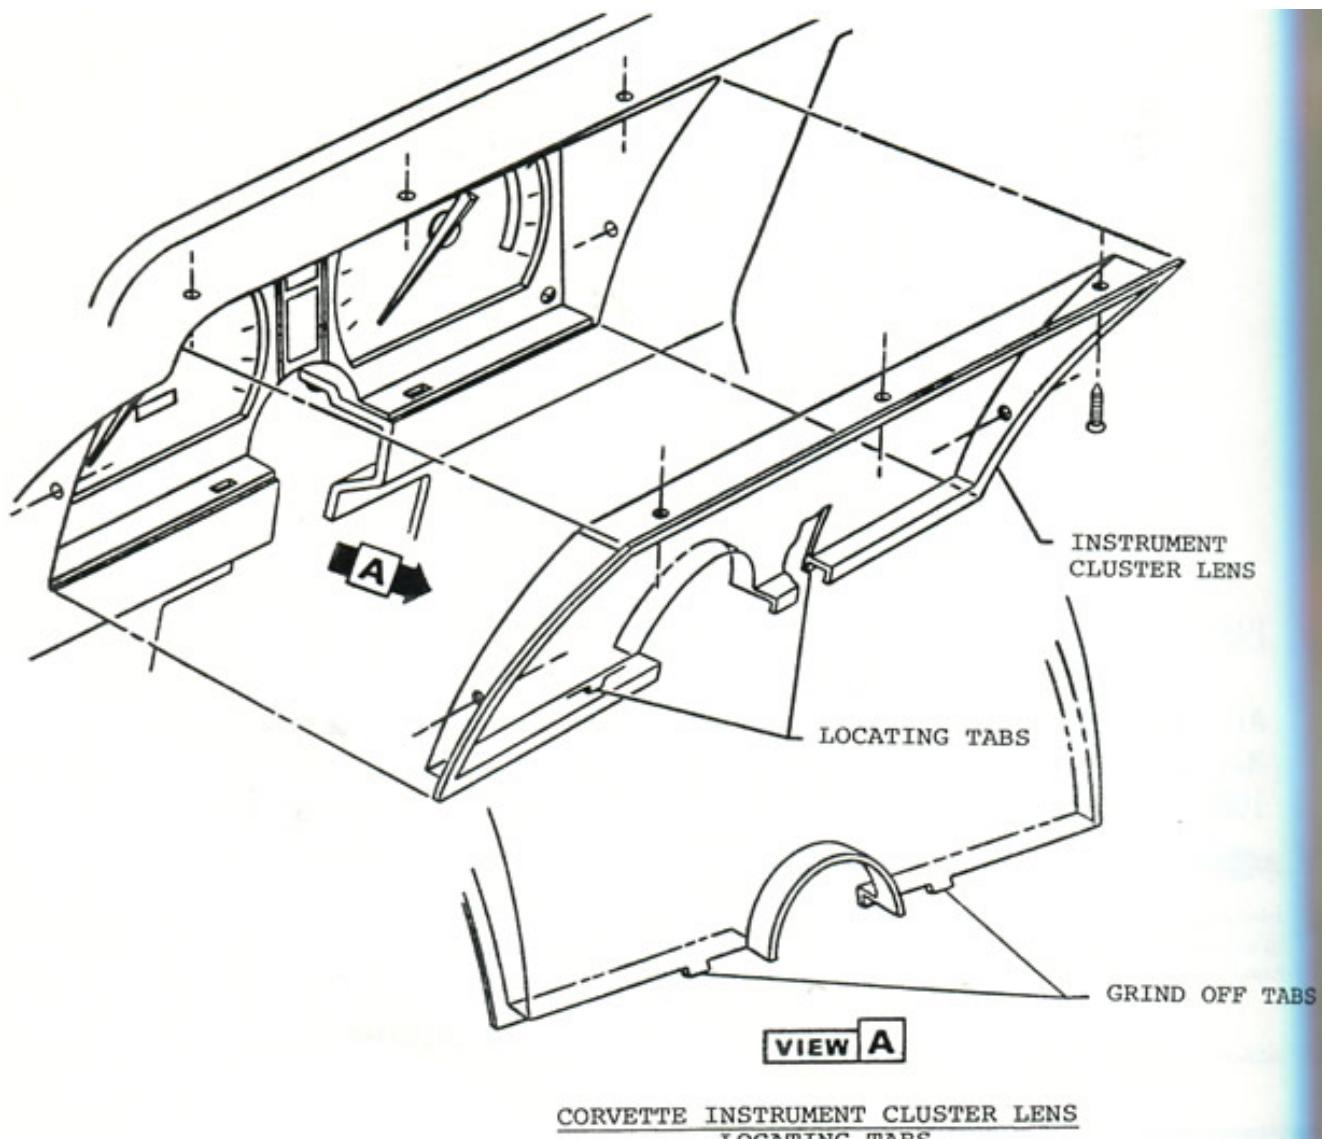
Lower tabs on cluster lens may rub against side of case locating holes. To verify this source, apply light hand pressure to lens.

1. Remove five (5) lens to case attaching screws and remove lens.
2. Grind off and file to a smooth surface the two (2) plastic locating tabs at bottom of lens, as illustrated on Page 2. **CAUTION** : The plastic lens is brittle and may crack if the tabs are snapped off rather than ground.
3. Reinstall lens to case with five (5) screws.
