1965 Corvette: Service News: Vent the Window Regulator Motor

Subject: Vent the Window Regulator Motor

Model and Year: 1965 - All Chevrolets

Date: December, 1965 - Volume 37 - Number 11

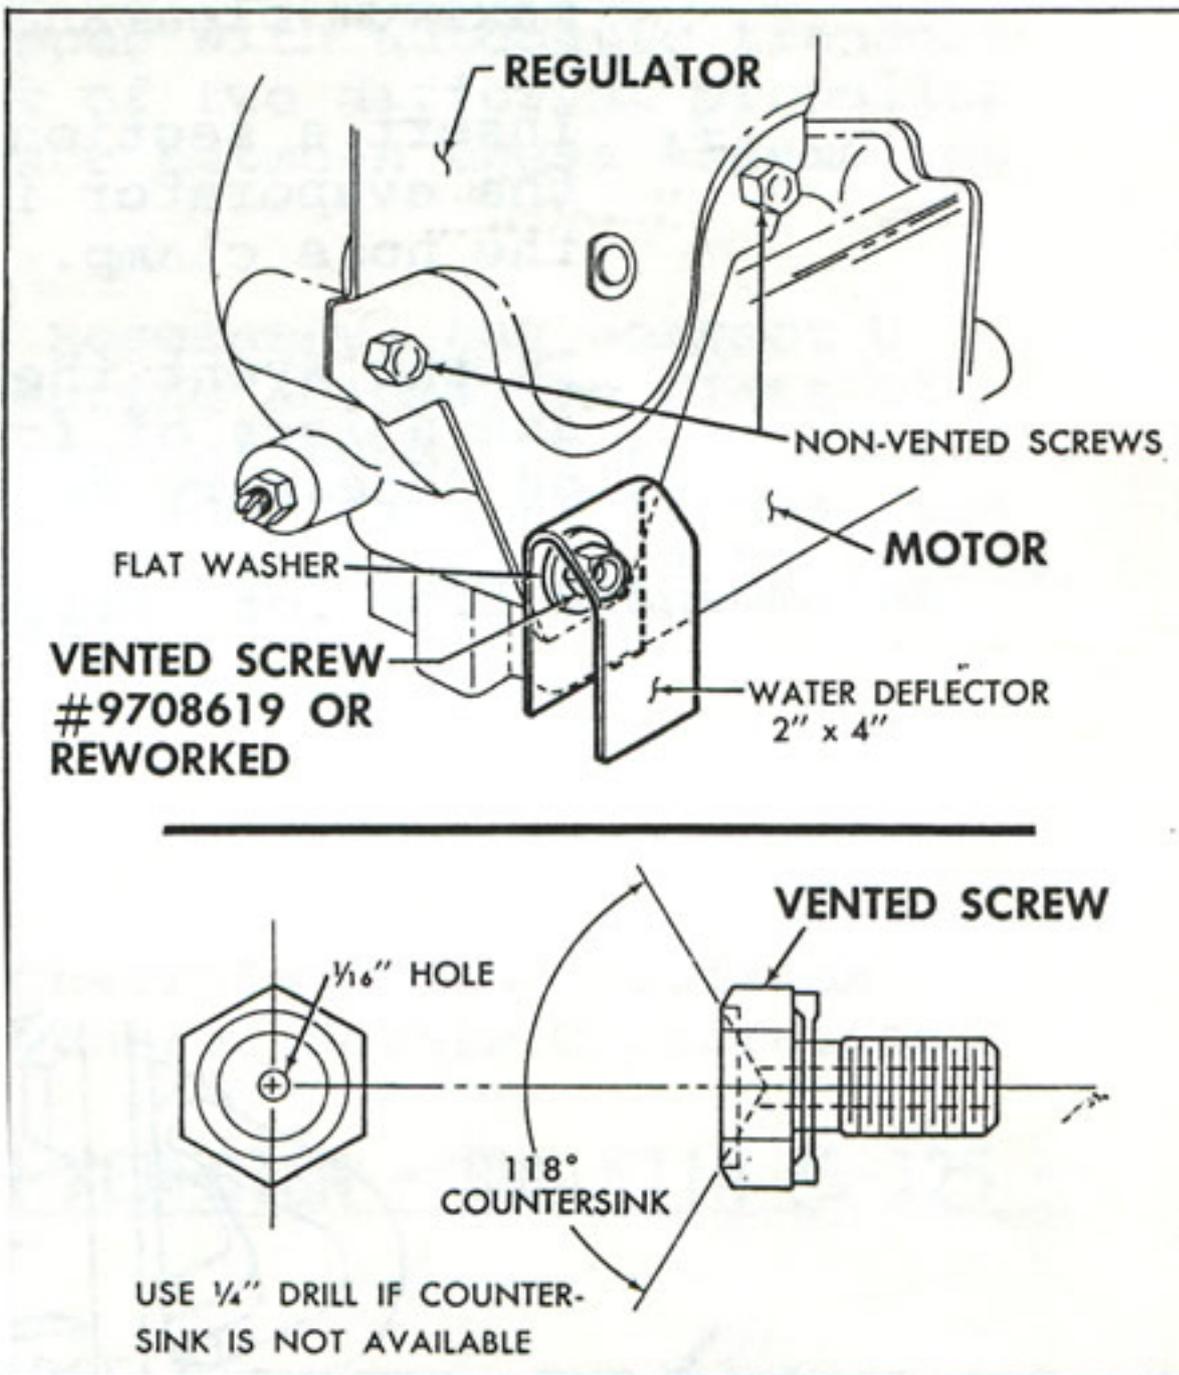
IMPORTANT: *The screw to be vented is the lower one of the three screws. The motor housing is cored to permit air to enter motor interior only at this one location.*

Fig. 1—Installing Window Regulator Motor Lower Attaching Screw (Vented)

Refer to article "Replacing Window Regulator Motor", on the last page of November issue of Service News for door window regulator motor replacement and before completely replacing the motor, the lower attaching screw should be drilled through (hollow) to vent the motor (See Fig. 1). Venting the motor on all replacement motors will improve the reliability of power window motors.

NOTE: *If vented screw Part No. 9708619 is not available, drill a 1/16" hole through the center of one of the motor to regulator attaching screws and countersink the head of the screw (Refer to Fig. 1). Drill hole starting at threaded end of screw.*

Construct a water deflector, 2" x 4" with a 1/4" hole 1-1/4" from one end, from suitable water repellent material.
