# 2020 - 2021 Corvette: GM TechLink: Tips for Over-The-Air Software Programming

## 2020 - 2021 Corvette: Tips for Over-The-Air Software Programming

March 12, 2021

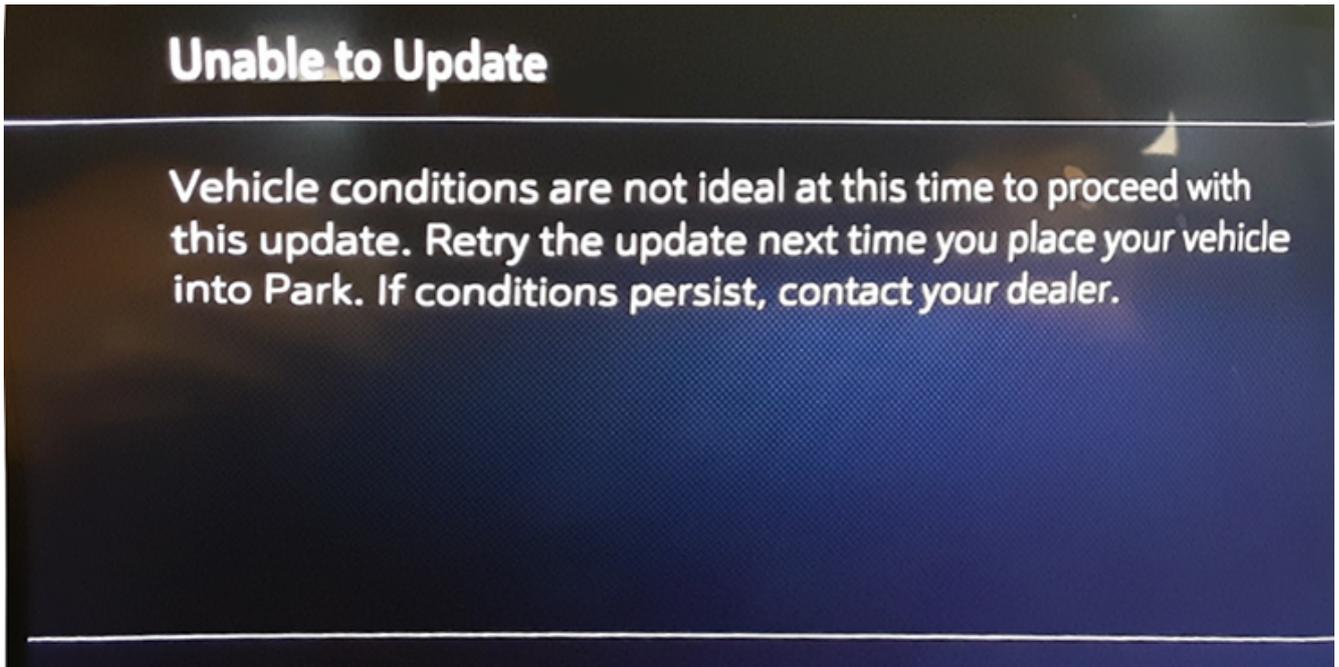
**Fig. 4**

There are a number of criteria that must be met in order to successfully complete the software update installation on a vehicle. The most common cause of being unable to complete an installation is the State of Charge (SOC)

of the 12V battery. If the 12V battery does not meet the minimum SOC requirement of 70 percent or greater along with an Outside Ambient Temperature (OAT) greater than 14°F (-10°C), the OTA update installation will not occur. The colder the ambient air temperature is, the higher the target SOC becomes. To determine the battery SOC for VIP vehicles, go to BCM / 12V Battery / Battery Sensor Module – State of Charge in GDS 2.

There may be other conditions that will affect an OTA update installation. If any of these conditions are present, a “Vehicle Conditions Not Ideal” message may display on the infotainment screen stating that conditions are not ideal to proceed with the update installation. These conditions do not indicate a failure; only that the vehicle does not meet all the criteria necessary to complete the OTA update installation. (Fig. 4)

If a low battery SOC is preventing the OTA update installation, the 12V battery should be charged to meet the target SOC of 70 percent.

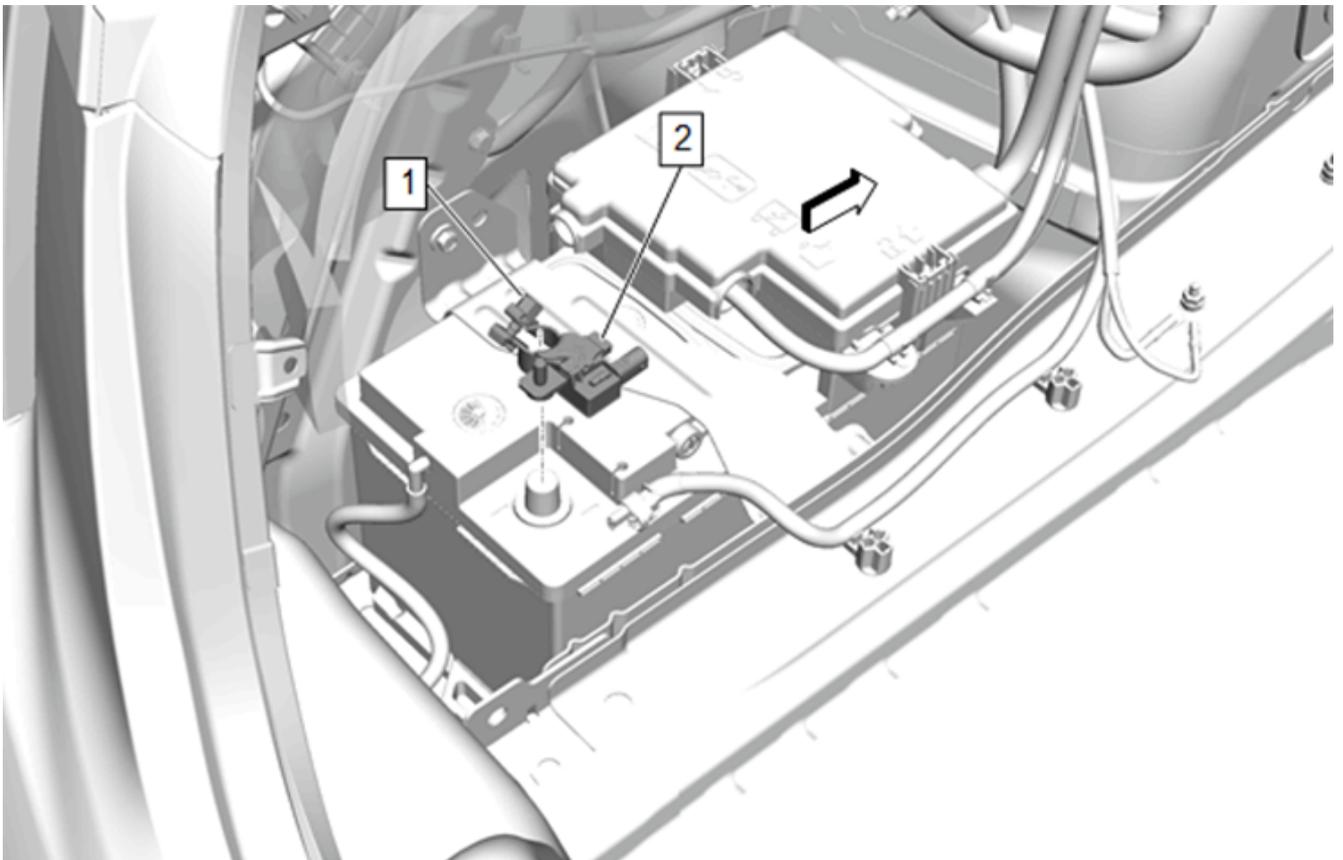
## Fig. 5

On some GM models, connecting the battery charger directly to the 12V battery posts will bypass the Battery Sensor Module, resulting in a default SOC value of 65 percent and a “Conditions Not Met” message.

**TIP:** The Battery Sensor Module (Fig. 5) is attached directly to the battery

negative terminal. It determines the battery condition by calculating the battery SOC, functions, and state of health, which is used to help determine if the 12V Stop/Start system will allow an Auto Stop when the vehicle has come to a stop. To properly charge the battery, the negative lead of the charger must be connected to chassis ground, and not directly to the negative battery post. Connecting to chassis ground allows current to flow through the Battery Sensor Module during charging as well as be monitored. Connecting directly to the negative battery post charges the battery, but the current cannot be monitored by the Battery Sensor Module.

If a battery is improperly charged, the Battery Sensor Learn will be required to calibrate the Battery Sensor Module. With the ignition off, let the vehicle rest for a minimum of four hours without any interruptions (opening a door, using the key fob, etc.). Verify if the battery SOC is 70 percent or greater using GDS 2 before attempting to continue with an OTA update.
