2020 - 2021 Corvette: GM TechLink: Tips for Over-The-Air Software Programming

2020 - 2021 Corvette: Tips for Over-The-Air Software Programming

March 12, 2021

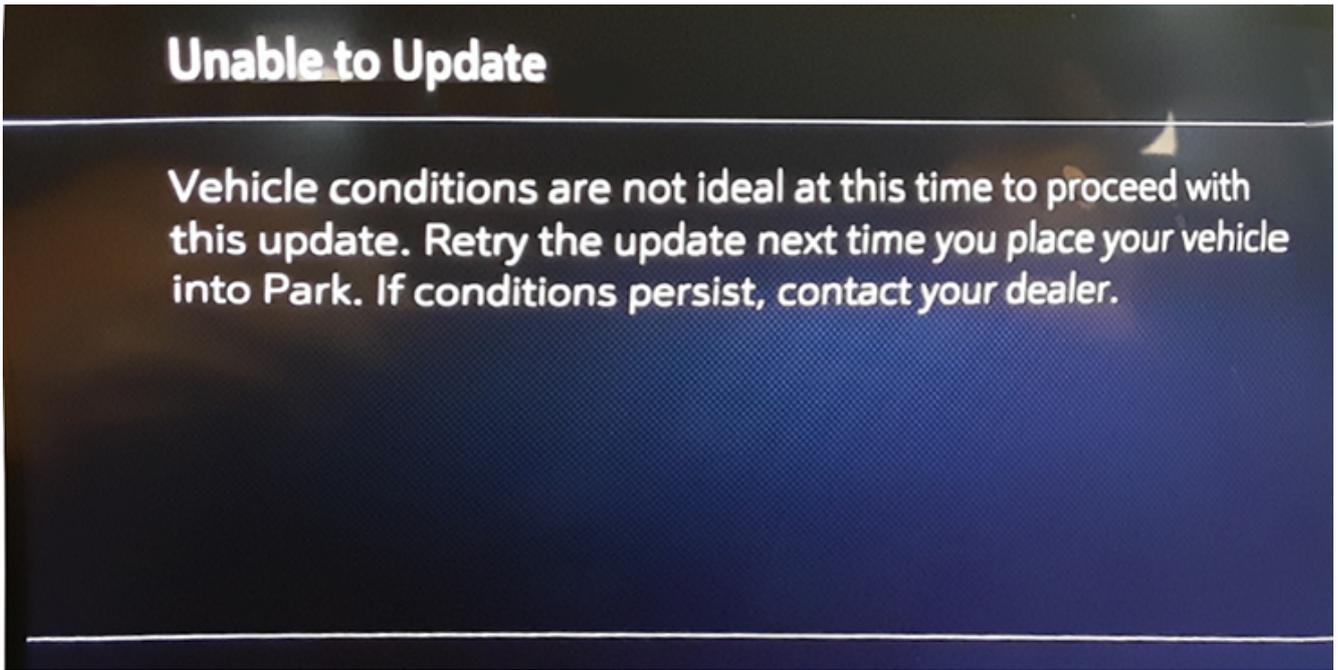
Fig. 4

There are a number of criteria that must be met in order to successfully complete the software update installation on a vehicle. The most common cause of being unable to complete an installation is the State of Charge (SOC)

of the 12V battery. If the 12V battery does not meet the minimum SOC requirement of 70 percent or greater along with an Outside Ambient Temperature (OAT) greater than 14°F (-10°C), the OTA update installation will not occur. The colder the ambient air temperature is, the higher the target SOC becomes. To determine the battery SOC for VIP vehicles, go to BCM / 12V Battery / Battery Sensor Module – State of Charge in GDS 2.

There may be other conditions that will affect an OTA update installation. If any of these conditions are present, a “Vehicle Conditions Not Ideal” message may display on the infotainment screen stating that conditions are not ideal to proceed with the update installation. These conditions do not indicate a failure; only that the vehicle does not meet all the criteria necessary to complete the OTA update installation. (Fig. 4)

If a low battery SOC is preventing the OTA update installation, the 12V battery should be charged to meet the target SOC of 70 percent.

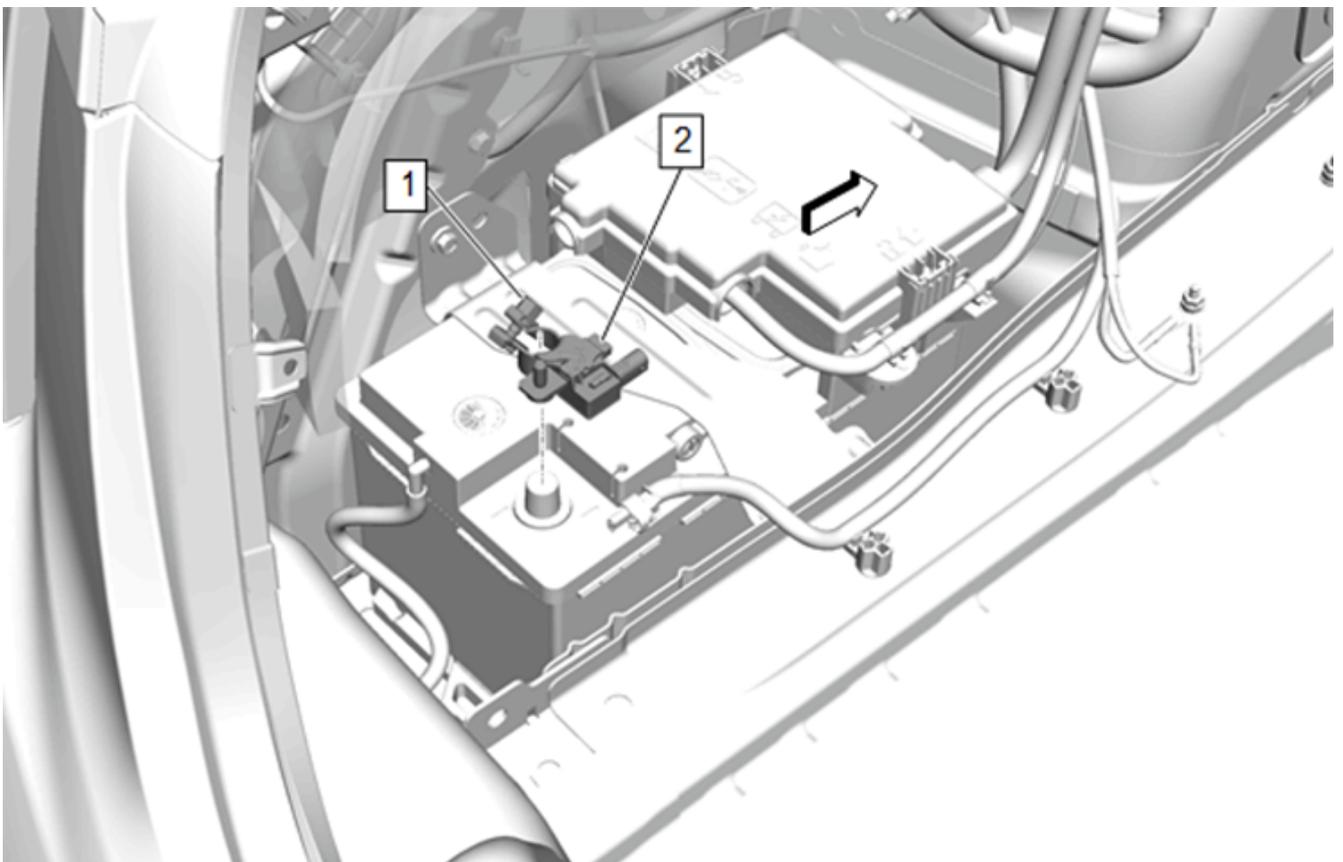
Fig. 5

On some GM models, connecting the battery charger directly to the 12V battery posts will bypass the Battery Sensor Module, resulting in a default SOC value of 65 percent and a “Conditions Not Met” message.

TIP: The Battery Sensor Module (Fig. 5) is attached directly to the battery

negative terminal. It determines the battery condition by calculating the battery SOC, functions, and state of health, which is used to help determine if the 12V Stop/Start system will allow an Auto Stop when the vehicle has come to a stop. To properly charge the battery, the negative lead of the charger must be connected to chassis ground, and not directly to the negative battery post. Connecting to chassis ground allows current to flow through the Battery Sensor Module during charging as well as be monitored. Connecting directly to the negative battery post charges the battery, but the current cannot be monitored by the Battery Sensor Module.

If a battery is improperly charged, the Battery Sensor Learn will be required to calibrate the Battery Sensor Module. With the ignition off, let the vehicle rest for a minimum of four hours without any interruptions (opening a door, using the key fob, etc.). Verify if the battery SOC is 70 percent or greater using GDS 2 before attempting to continue with an OTA update.
