1963 - 1982 Corvette: Rotor Bearing Installation

Submitted by: GTR1999

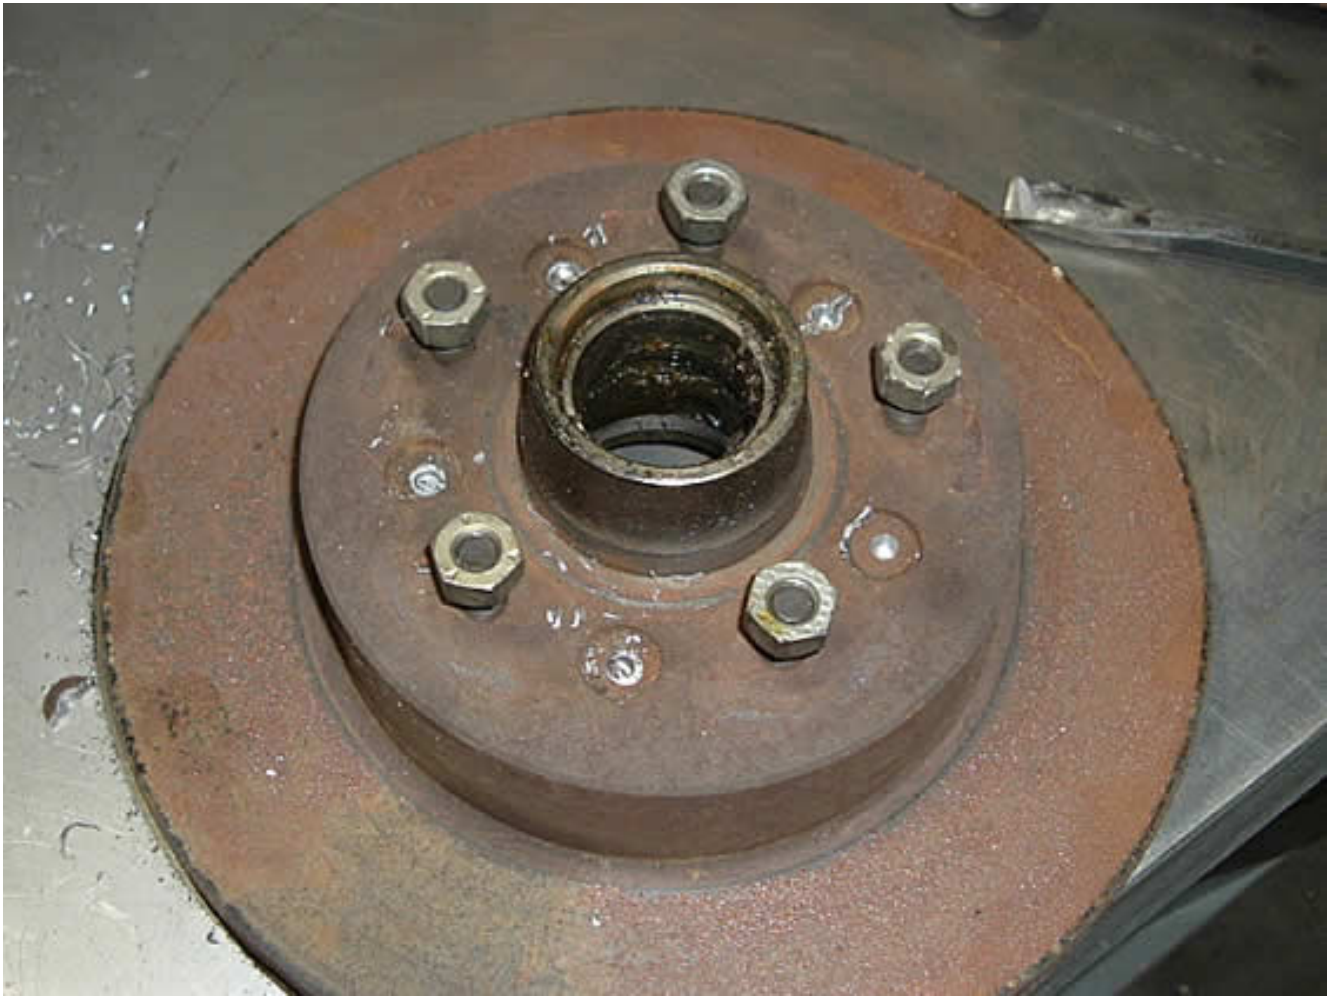
Here we have a rotor in typical used condition. Notice I already started on the rivets.

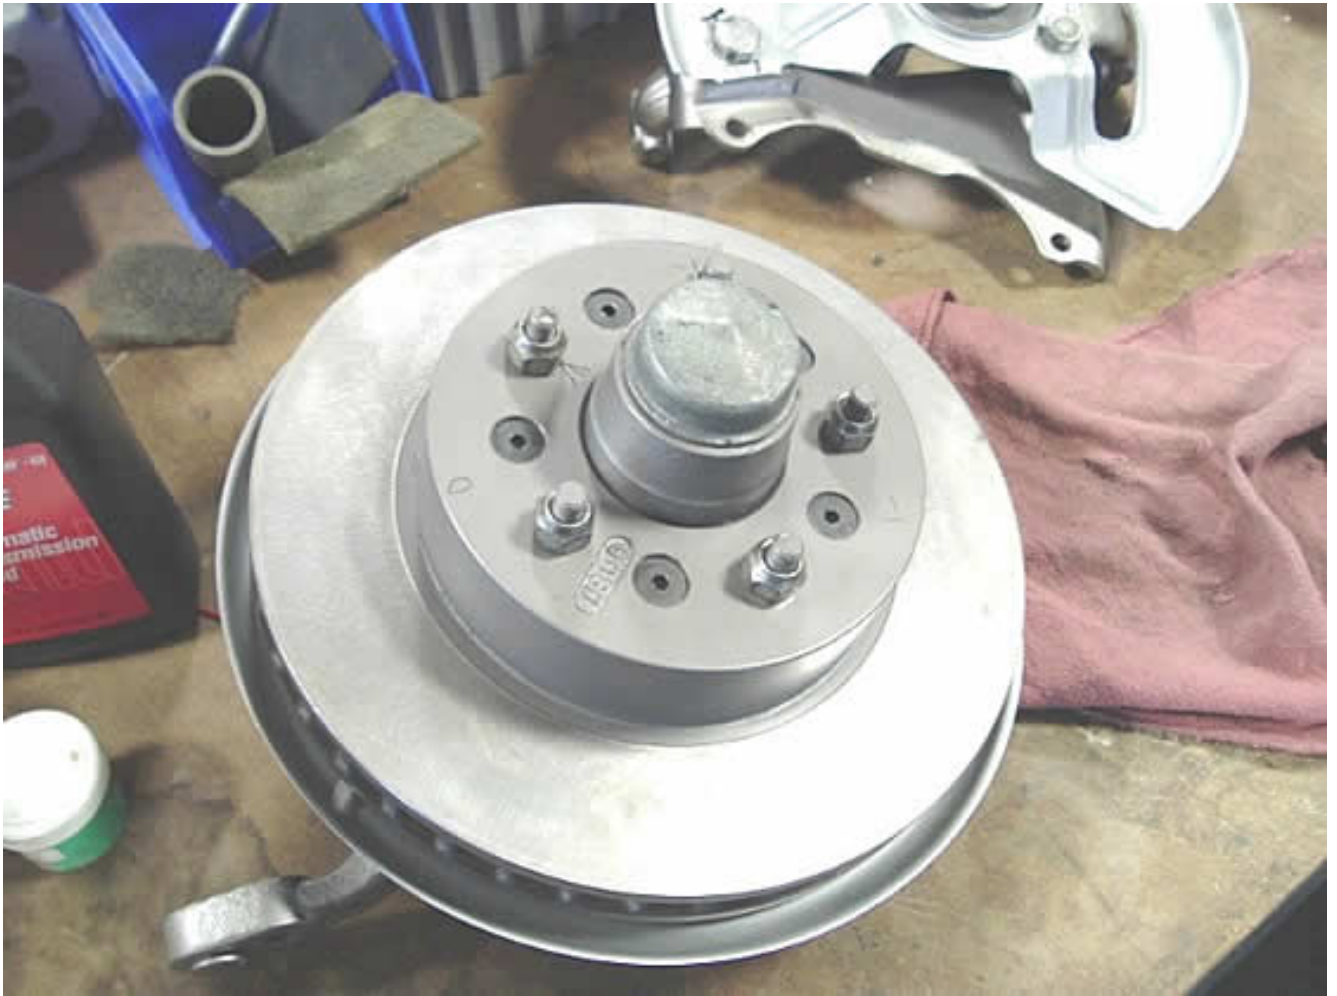
Here is my finished 72 assembly, look at the grease cap. It is the original GM one.

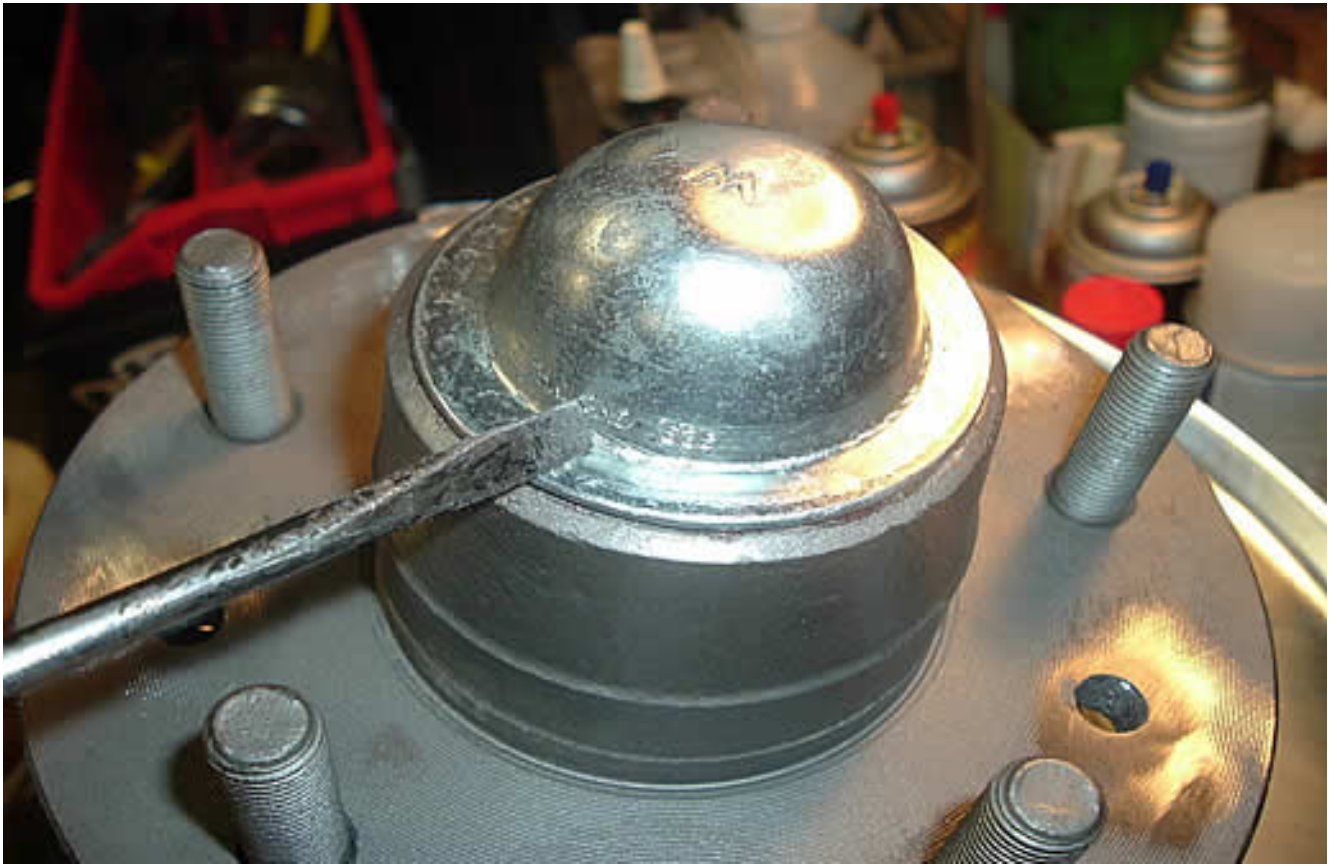
Here is the cap on the spindles I'm now doing. Not the same.

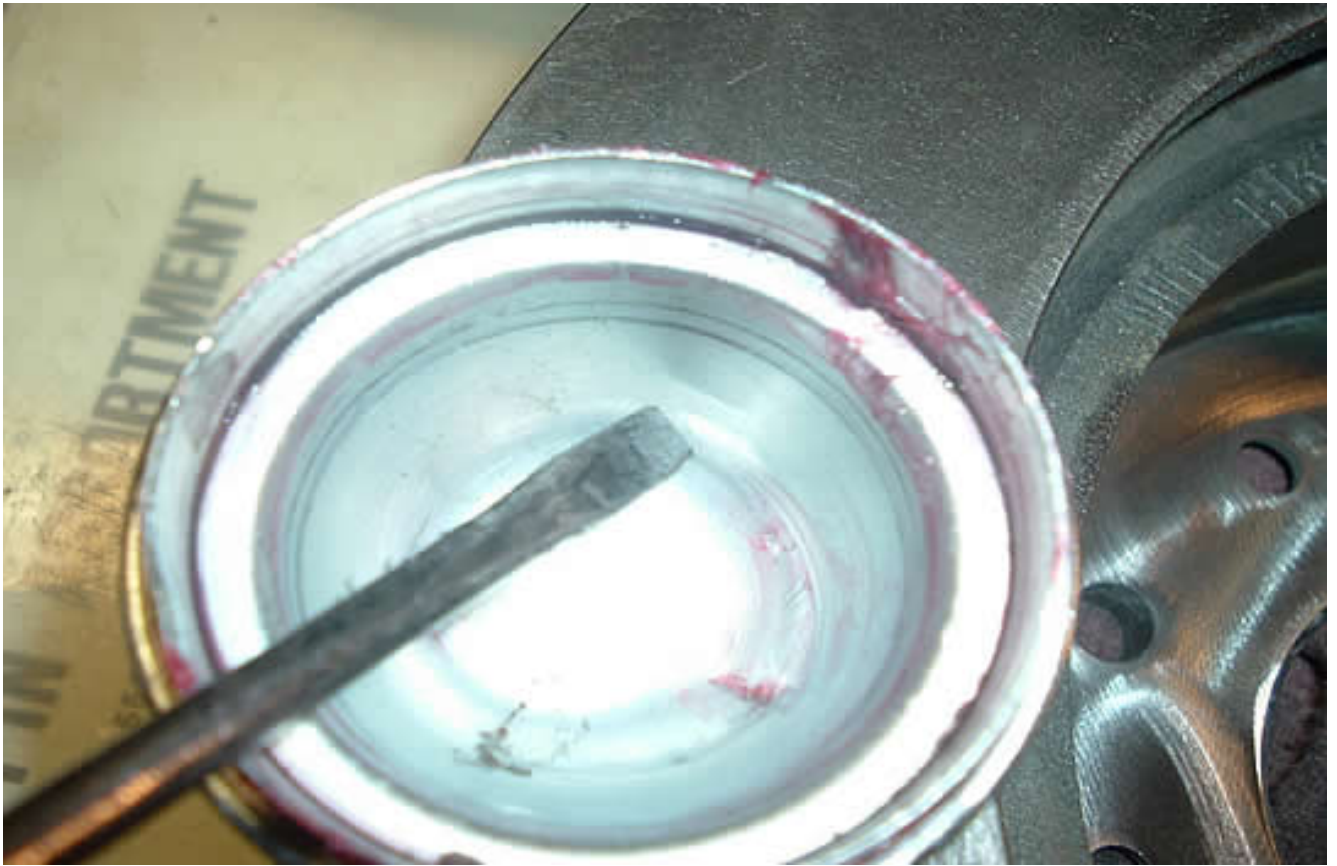
The cap's inner radius is tighter. I wondered why the bearings were getting snug after I set them up and installed the cap. The cotter pin was hitting the narrow inside angle and dragging. I installed a new pin and fit it under the cap with no drag.

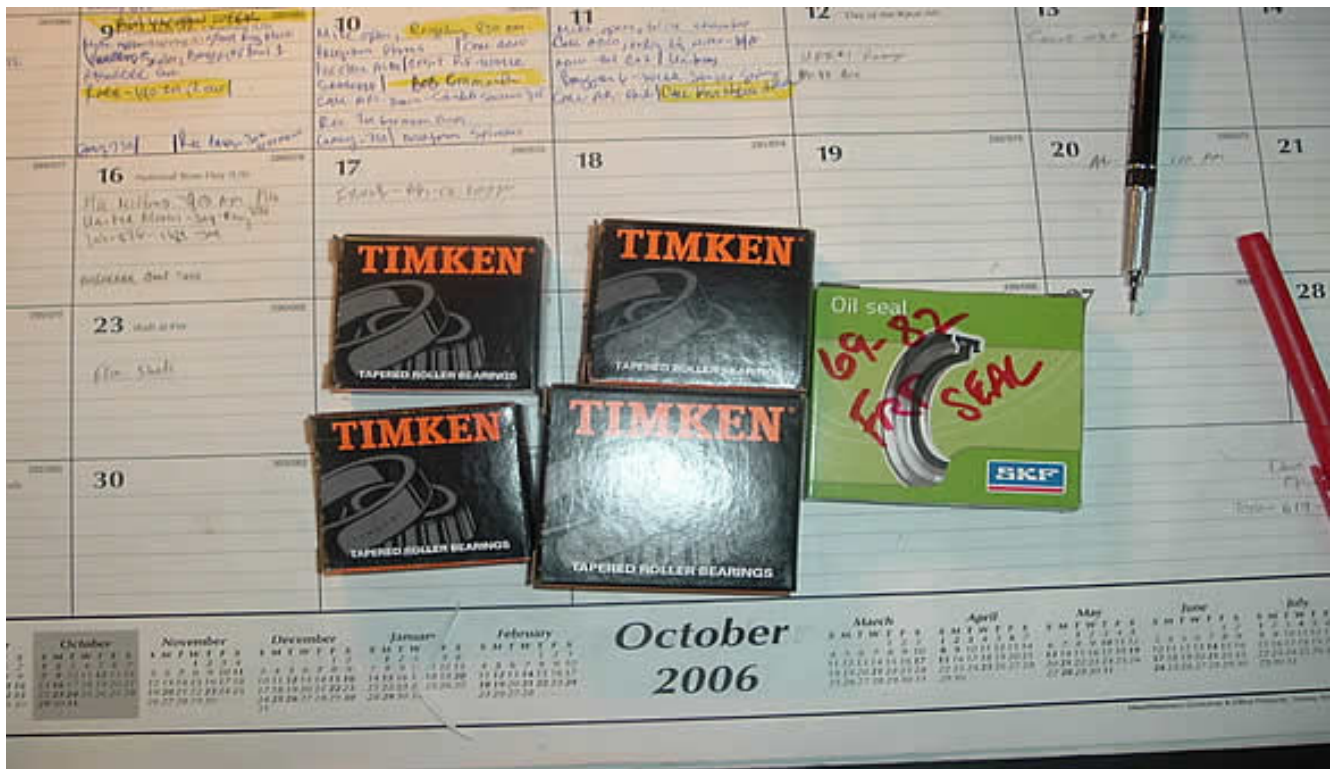
These are the only bearings I use. I think they're still made in the USA- but for how long? Several times this year I opened up front and rear bearings that were supposed to have new Timkens installed only to find imported no name bearings.

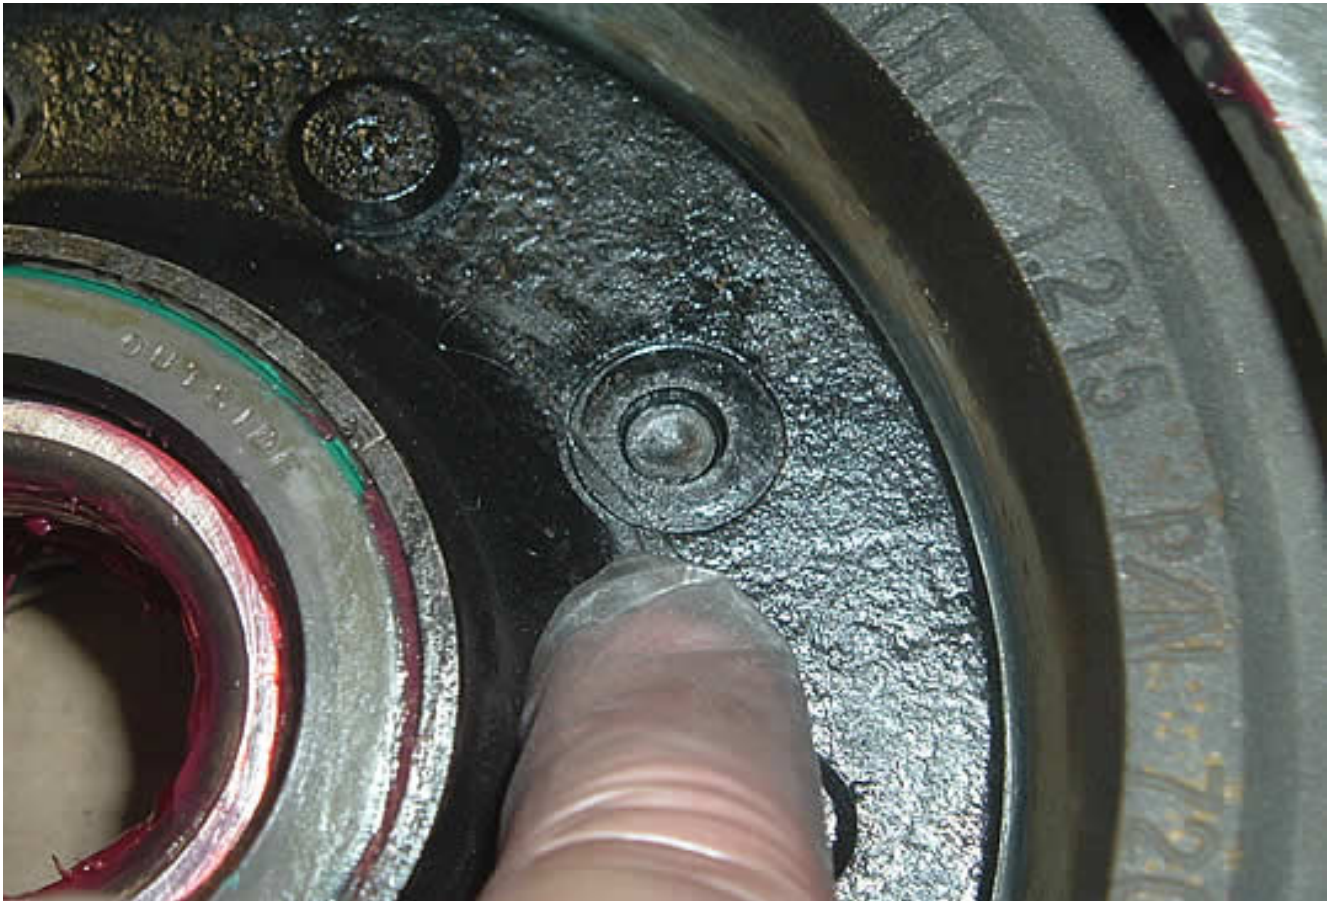
Notice the flat heads don't protrude beyond the tapped hole.

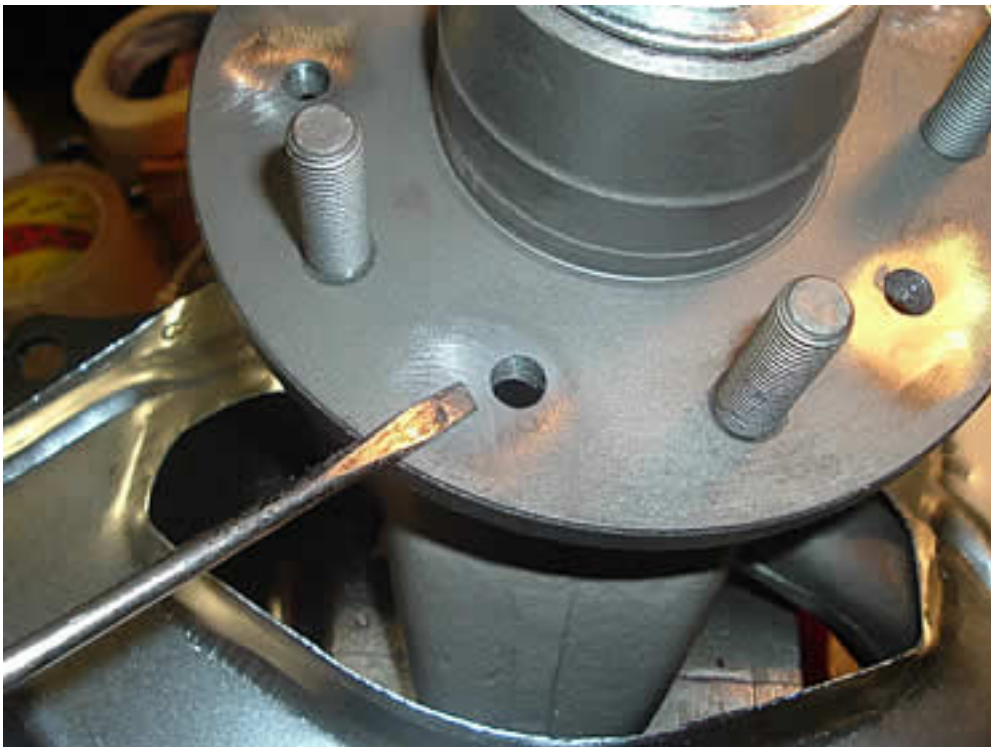
Here is the hub flange. Tapped 3/8-24 and the holes ground. Notice the turning lines still in the flange, there was no rust on this 35 year old part. The runout with the new rotor was .008" to start.

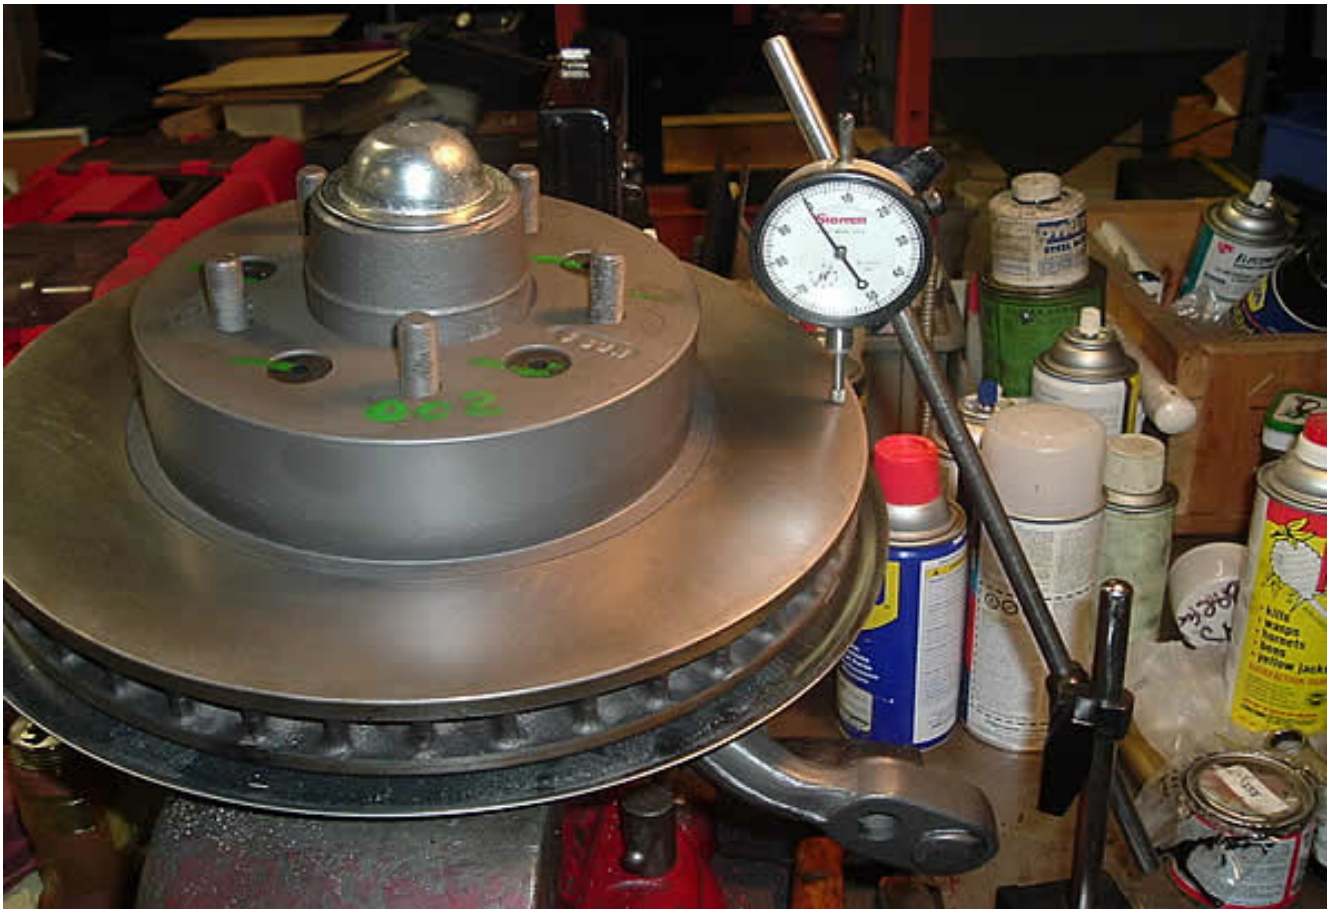
With the rotor bolted on and the bearings set to .001-.002 endplay I setup the indicator. I had to shim one location to get it just under .002" total runout. It's closer to .0015" but I marked it at .002'.

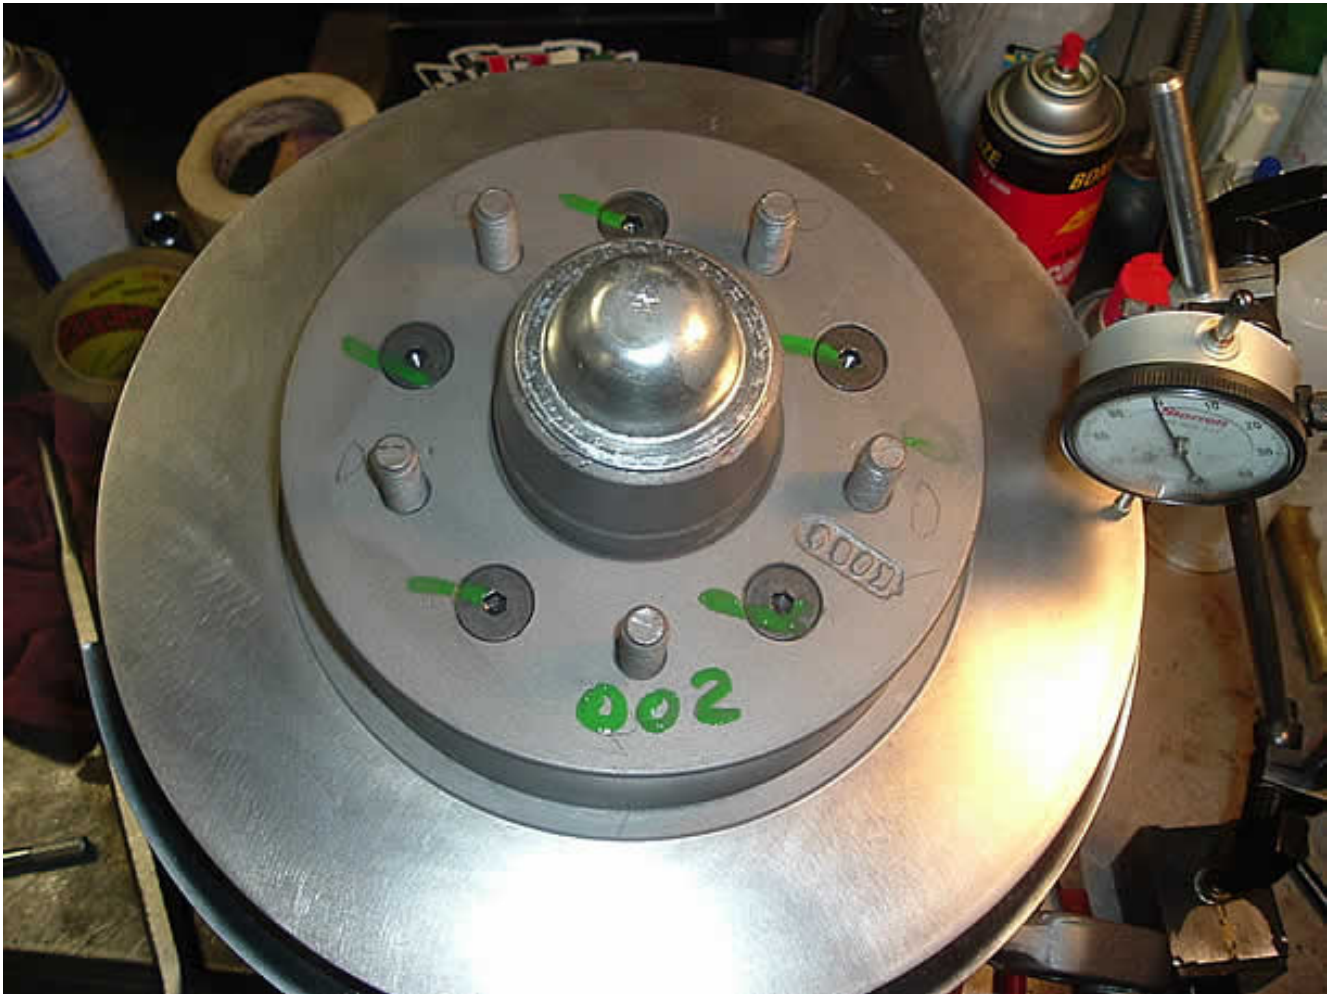
Here is the finished job. The green paint witness marks the rotor to hub location.
