1963 - 1982 Corvette: Rotor Bearing Installation

Submitted by: GTR1999

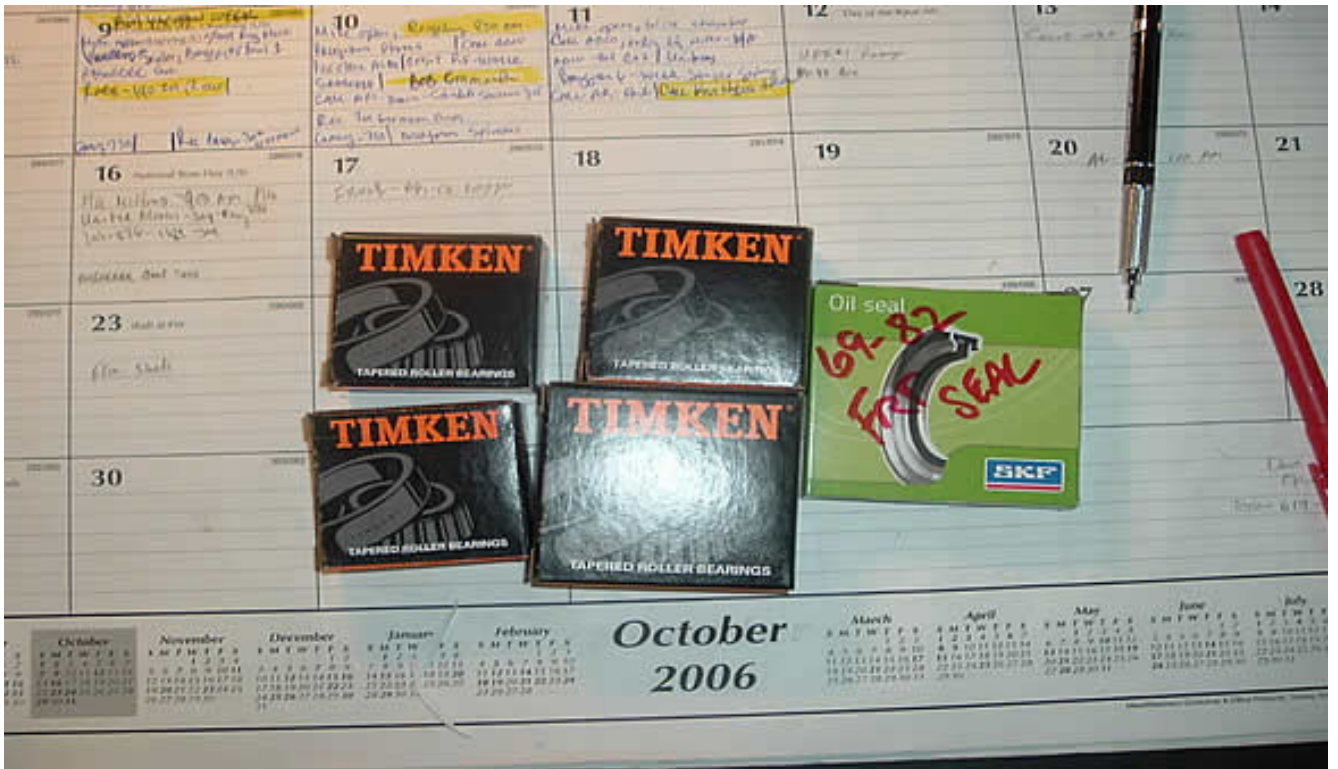
These are the only bearings I use. I think they're still made in the USA- but for how long? Several times this year I opened up front and rear bearings that were supposed to have new Timkens installed only to find imported no name bearings.

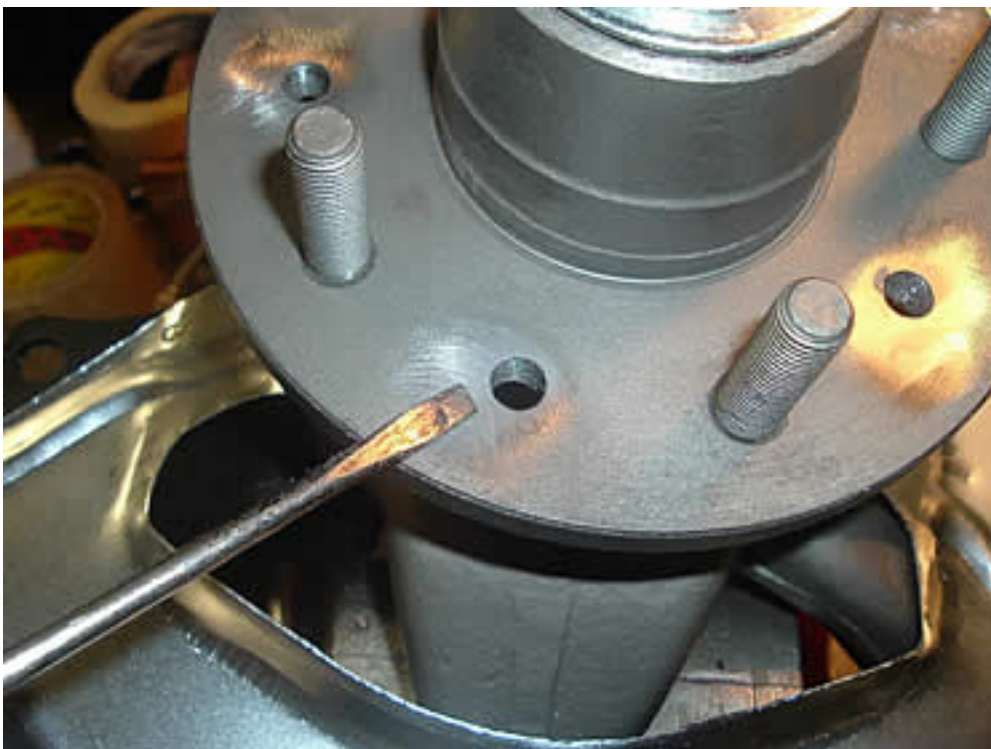
Here is the hub flange. Tapped 3/8-24 and the holes ground. Notice the turning lines still in the flange, there was no rust on this 35 year old part. The runout with the new rotor was .008" to start.

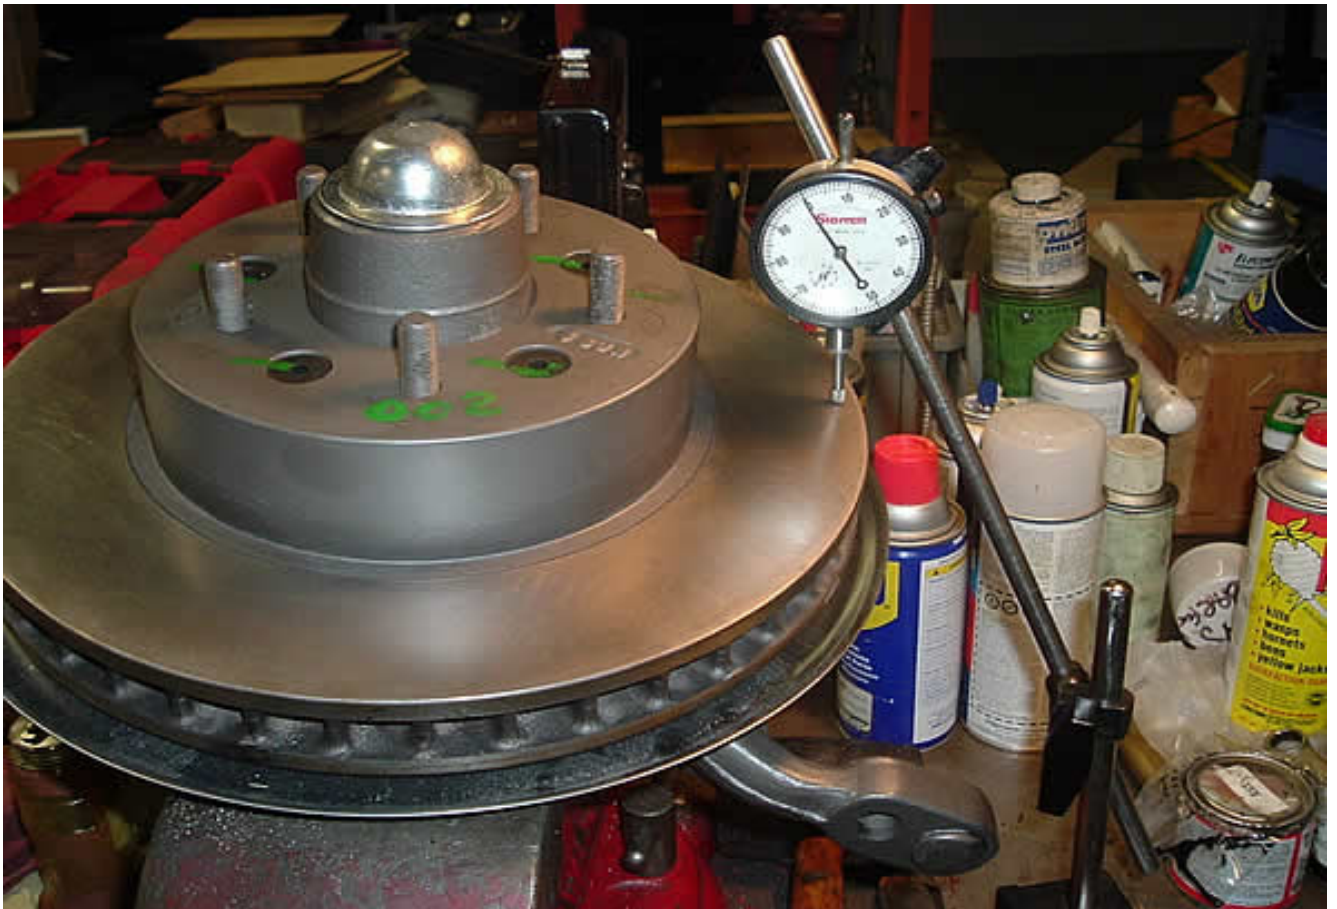
With the rotor bolted on and the bearings set to .001-.002 endplay I setup the indicator. I had to shim one location to get it just under .002" total runout. It's closer to .0015" but I marked it at .002'.

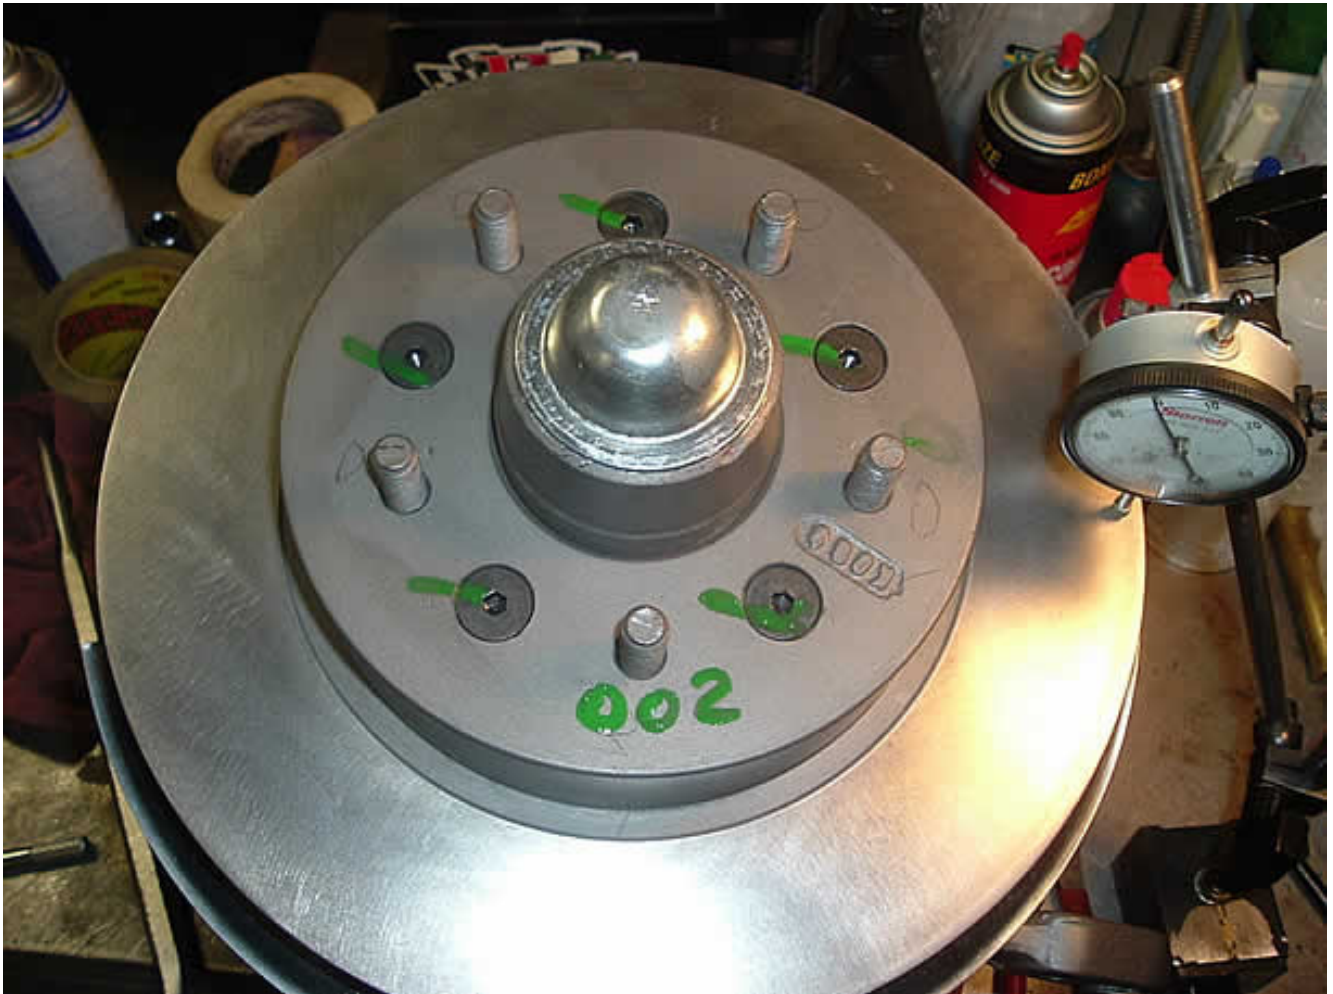
Here is the finished job. The green paint witness marks the rotor to hub location.
