# 1963 - 1982 Corvette: Rotor Bearing Installation

Submitted by: GTR1999

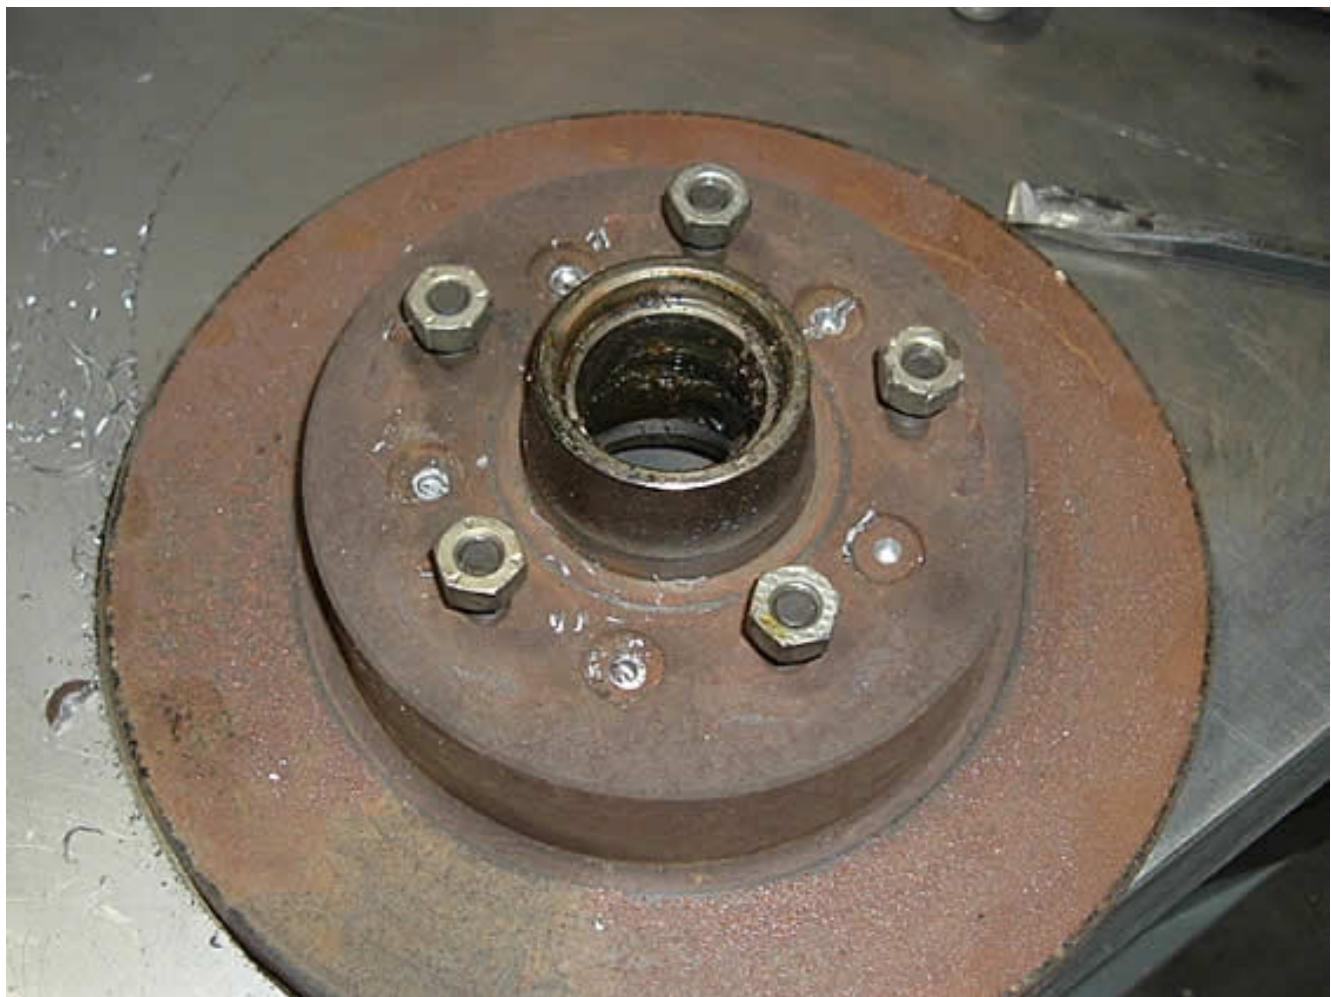
Here we have a rotor in typical used condition. Notice I already started on the rivets.

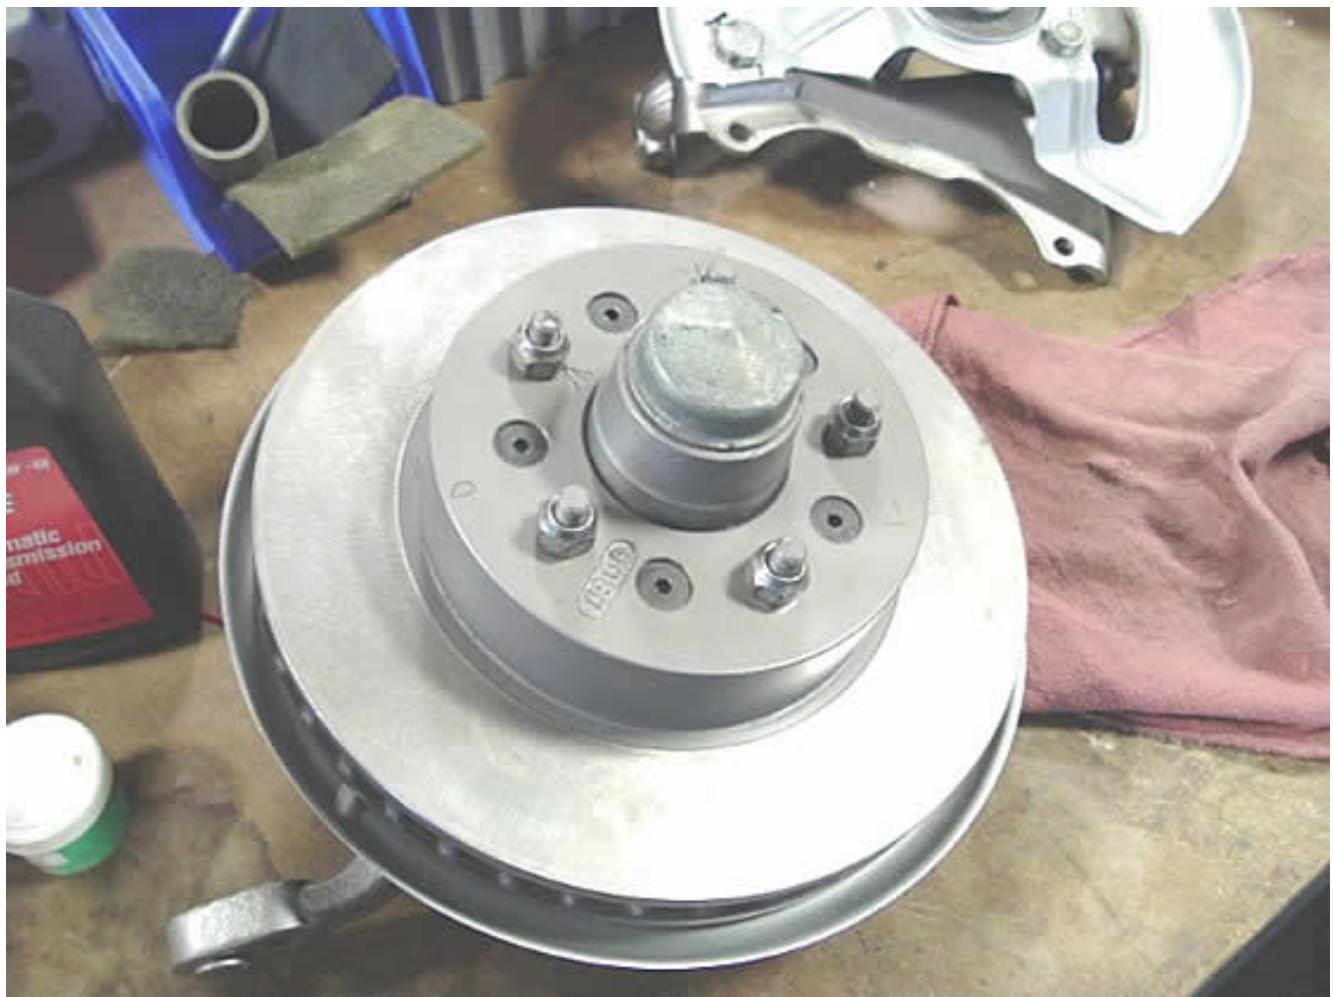
Here is my finished 72 assembly, look at the grease cap. It is the original GM one.

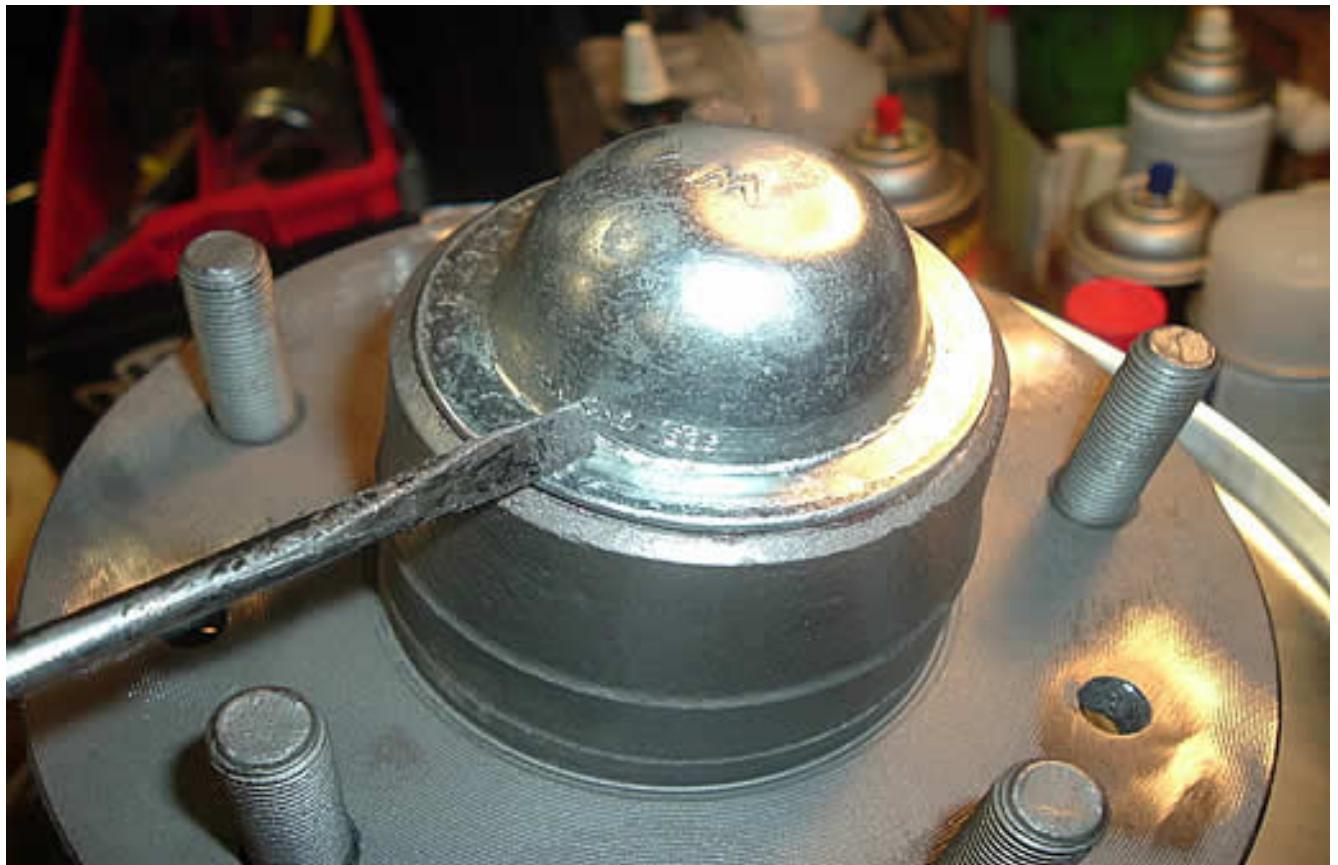
Here is the cap on the spindles I'm now doing. Not the same.

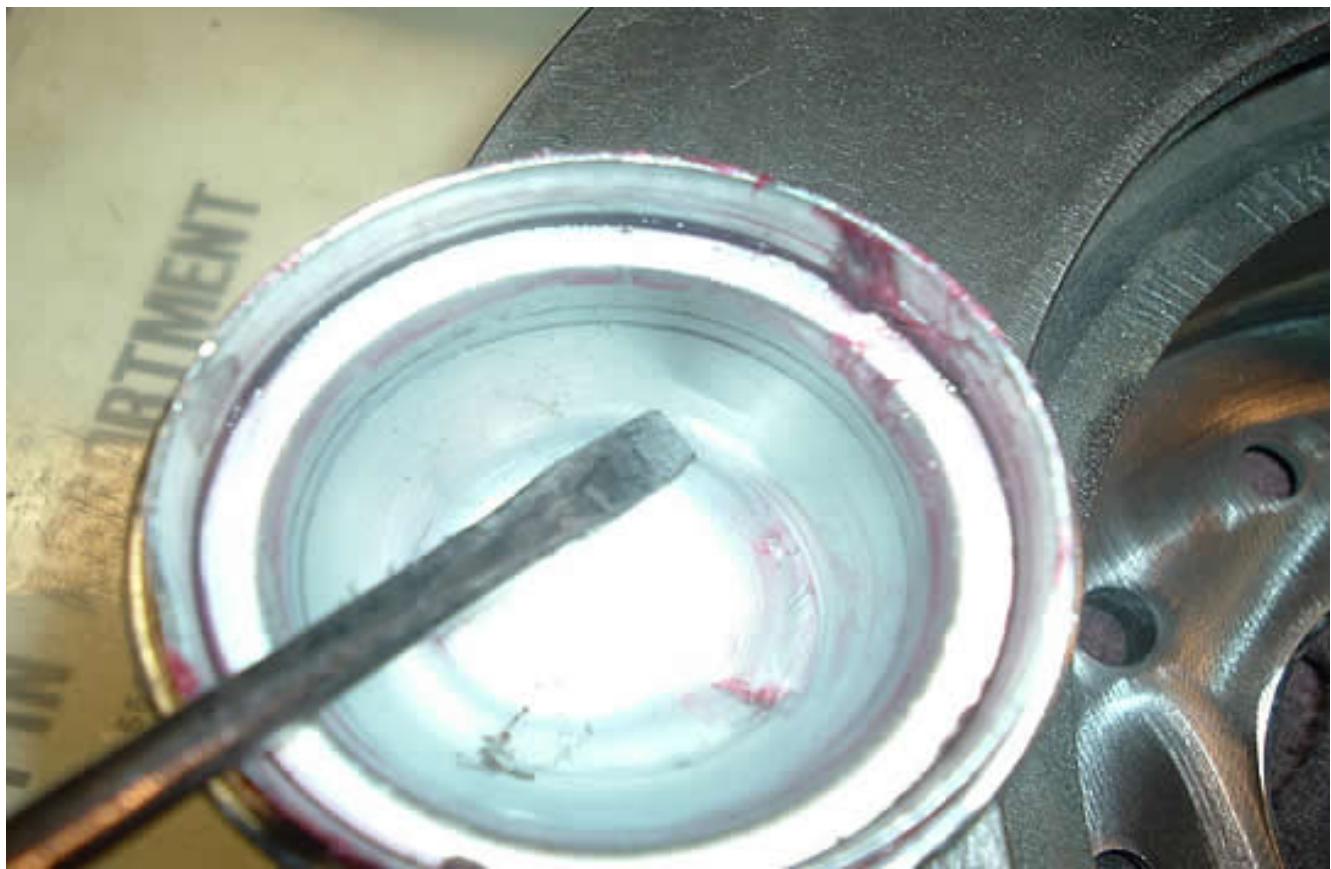
The cap's inner radius is tighter. I wondered why the bearings were getting snug after I set them up and installed the cap. The cotter pin was hitting the narrow inside angle and dragging. I installed a new pin and fit it under the cap with no drag.

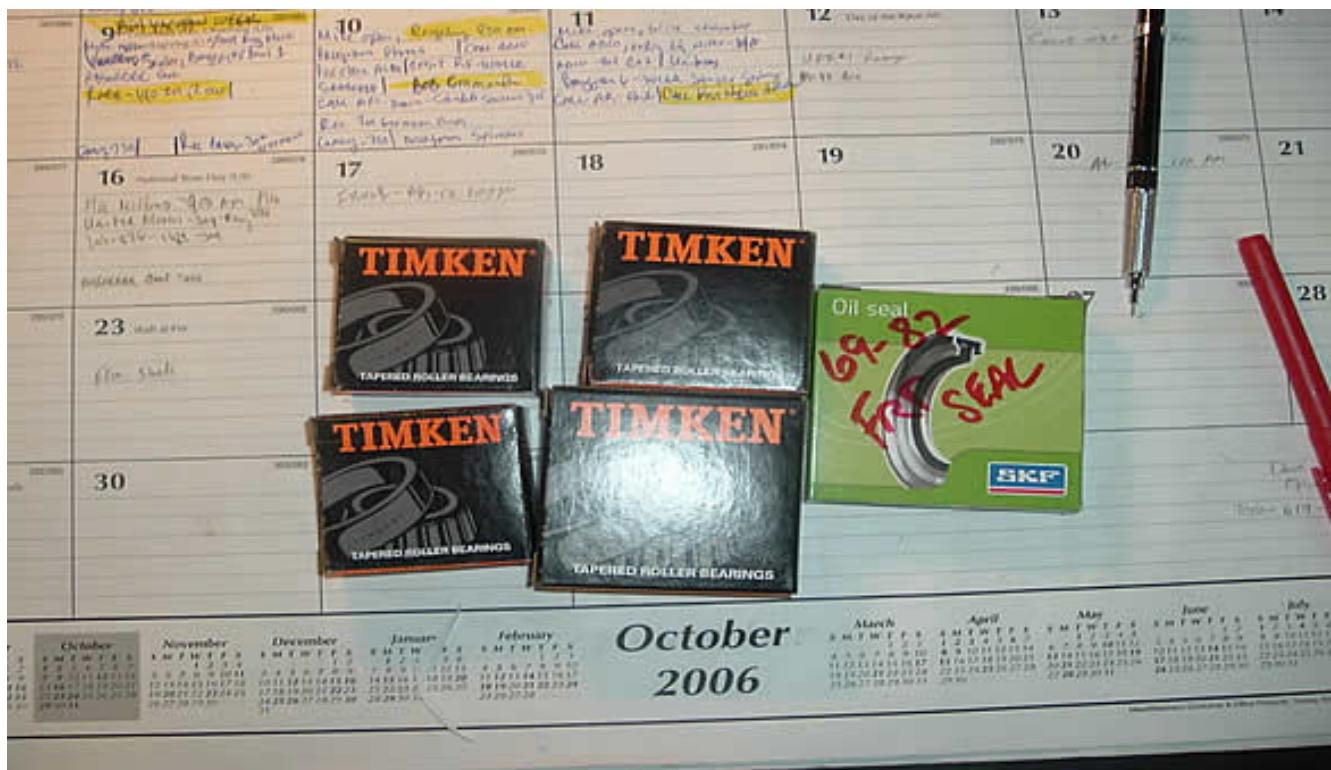
These are the only bearings I use. I think they're still made in the USA- but for how long? Several times this year I opened up front and rear bearings that were supposed to have new Timkens installed only to find imported no name bearings.

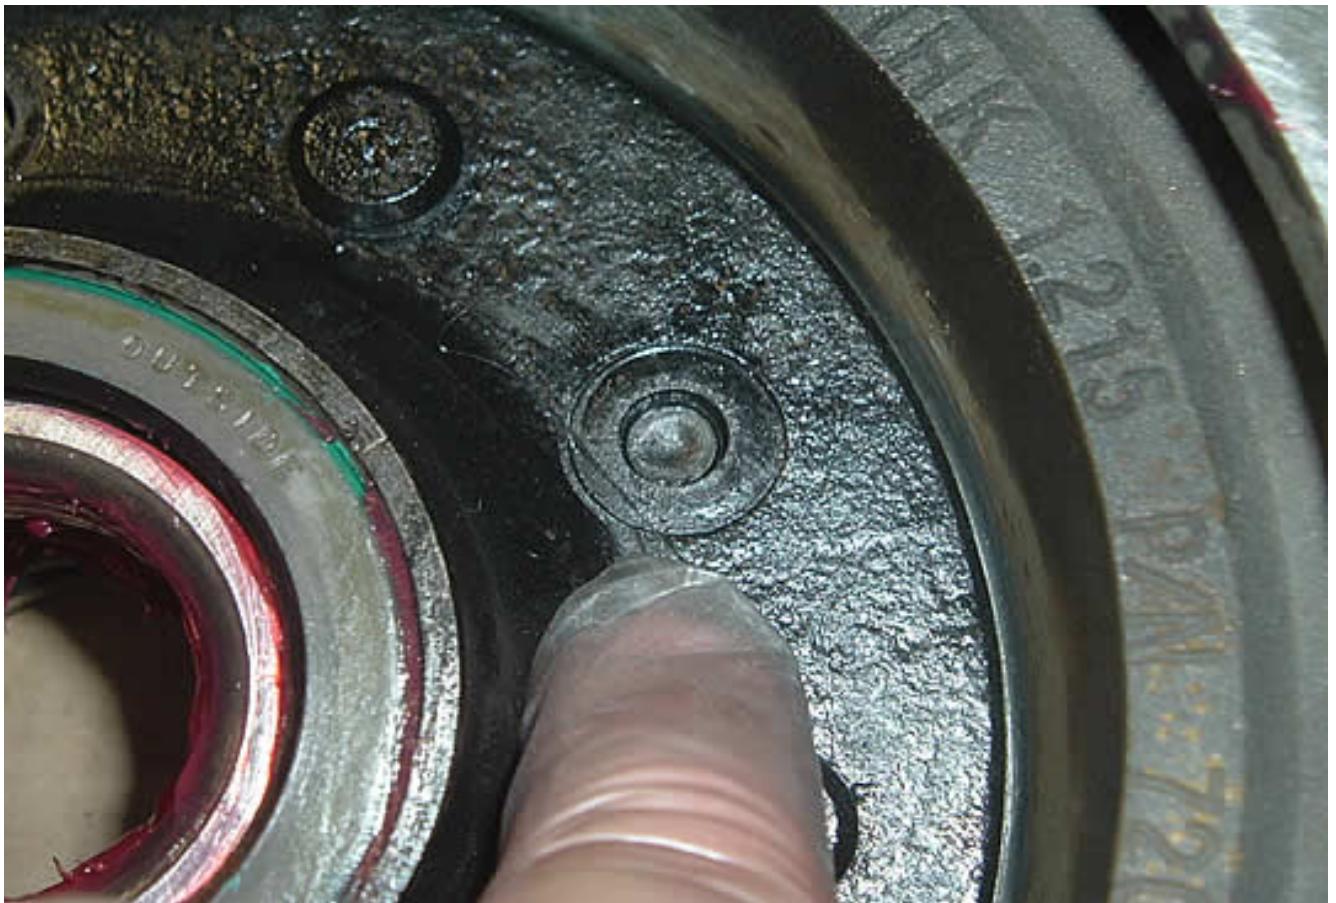
Notice the flat heads don't protrude beyond the tapped hole.

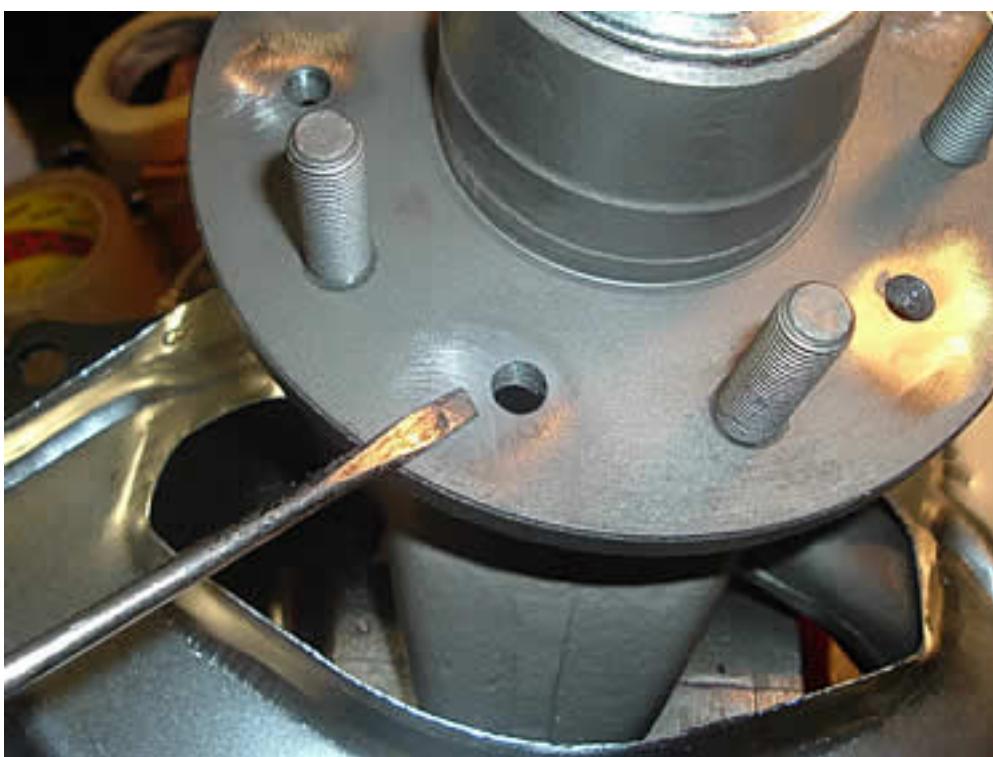
Here is the hub flange. Tapped 3/8-24 and the holes ground. Notice the turning lines still in the flange, there was no rust on this 35 year old part. The runout with the new rotor was .008" to start.

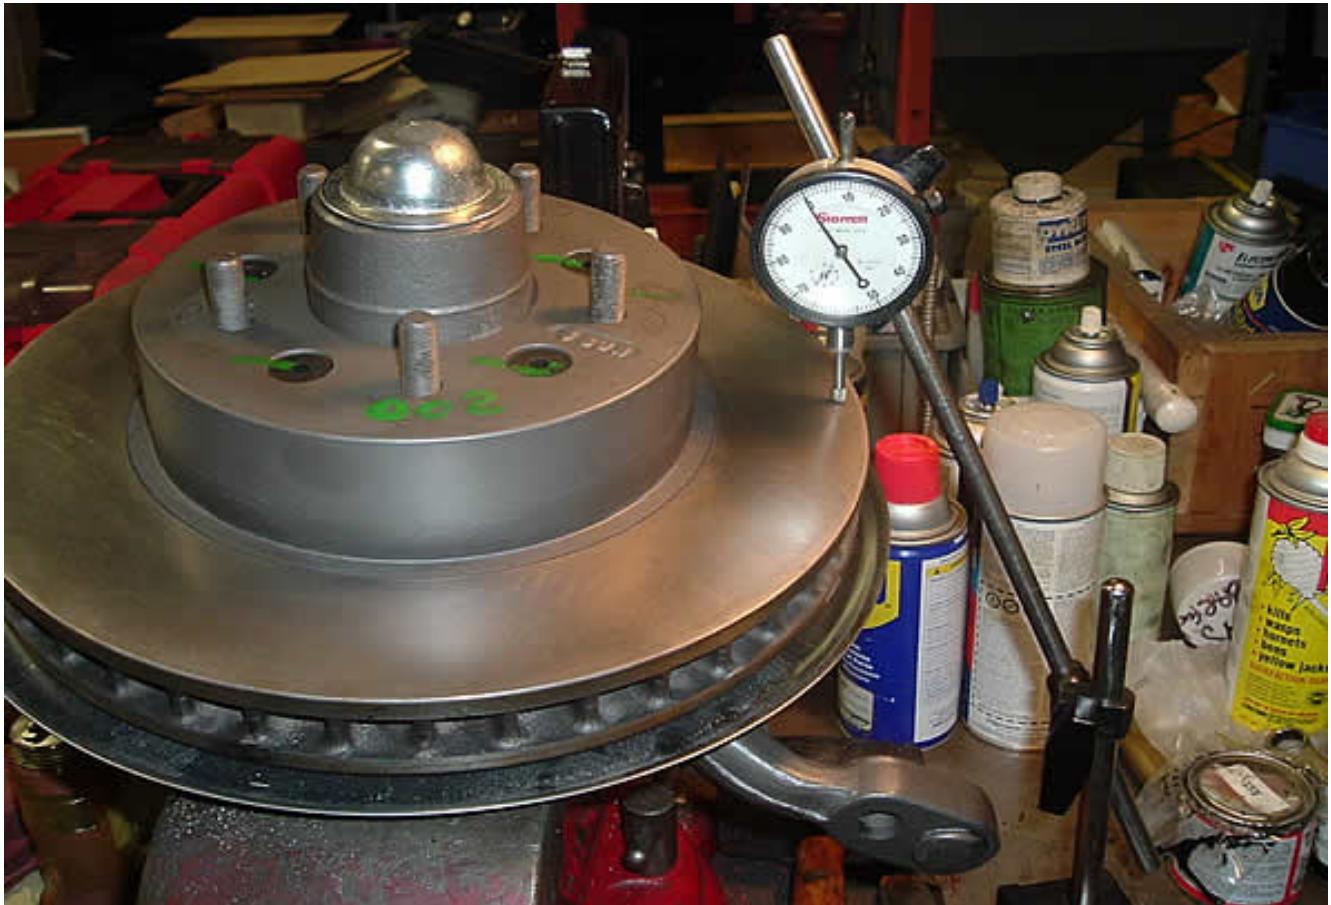
With the rotor bolted on and the bearings set to .001-.002 endplay I setup the indicator. I had to shim one location to get it just under .002" total runout. It's closer to .0015" but I marked it at .002".

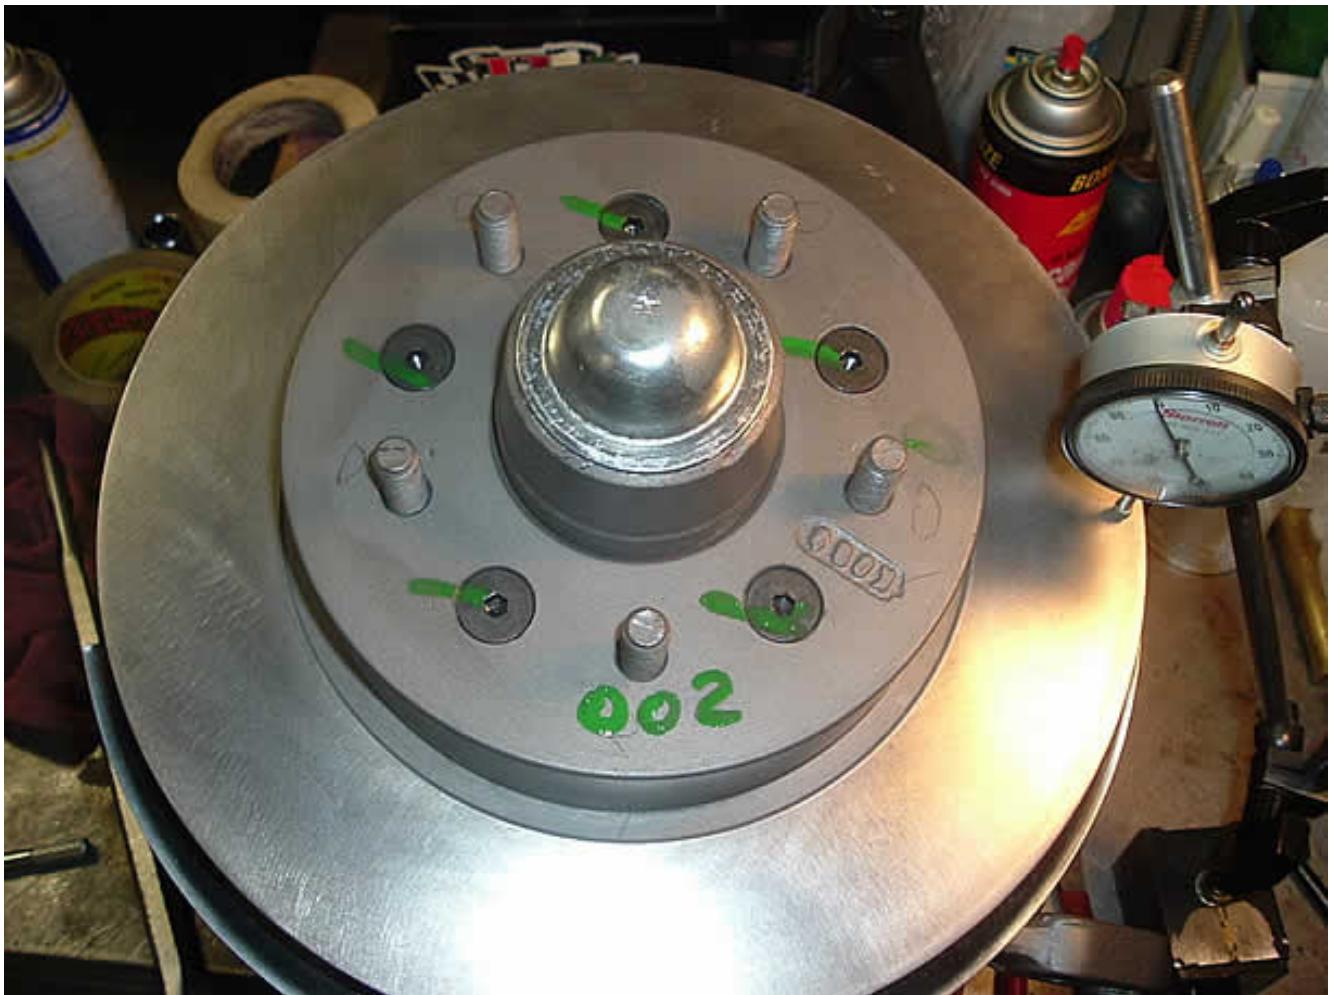
Here is the finished job. The green paint witness marks the rotor to hub location.
