1963 - 1982 Corvette: Rotor Bearing Installation

Submitted by: [GTR1999](#)

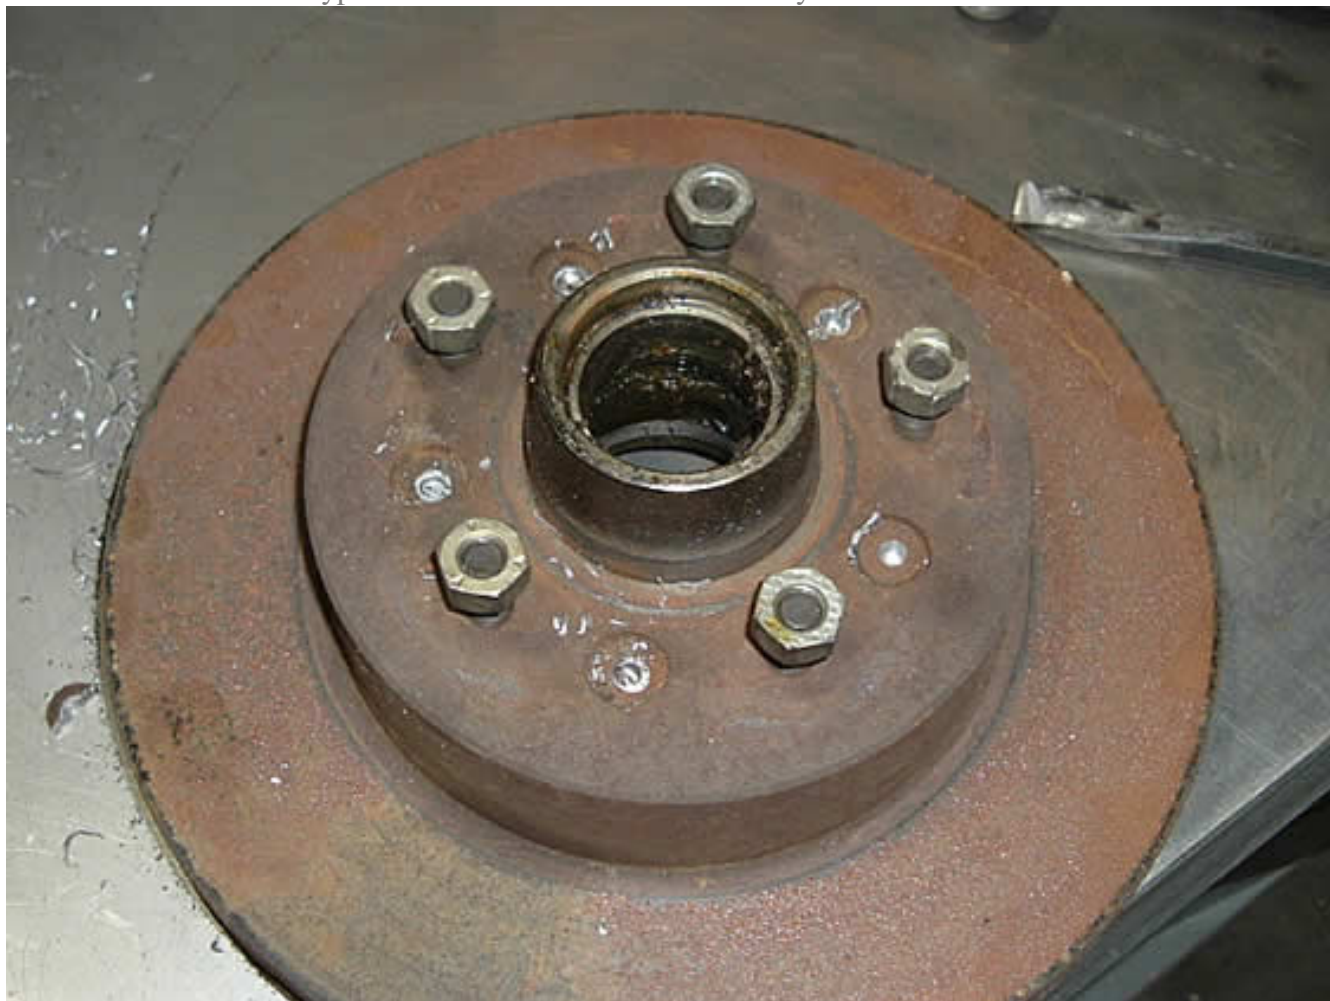
Here we have a rotor in typical used condition. Notice I already started on the rivets.

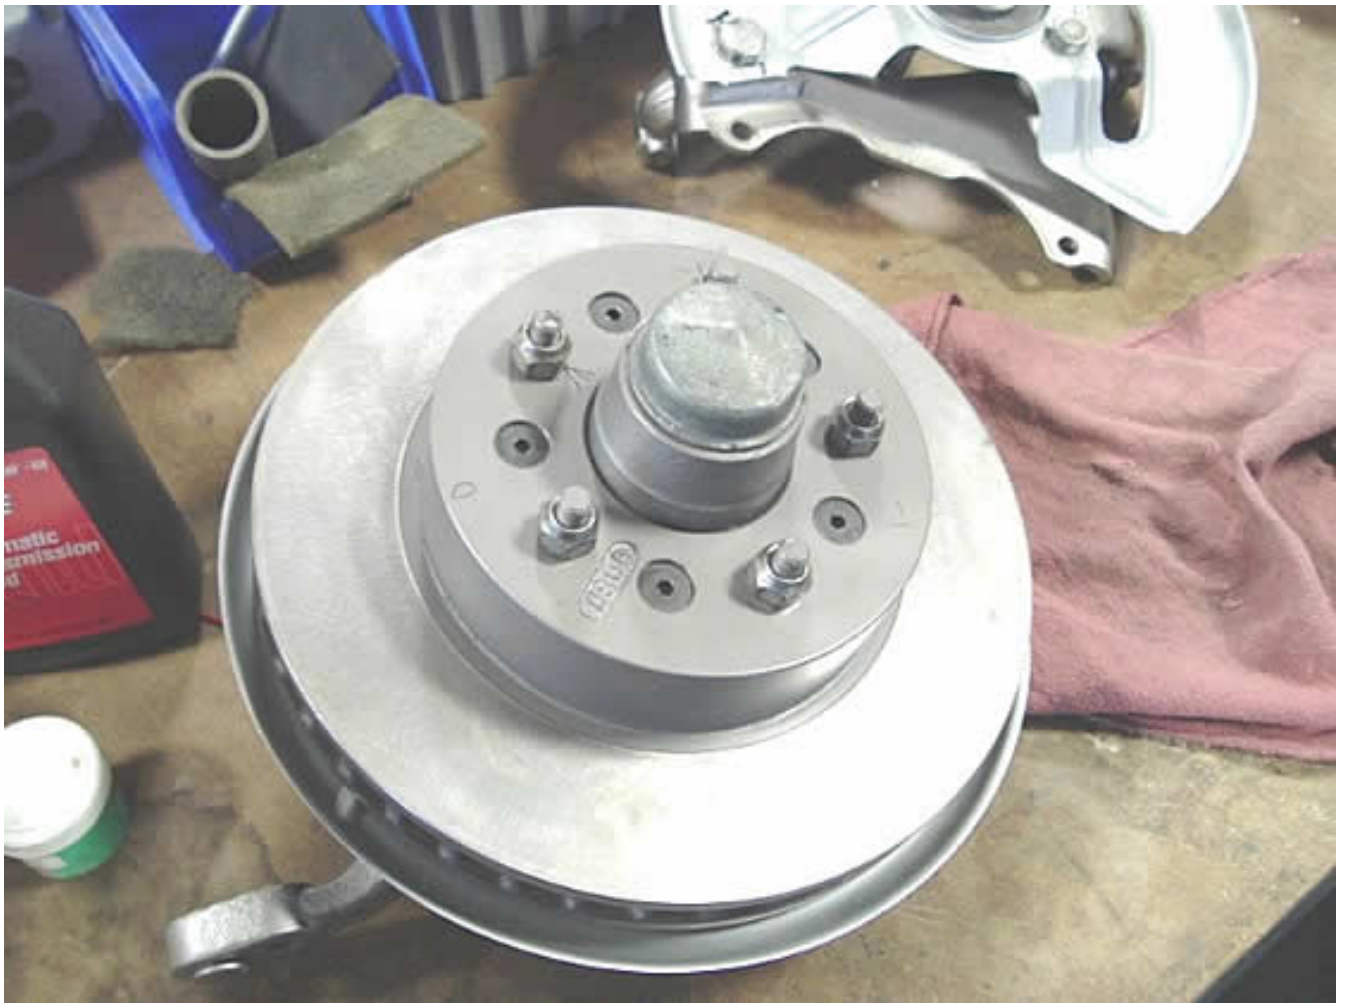
Here is my finished 72 assembly, look at the grease cap. It is the original GM one.

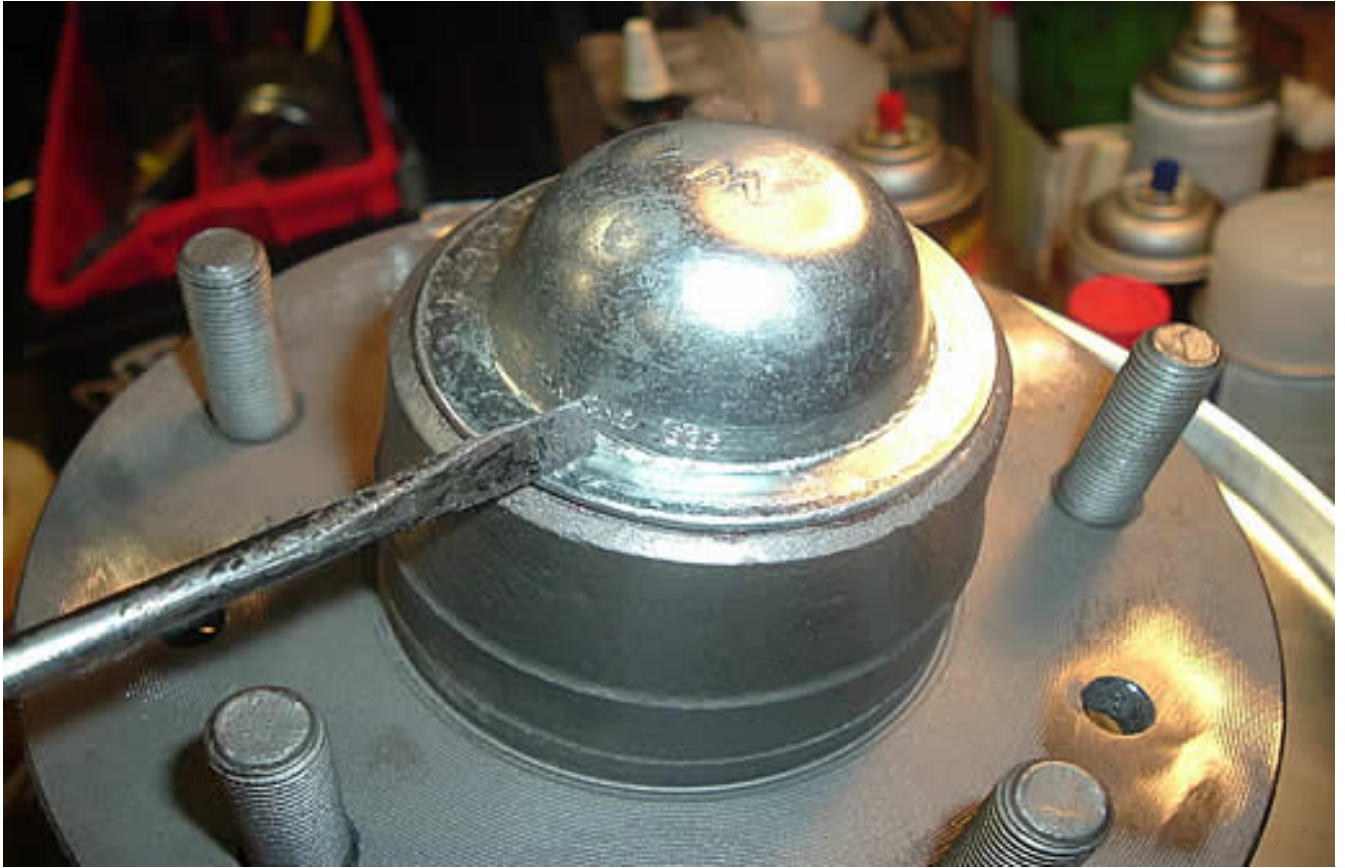
Here is the cap on the spindles I'm now doing. Not the same.

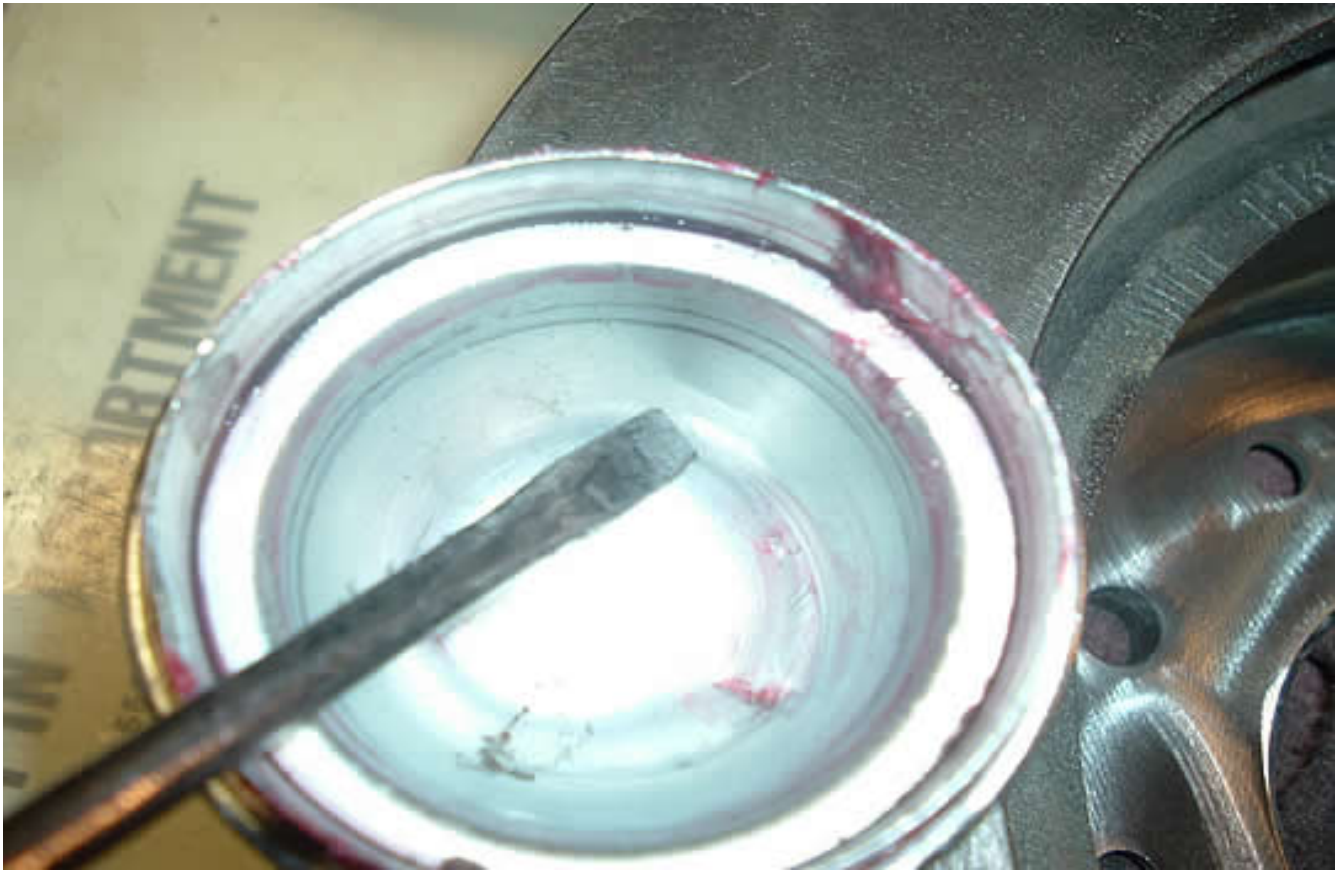
The cap's inner radius is tighter. I wondered why the bearings were getting snug after I set them up and installed the cap. The cotter pin was hitting the narrow inside angle and dragging. I installed a new pin and fit it under the cap with no drag.

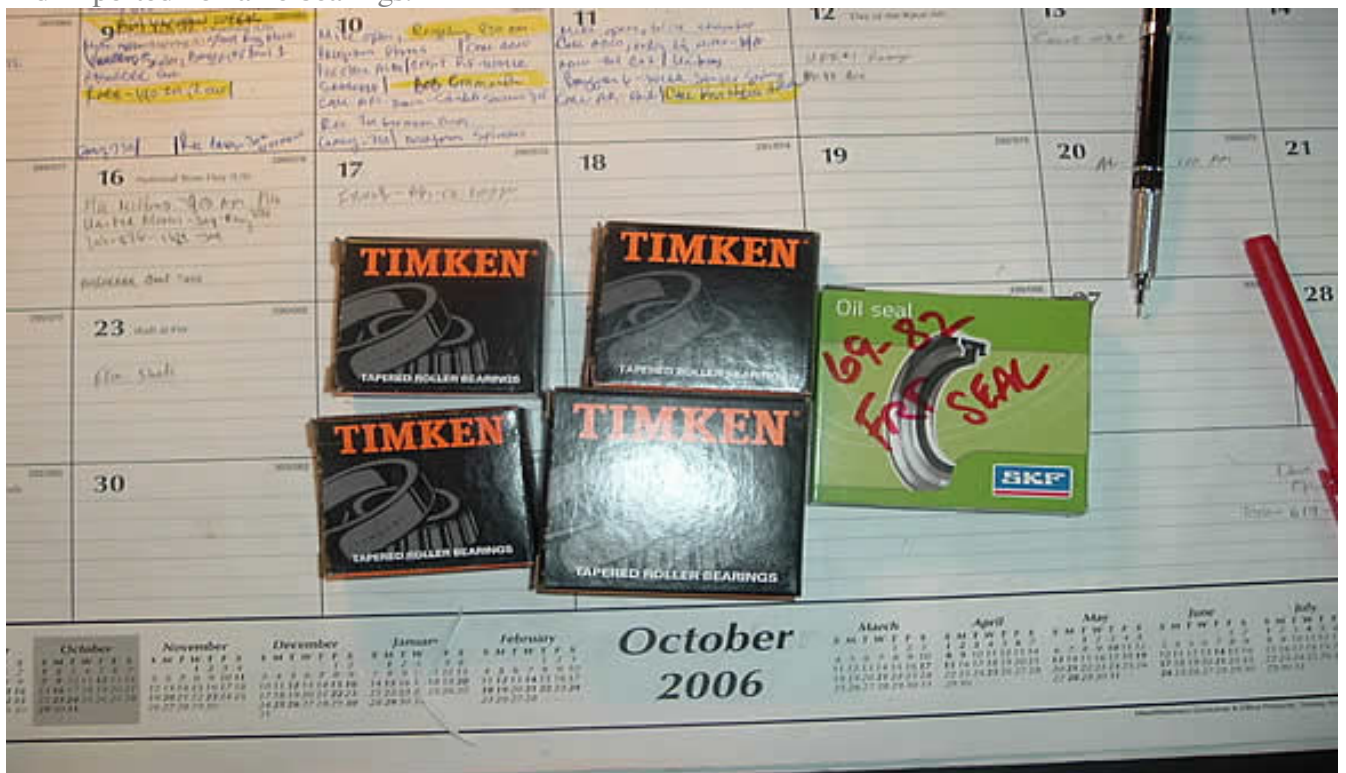
These are the only bearings I use. I think they're still made in the USA- but for how long? Several times this year I opened up front and rear bearings that were supposed to have new Timkens installed only to find imported no name bearings.

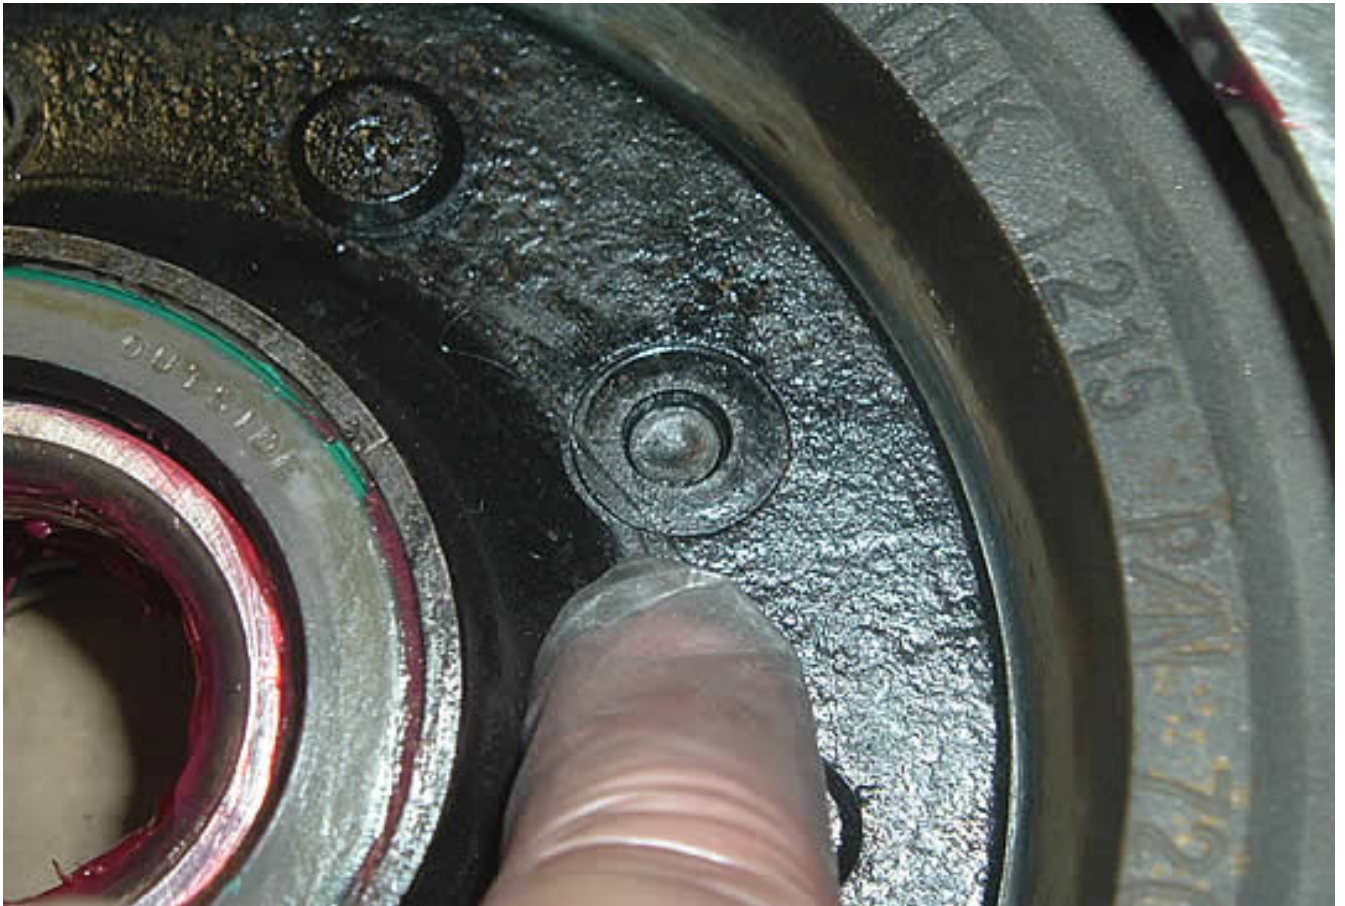
Notice the flat heads don't protrude beyond the tapped hole.

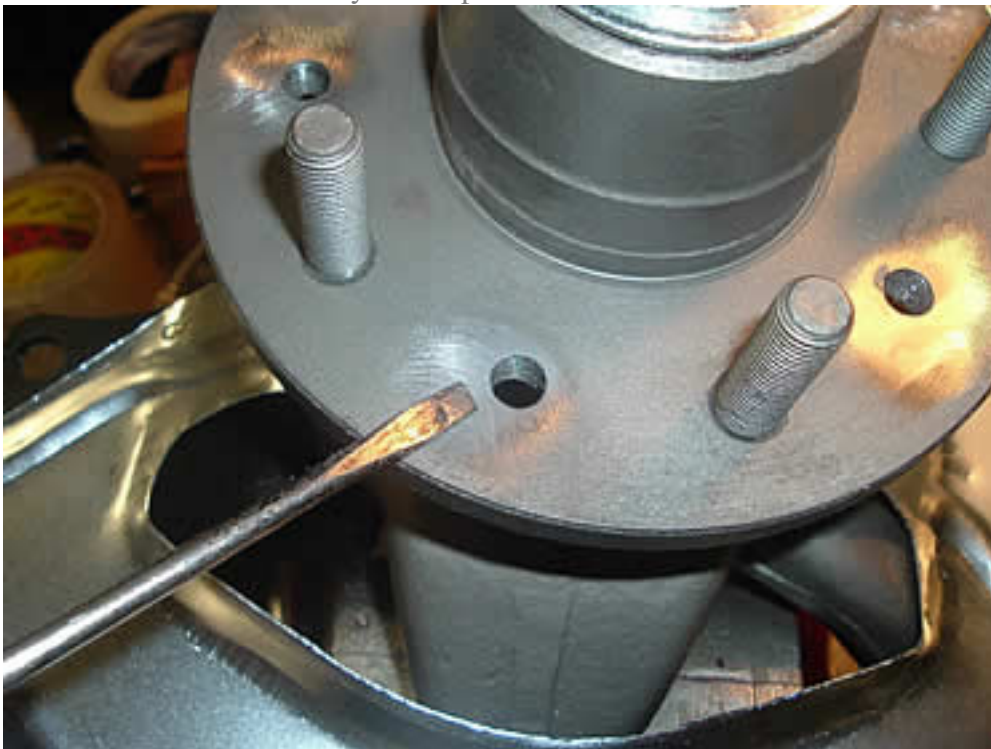
Here is the hub flange. Tapped 3/8-24 and the holes ground. Notice the turning lines still in the flange, there was no rust on this 35 year old part. The runout with the new rotor was .008" to start.

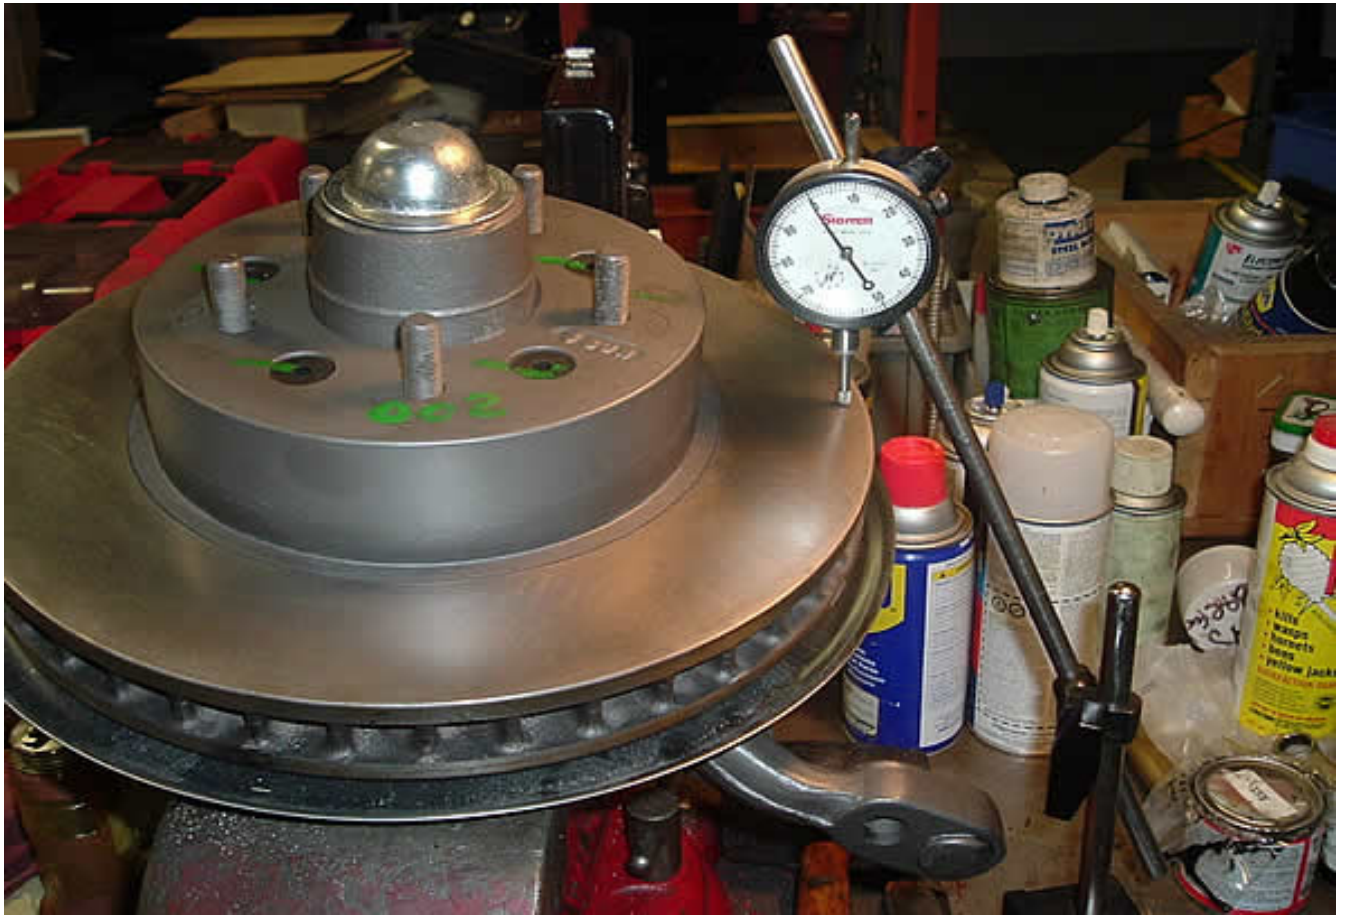
With the rotor bolted on and the bearings set to .001-.002 endplay I setup the indicator. I had to shim one location to get it just under .002" total runout. It's closer to .0015" but I marked it at .002'.

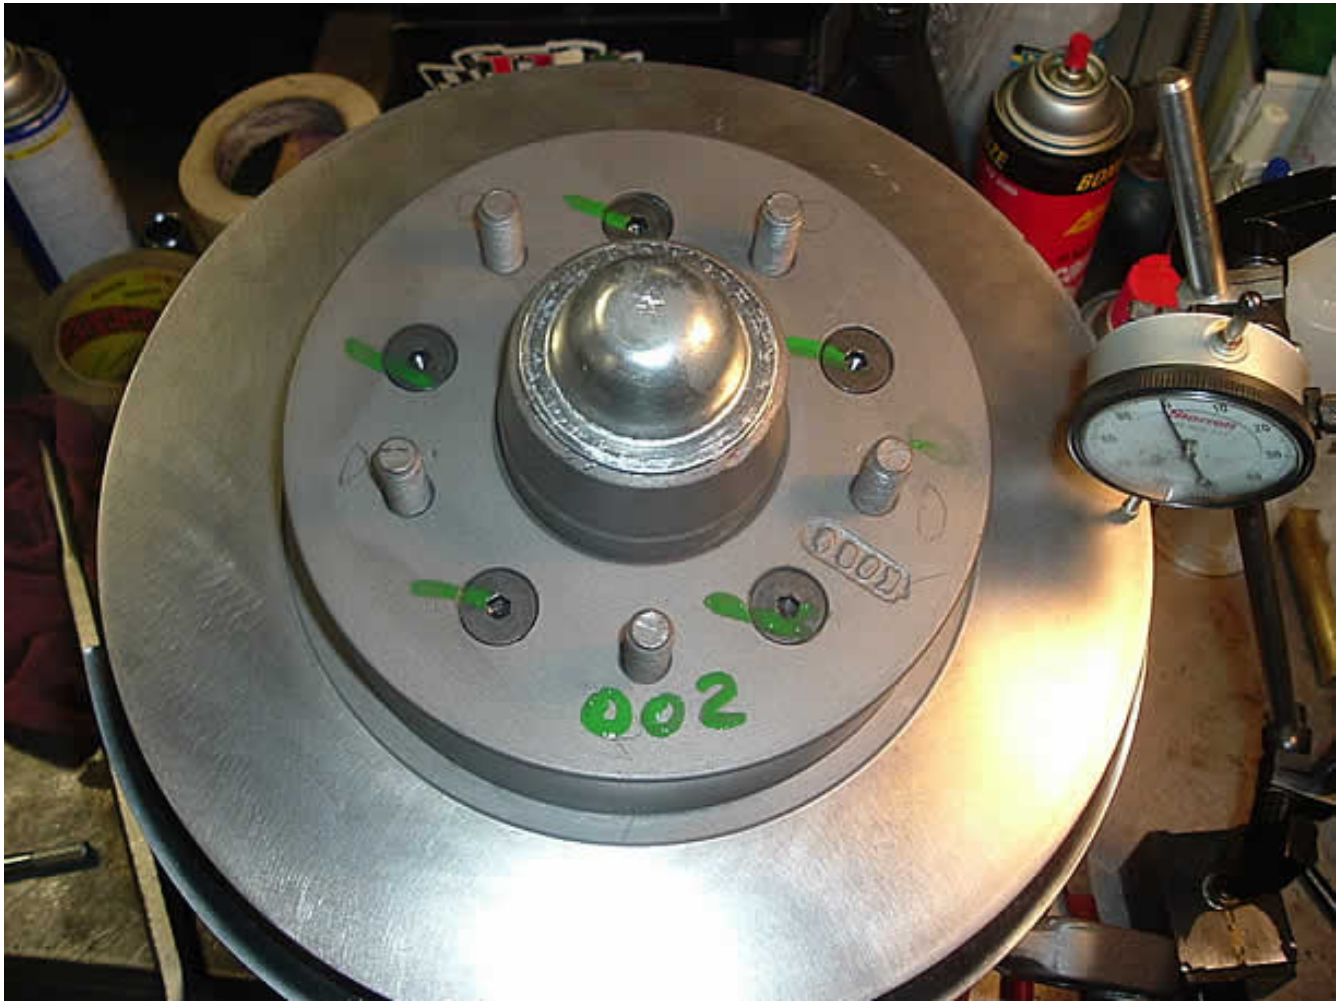
Here is the finished job. The green paint witness marks the rotor to hub location.
