VEHICLE ANALYSIS

CHEVROLET CORVETTE SPORTS CAR

REPORT No. V.A.18

THE MOTOR INDUSTRY RESEARCH ASSOCIATION

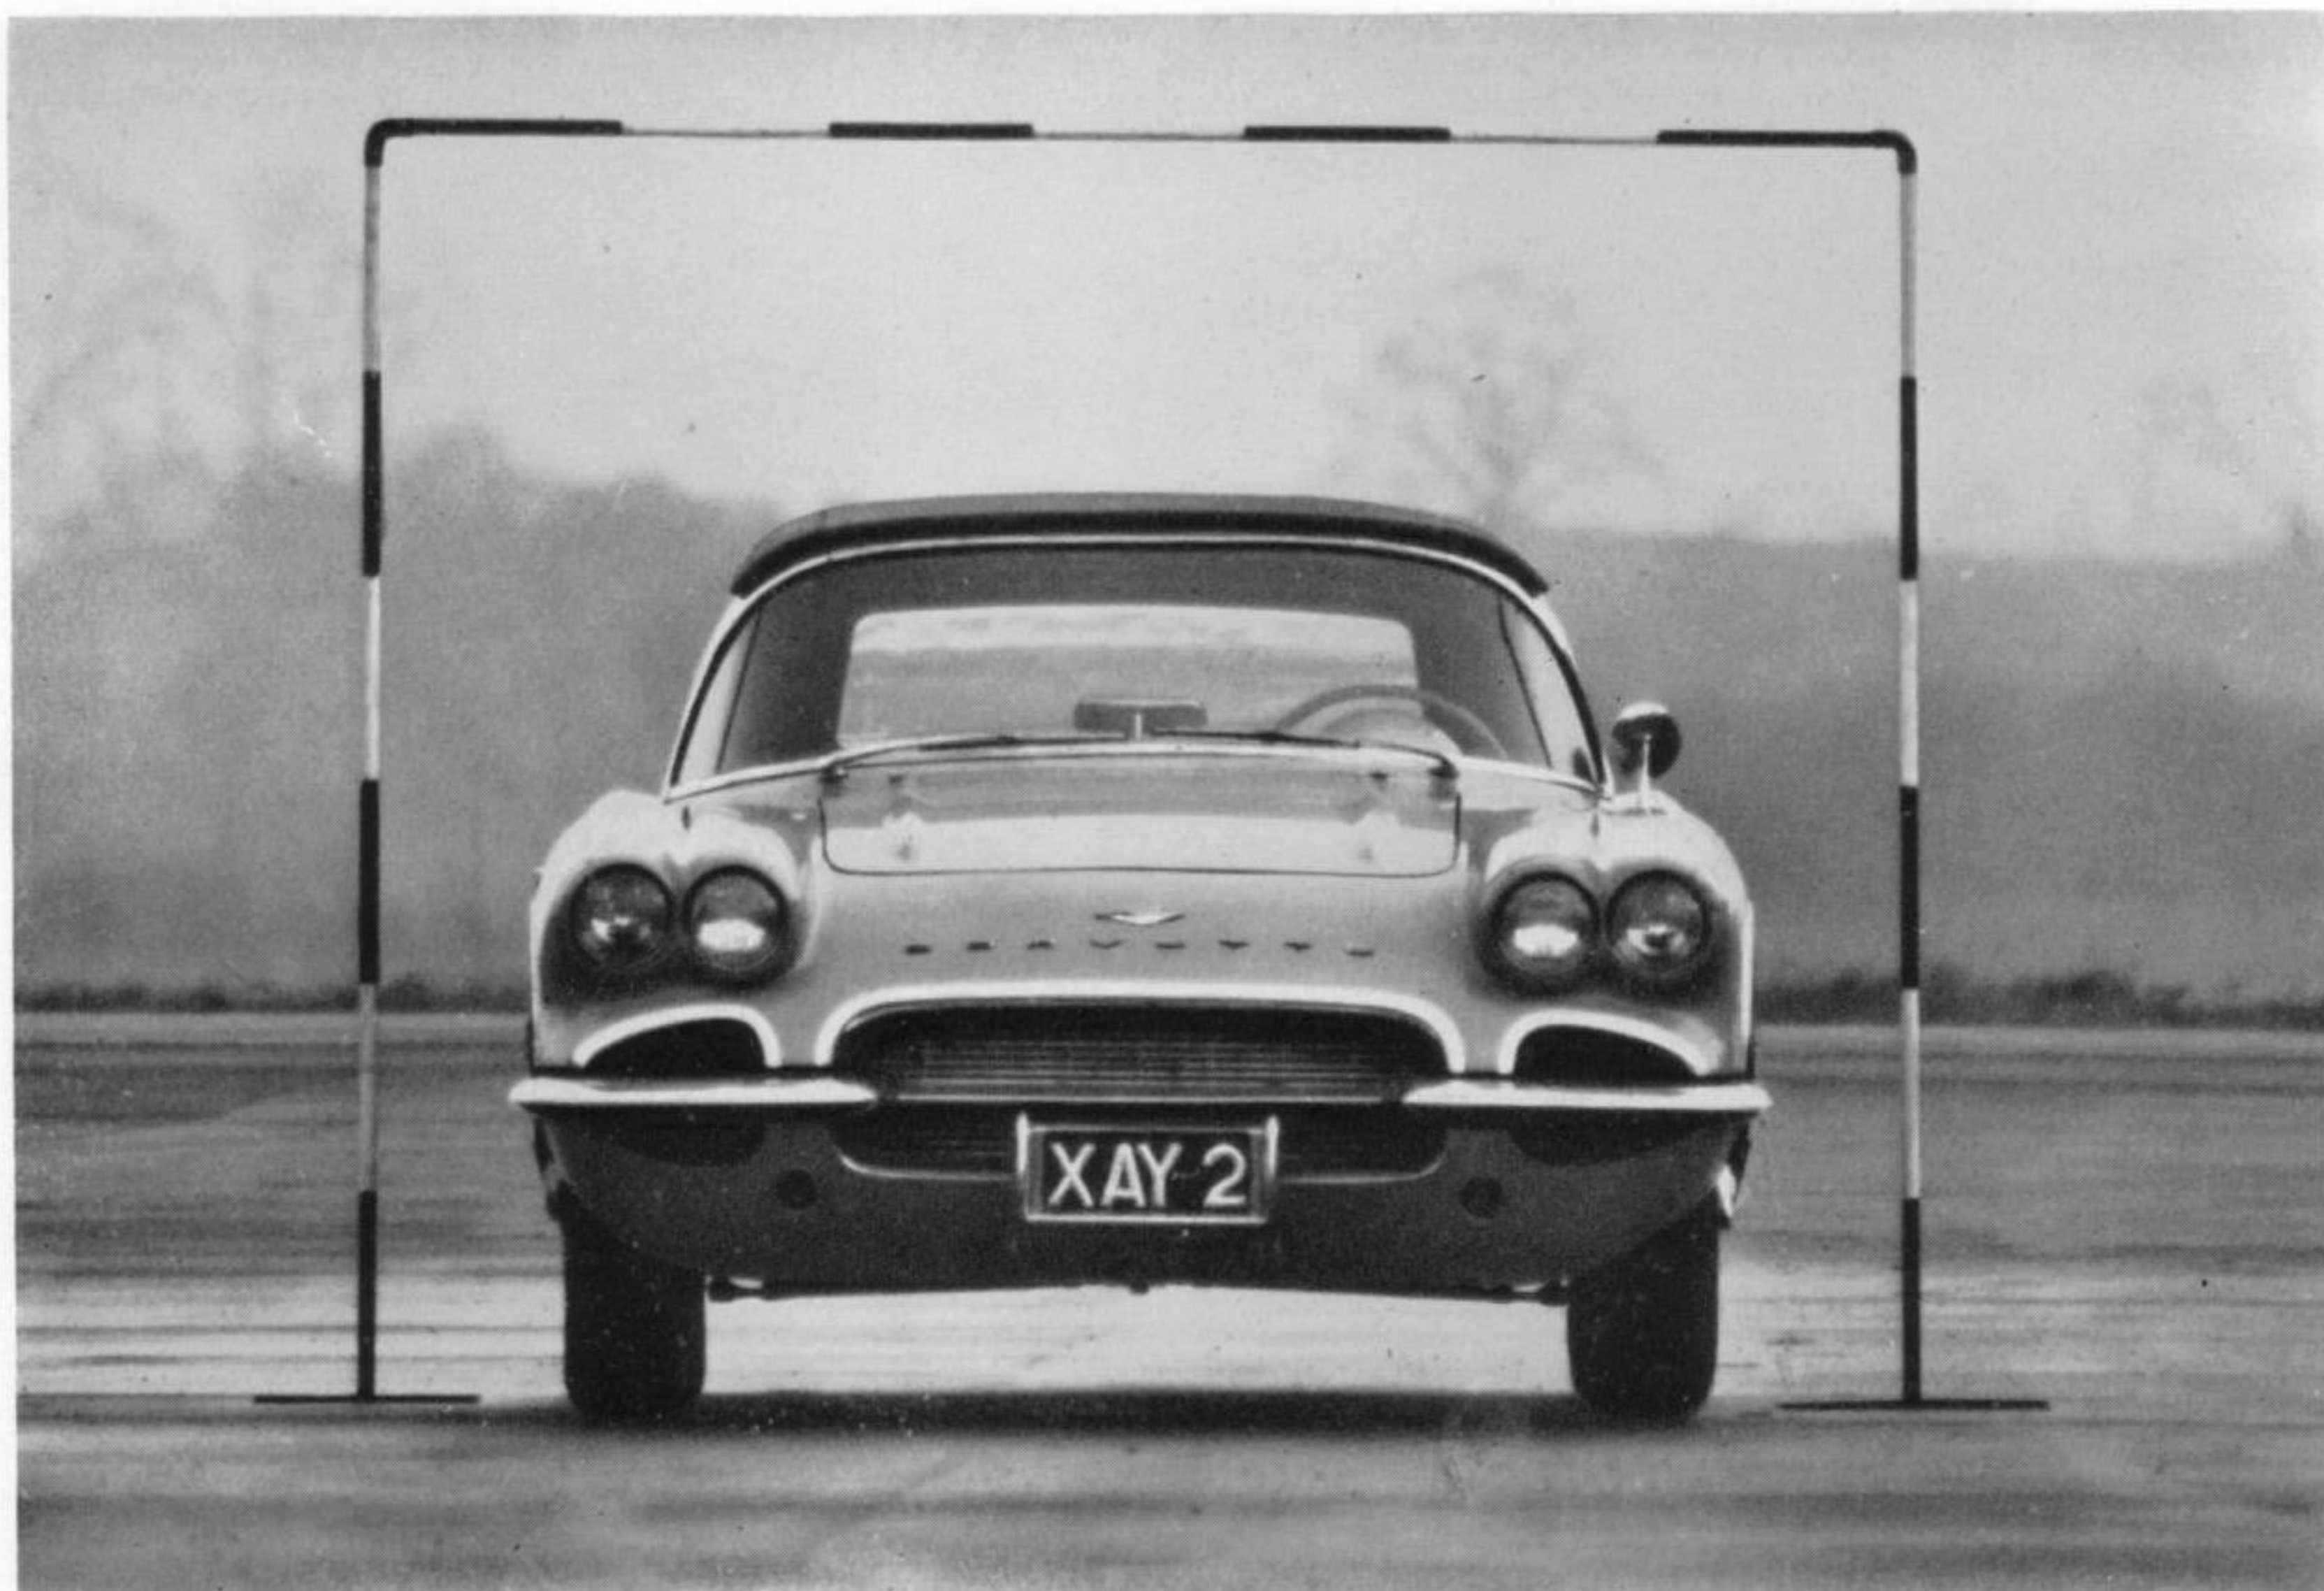
Fig. 2. Front view. Scale bars marked at 1 ft. intervals, camera 200 ft. from windscreen.

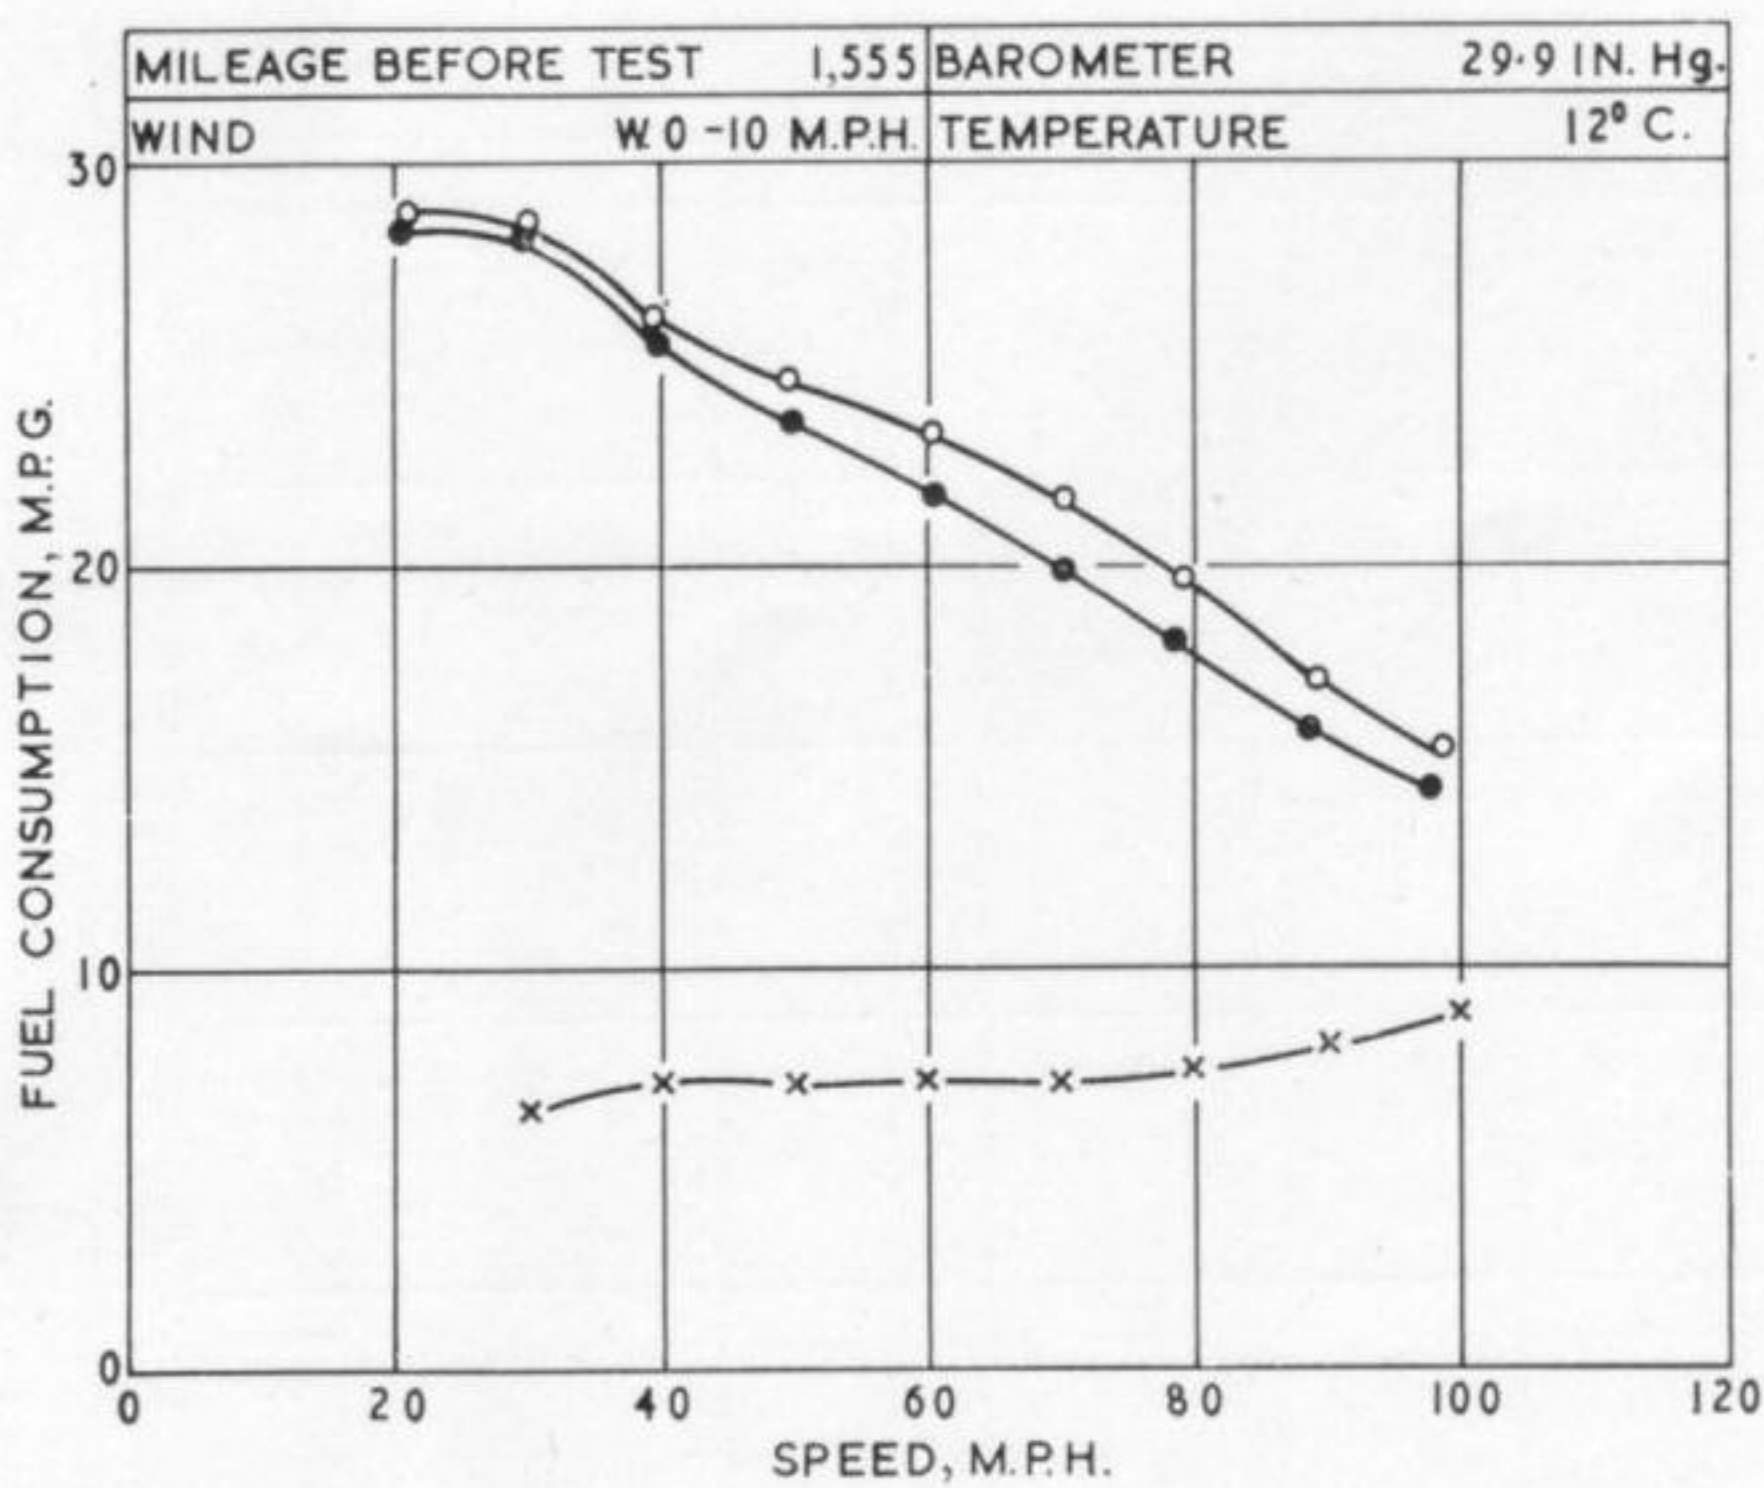
Fig. 21. Fuel consumption in top gear.

- x—x—x Full throttle (maximum consumption).
- o—o—o Part throttle, soft top up (minimum consumption).
- Part throttle, soft top down (minimum consumption).

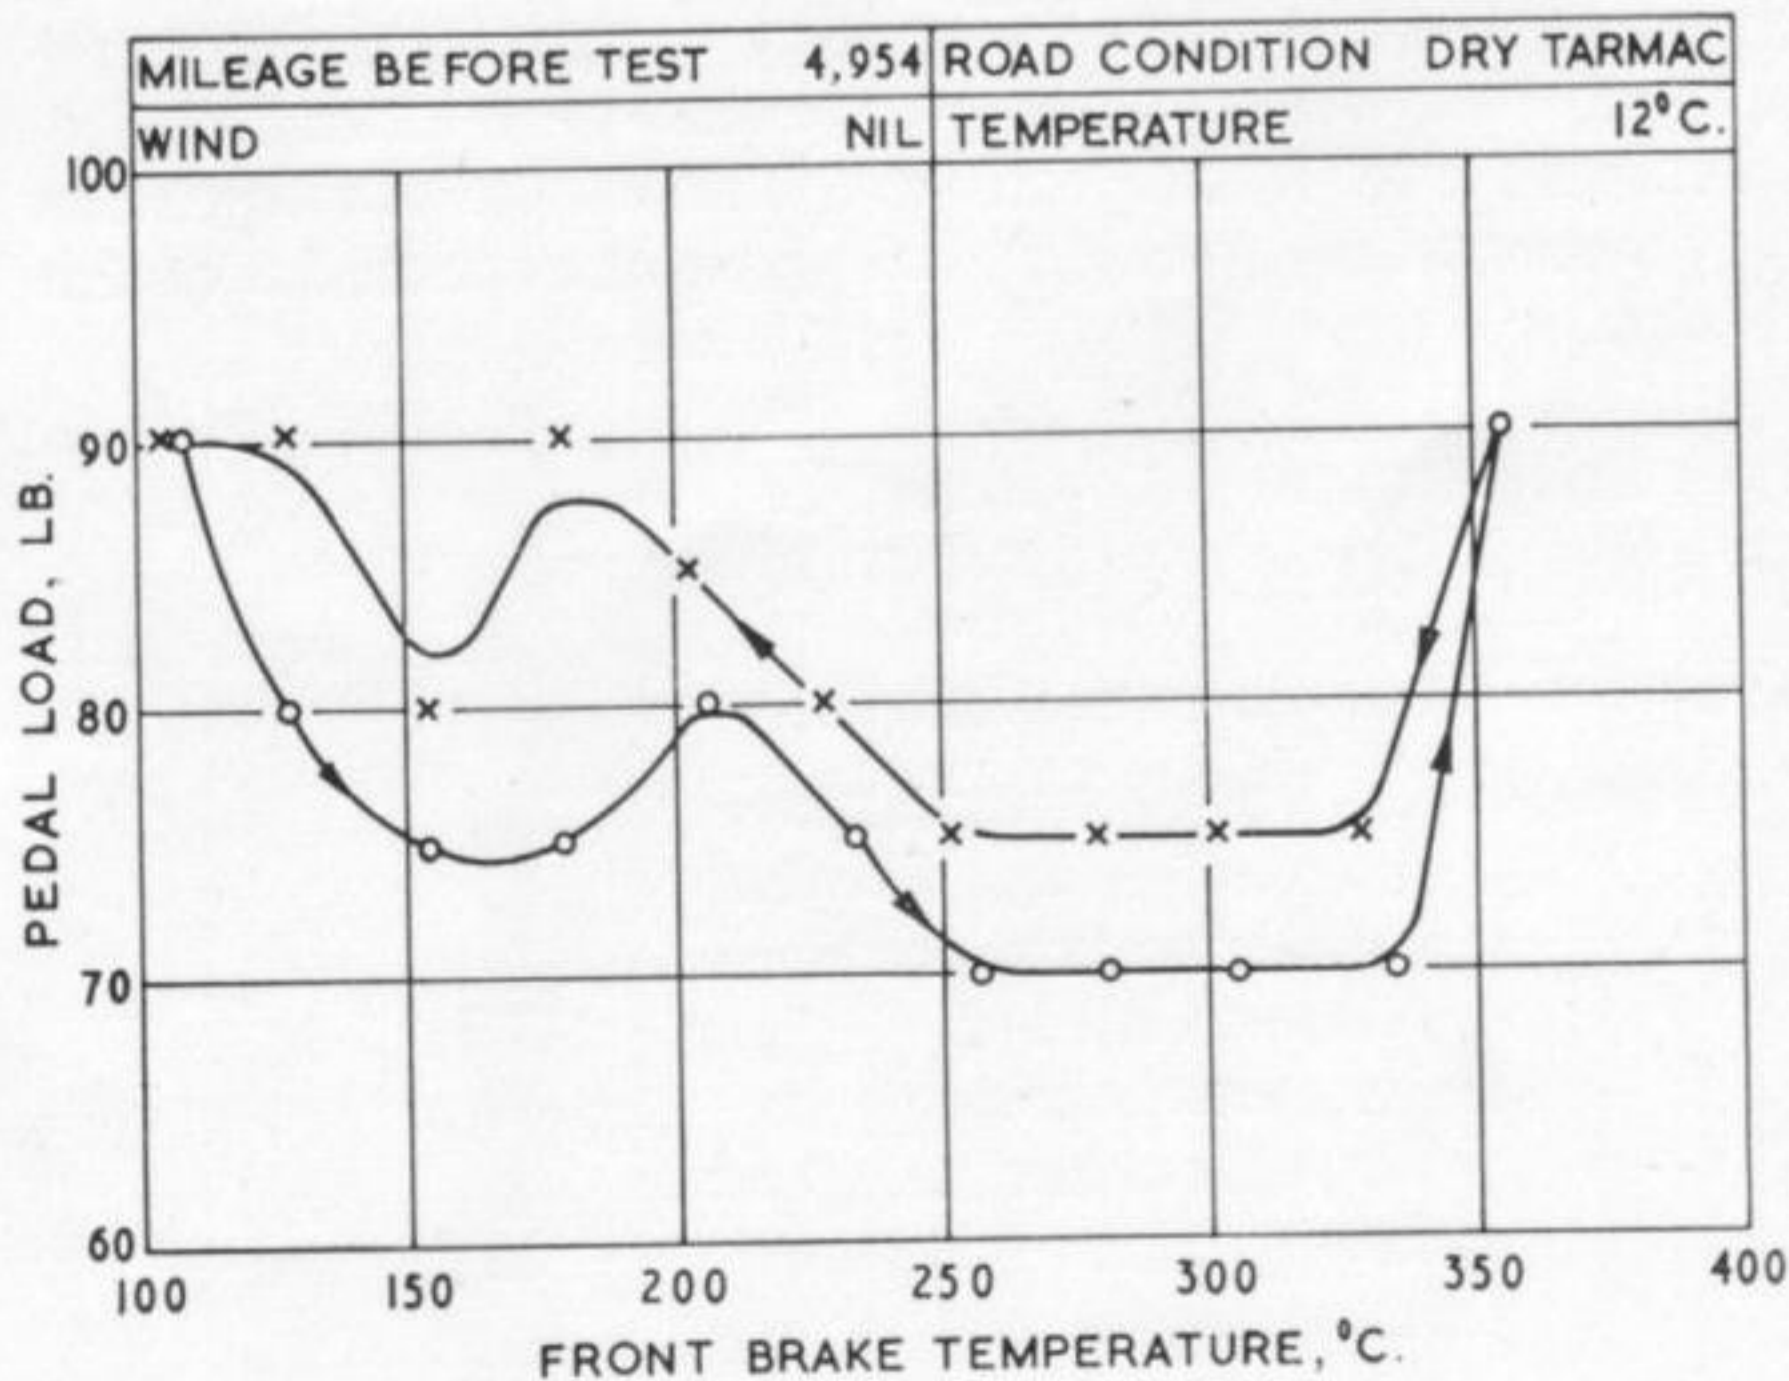
Fig. 26. Brakes—temperature effect. All stops at 0.4 g deceleration from 30 m.p.h.

o—o—o Brakes heating.
x—x—x Brakes cooling.

The results of a temperature effect test on the front brakes are presented in Fig. 26. The pedal loads shown in the graph are those initially used for braking; in every case it was necessary to reduce these loads by 15-20 lb. towards the end of the stop, in order to prevent the deceleration from increasing above 0.4 g.

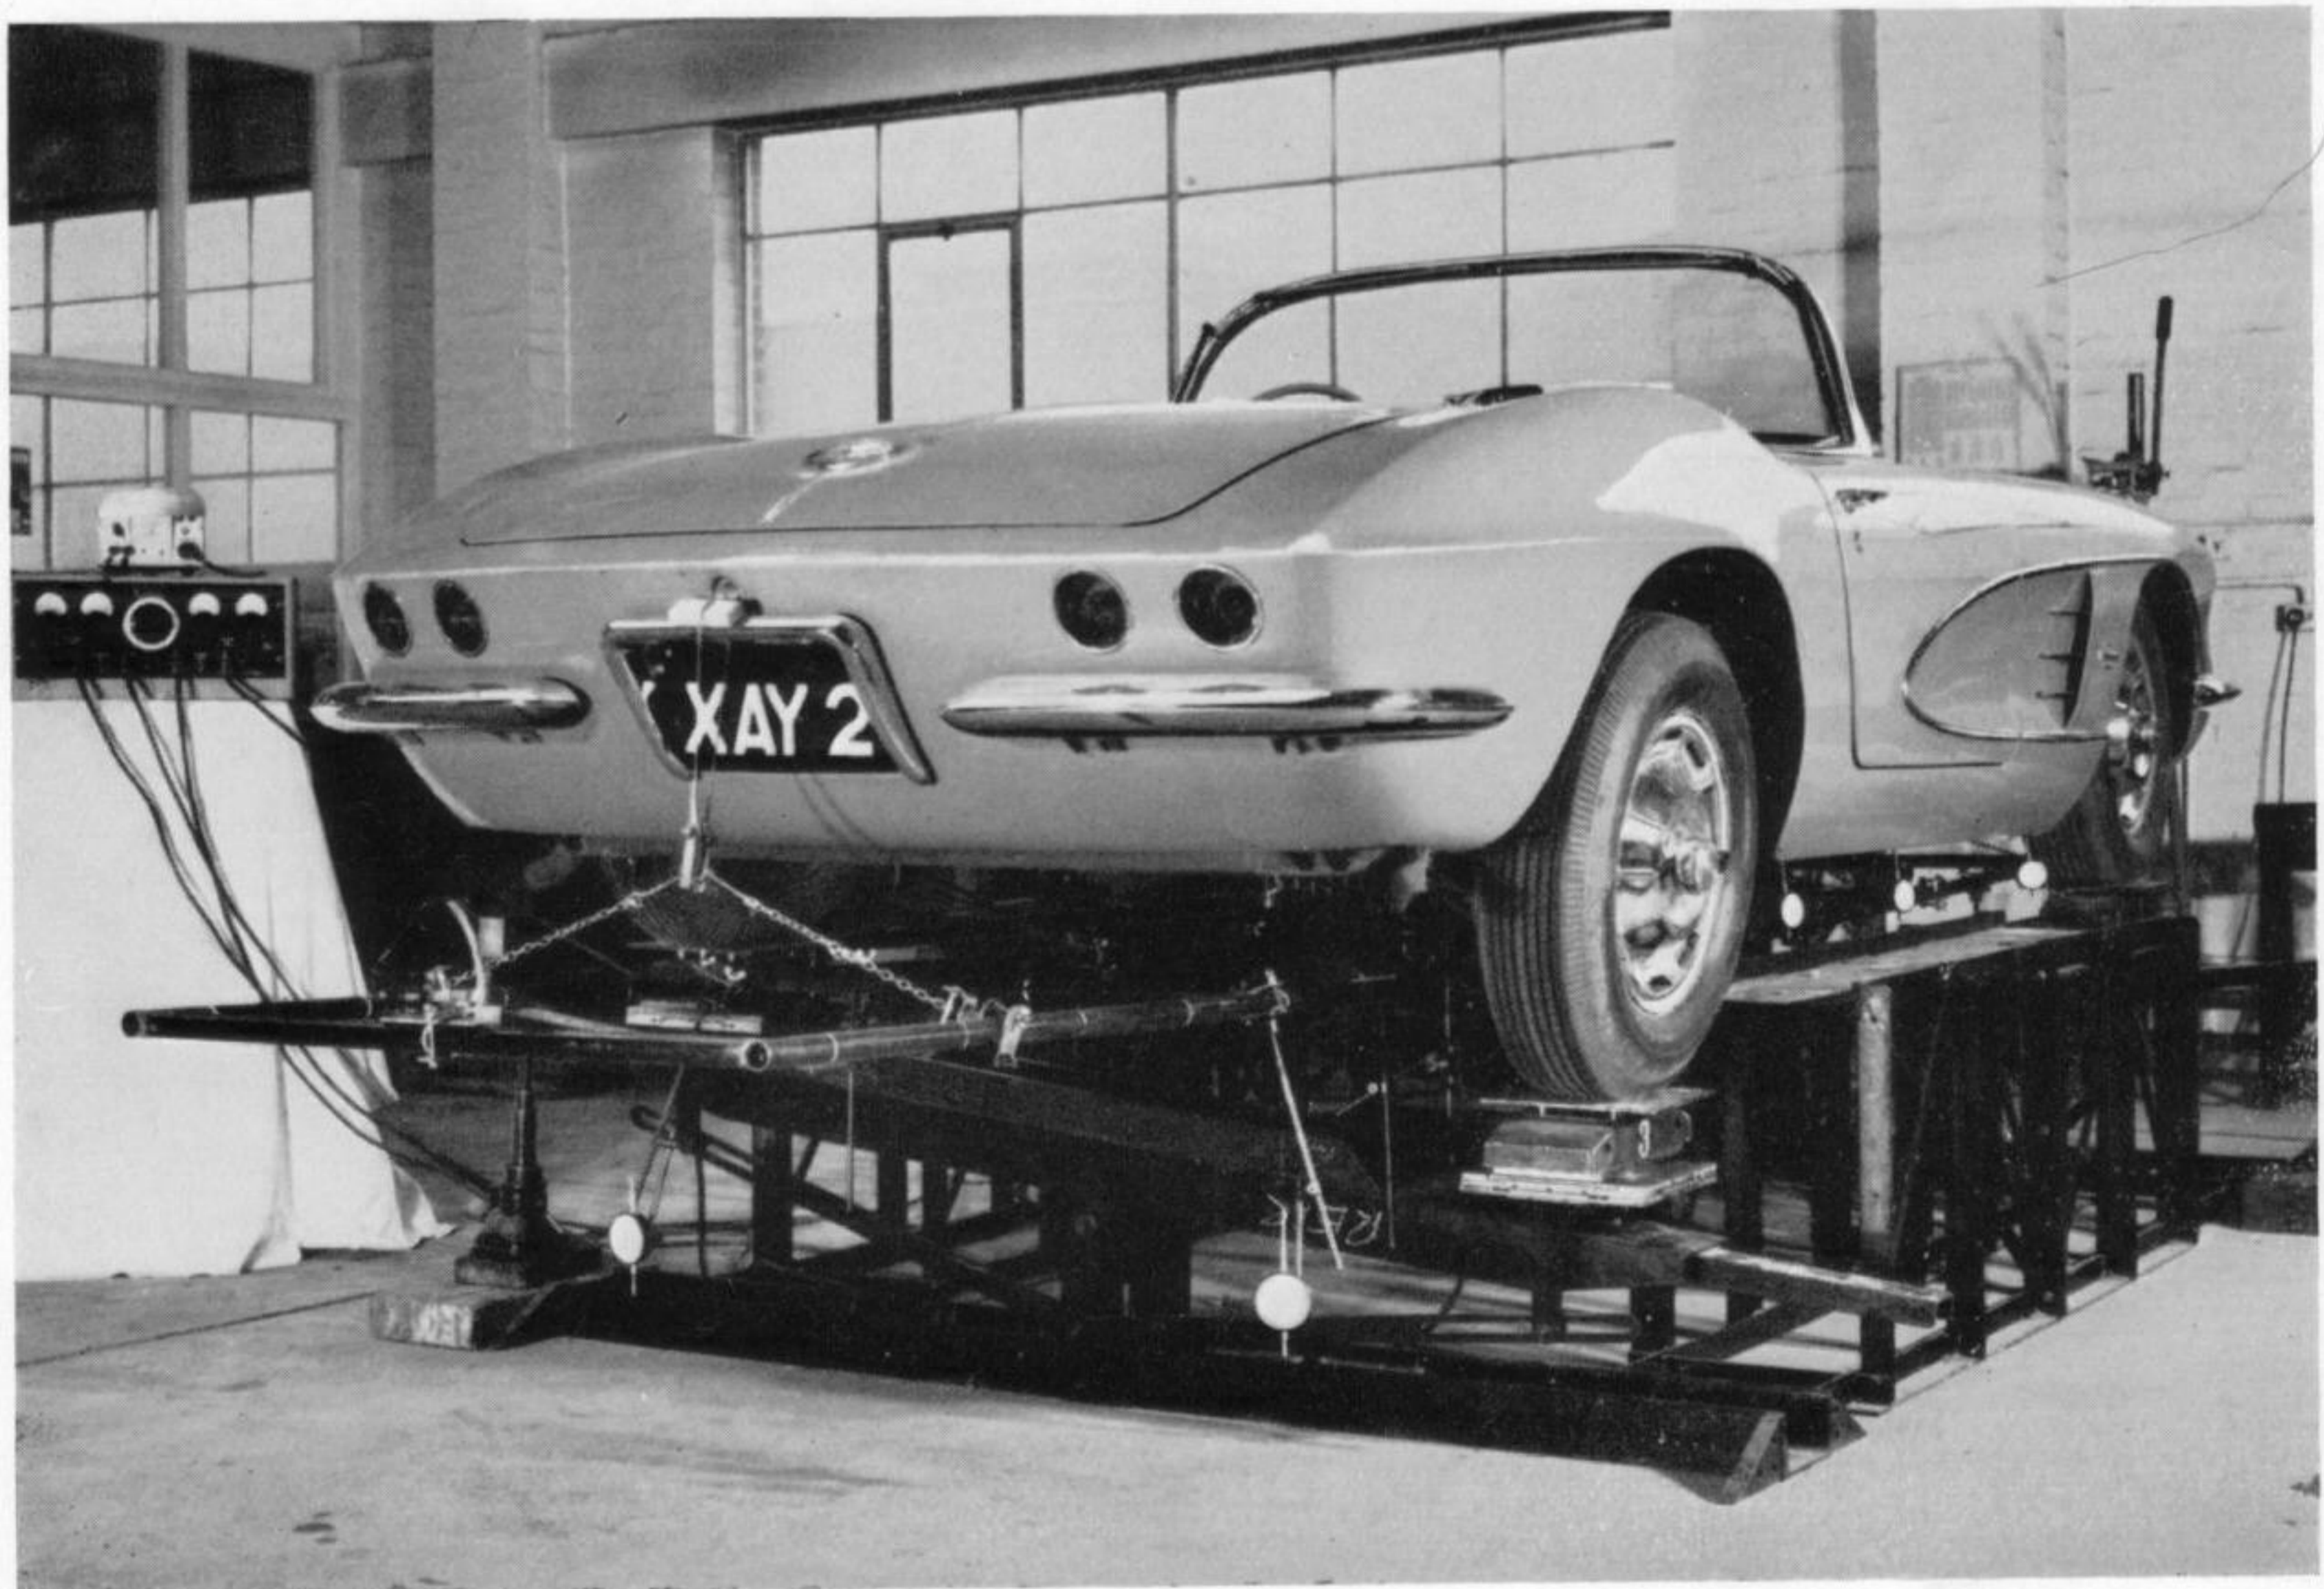
Fig. 38. Vehicle mounted for torsional testing.

The complete car was tested with the soft top up and down, and with the top down and windscreen removed. The body was then removed and the chassis was tested in the condition shown in Fig. 10. The complete vehicle mounted for testing is shown in Fig. 38.

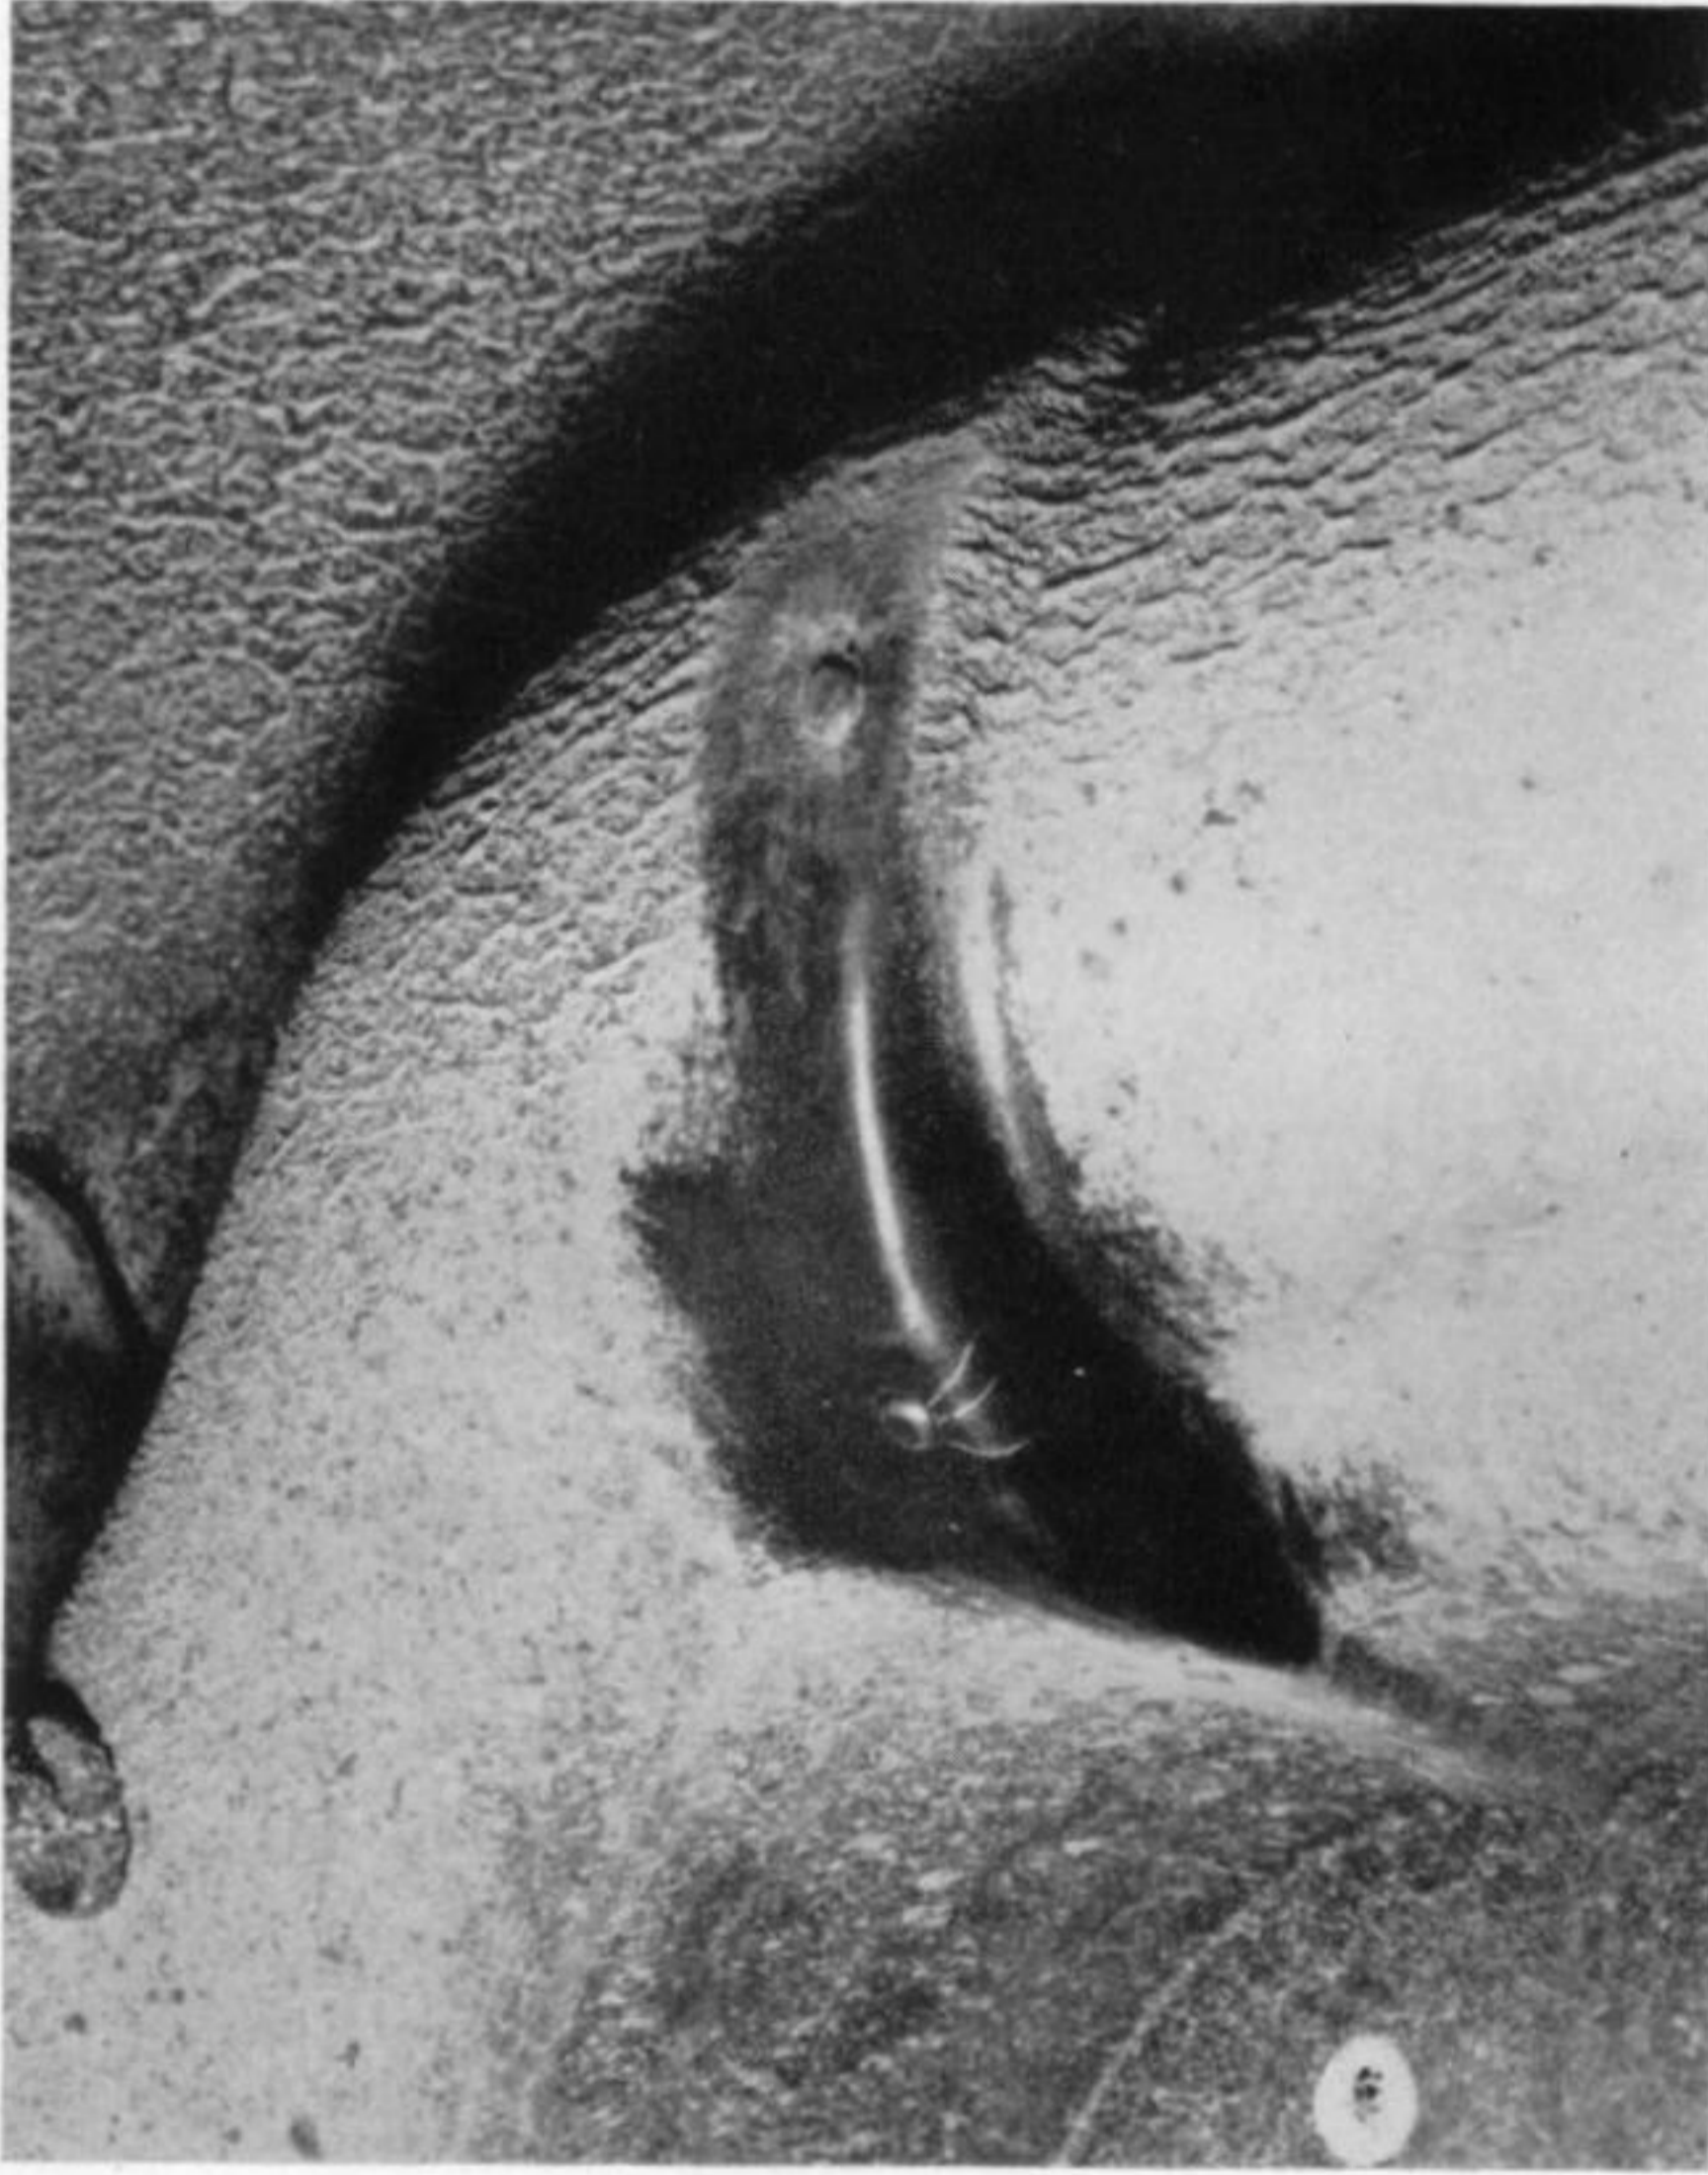
Fig. 45. Wing support, left front cracked on delivery.

Fig. 46. Wing support, left front cracked on delivery.

On delivery. The resin-bonded glass fibre body was cracked under the left and right front wings (see Fig. 45 and Fig. 46) in the areas around the rivets supporting the metal inner valances. It was found that rain entered the passenger compartment via the sealing rubbers along the edges of both the left and right sides of the soft top. Water was also found in the luggage compartment, entry being gained at the base of the spare wheel well.
