1977 Corvette: Service Bulletin: Anti-Theft Alarm System Interim Modifications

Model and Year: 1977 Corvette

Bulletin No: 77-I-38

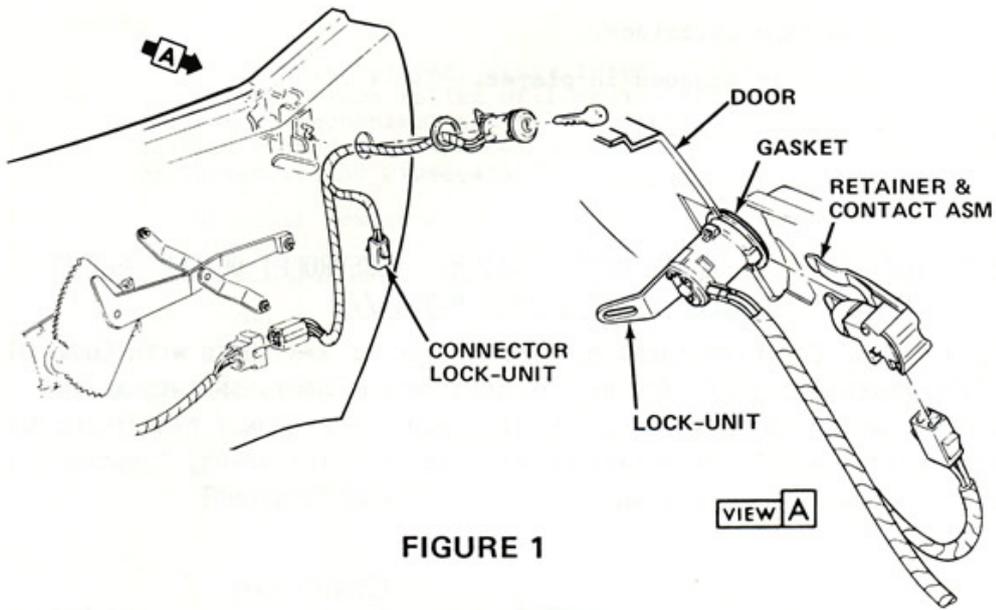
FIGURE 1

- The actuating switch for the system is no longer located on the left front fender. It has been incorporated into the left front door lock and must be activated by locking this door with the key from outside of the vehicle (Figure 1). This is the only way the alarm can be set. Turning the inside door knob to the locked position when exiting the vehicle will not activate the alarm system.
- The anti-theft alarm system horn has been moved from the left rear inner fender to the far left side of the engine compartment dash panel. (Figure 2).
- The anti-theft alarm system flasher assembly is now located on the console trim plate (Figure 3), rather than the rear compartment underbody panel.
- The new anti-theft alarm system wiring diagram is illustrated in Figure 4.

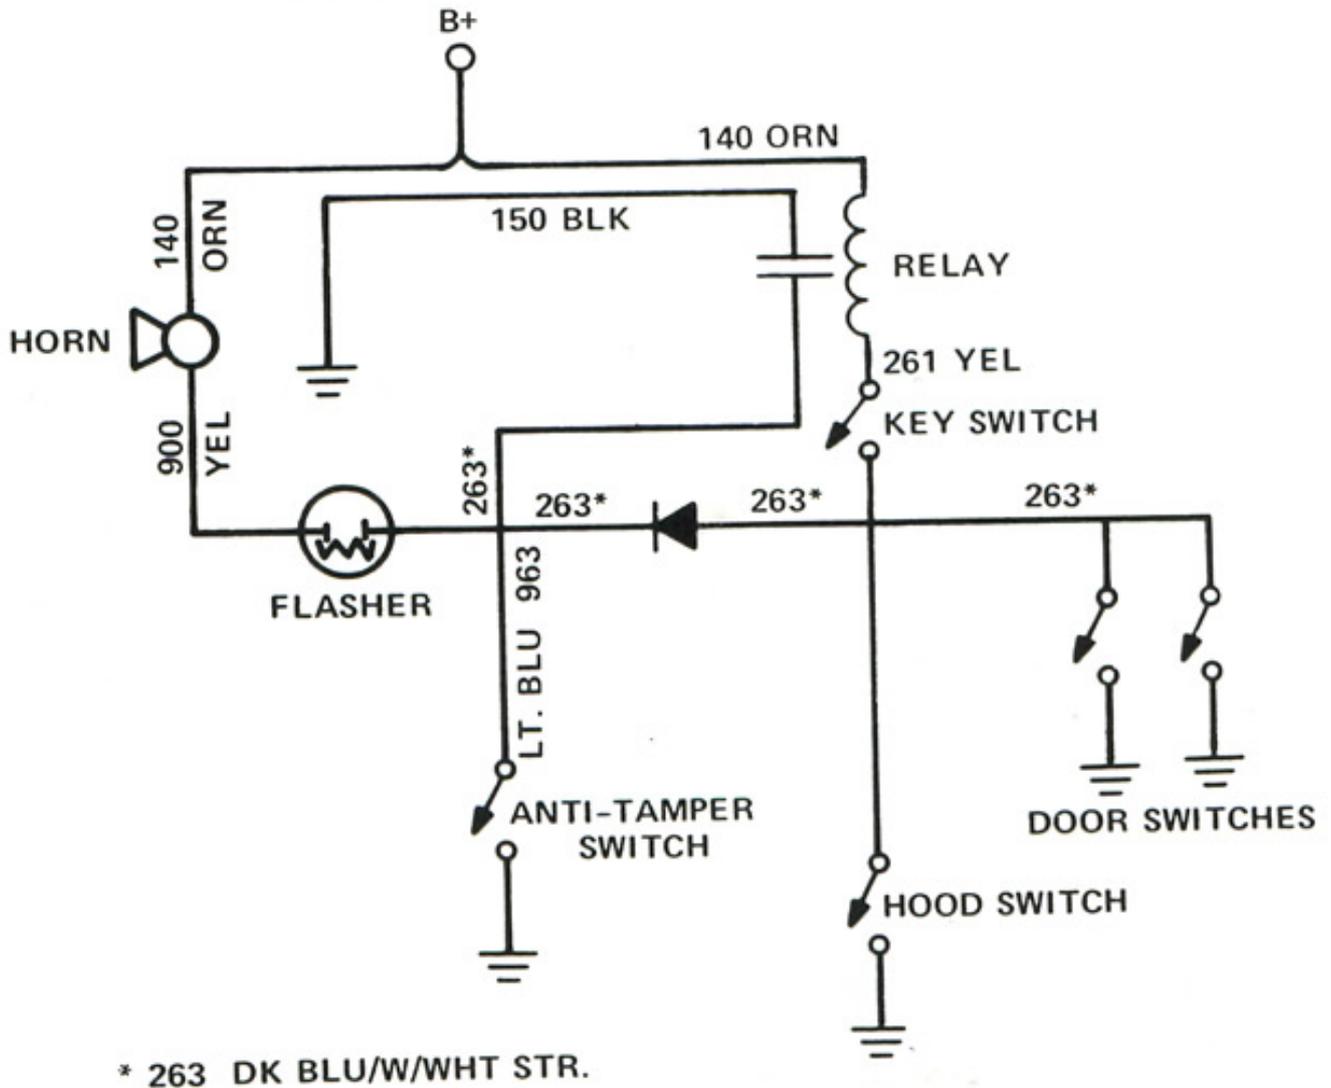
FIGURE 4

NEW 77½ CORVETTE THEFT DETERRENT CIRCUIT
