1977 Corvette: Service Bulletin: Anti-Theft Alarm System Interim Modifications

Bulletin No: 77-I-38

Date: May 1977

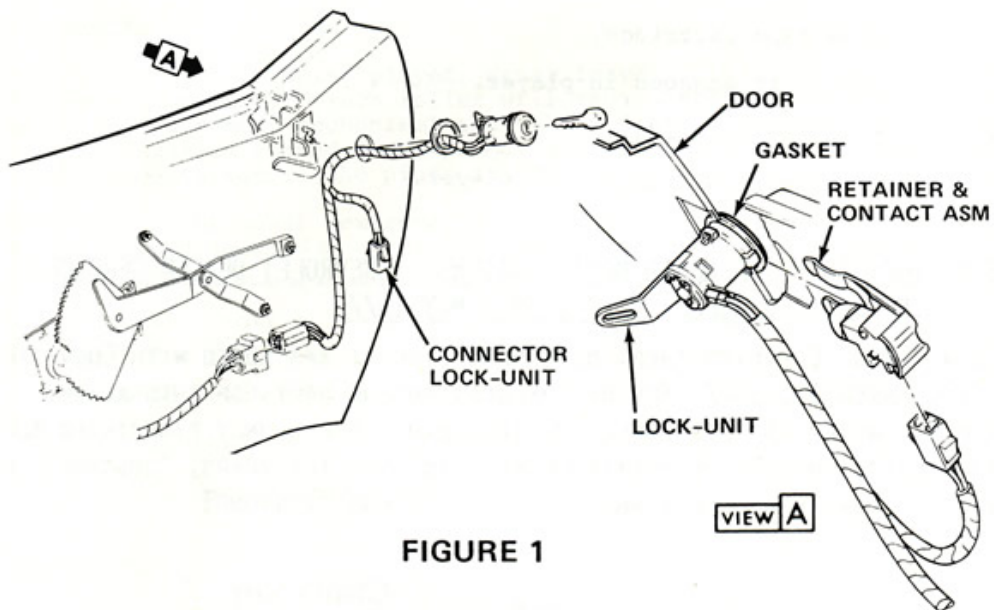
FIGURE 1

- The actuating switch for the system is no longer located on the left front fender. It has been incorporated into the left front door lock and must be activated by locking this door with the key from outside of the vehicle (Figure 1). This is the only way the alarm can be set. Turning the inside door knob to the locked position when exiting the vehicle will not activate the alarm system.
- The anti-theft alarm system horn has been moved from the left rear inner fender to the far left side of the engine compartment dash panel. (Figure 2).
- The anti-theft alarm system flasher assembly is now located on the console trim plate (Figure 3), rather than the rear compartment underbody panel.
- The new anti-theft alarm system wiring diagram is illustrated in Figure 4.

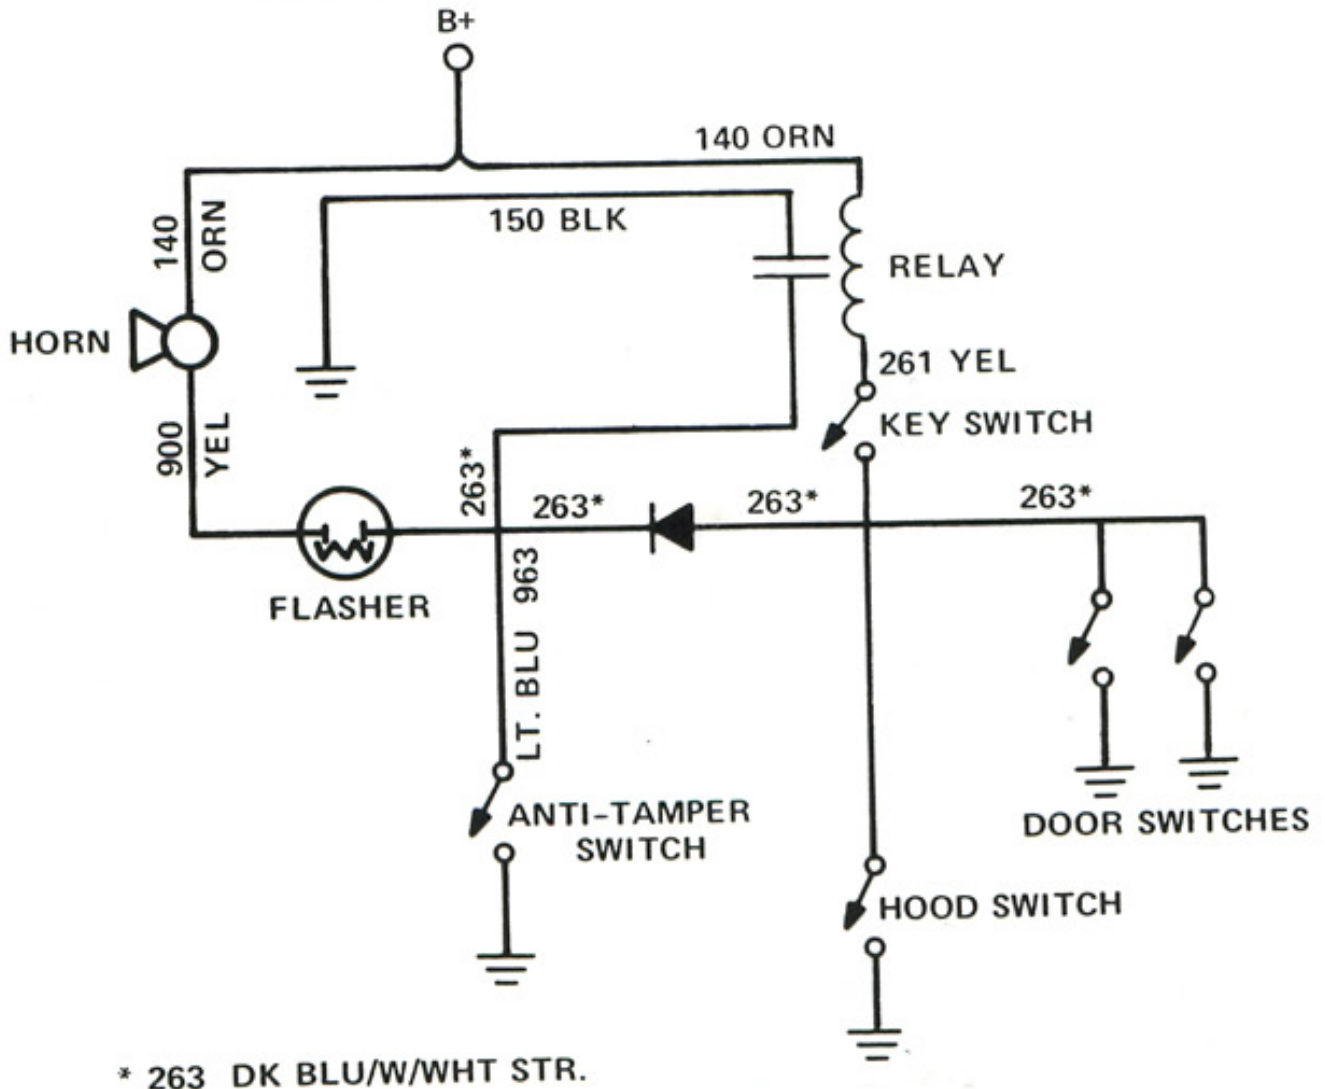
FIGURE 4

NEW 77½ CORVETTE THEFT DETERRENT CIRCUIT
