# 1977 Corvette: Service Bulletin: Anti-Theft Alarm System Interim Modifications

**Subject:** Anti-Theft Alarm System Interim Modifications

**Model and Year:** 1977 Corvette

**Bulletin No:** 77-I-38

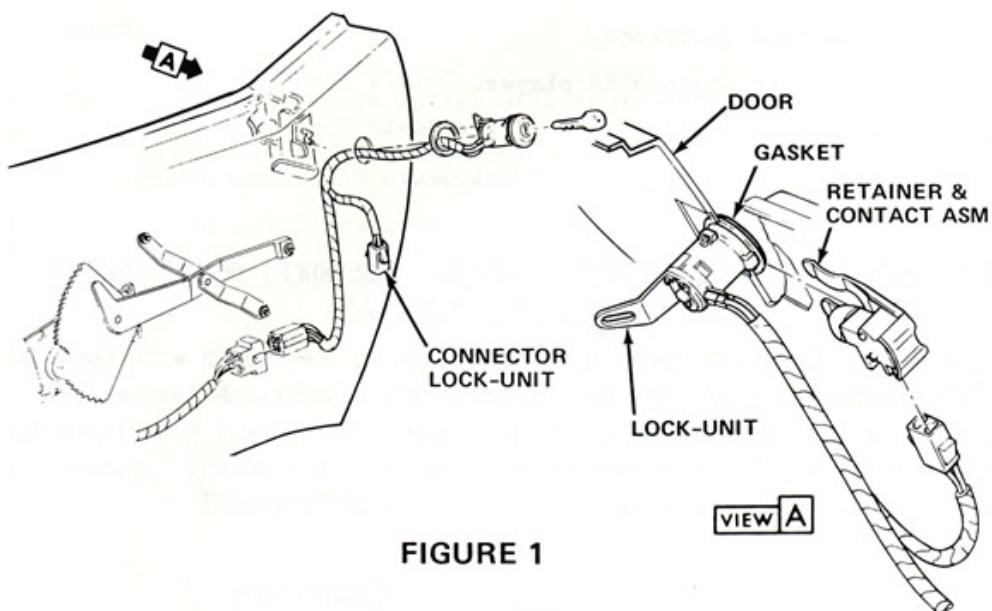
FIGURE 1

- The actuating switch for the system is no longer located on the left front fender. It has been incorporated into the left front door lock and must be activated by locking this door with the key from outside of the vehicle (Figure 1). This is the only way the alarm can be set. Turning the inside door knob to the locked position when exiting the vehicle will not activate the alarm system.
- The anti-theft alarm system horn has been moved from the left rear inner fender to the far left side of the engine compartment dash panel. (Figure 2).
- The anti-theft alarm system flasher assembly is now located on the console trim plate (Figure 3), rather than the rear compartment underbody panel.
- The new anti-theft alarm system wiring diagram is illustrated in Figure 4.

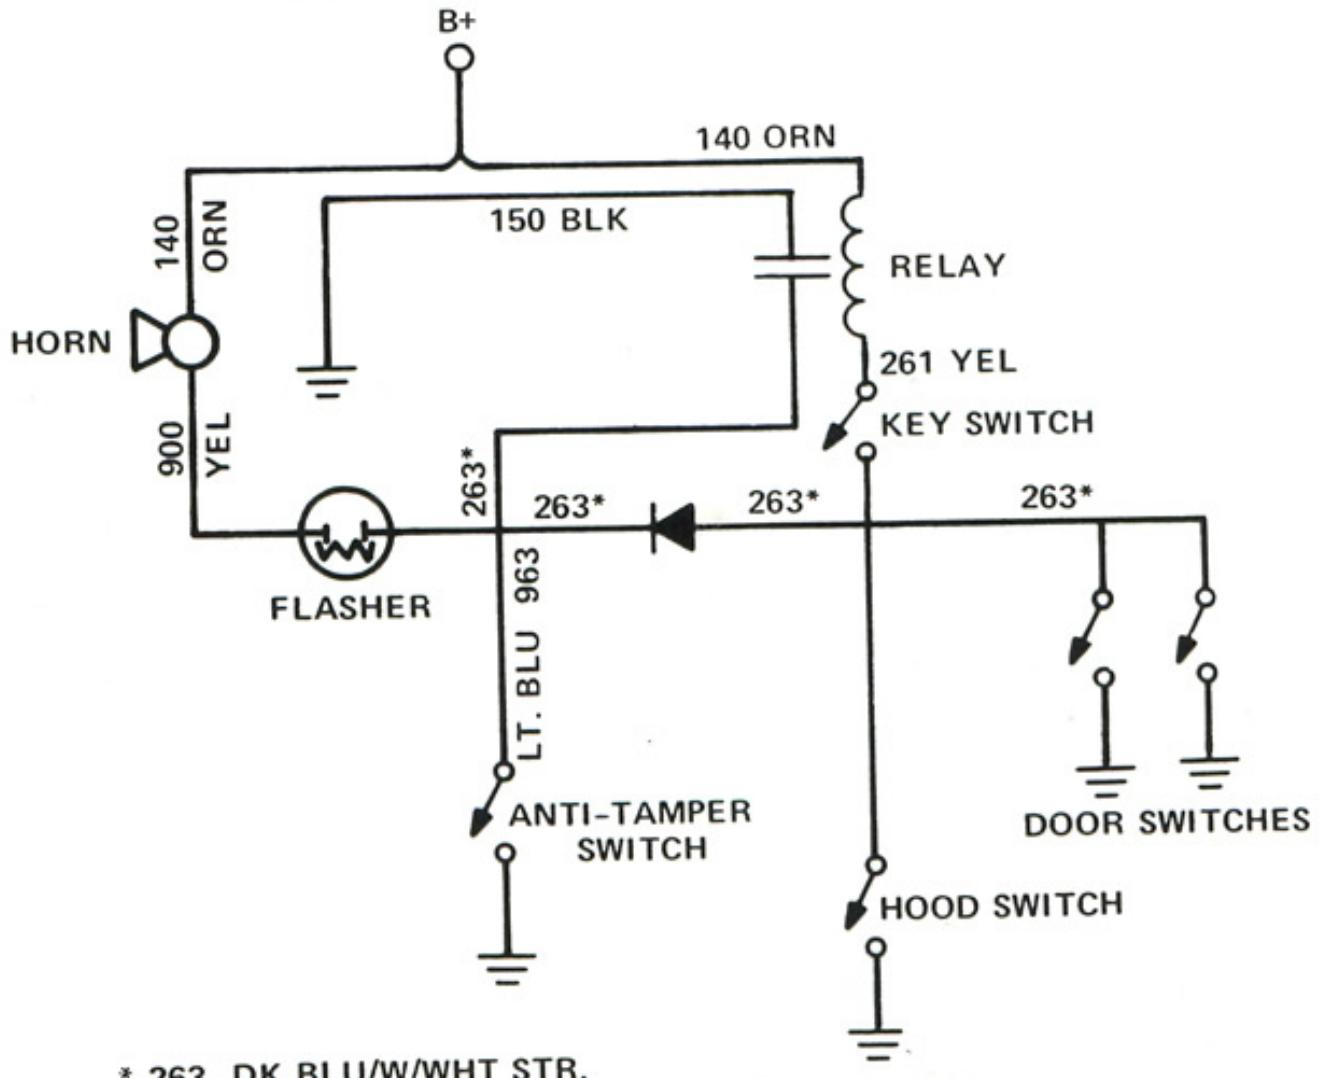
FIGURE 4

## NEW 77½ CORVETTE THEFT DETERRENT CIRCUIT
