# 1988 - 1989 Corvette: Hood Rubs Air Conditioning Hose

**Model and Year:** 1988 - 1989 Corvette

**Source:** Chevrolet Dealer Service Bulletin

**Bulletin No:** 89-183-1B

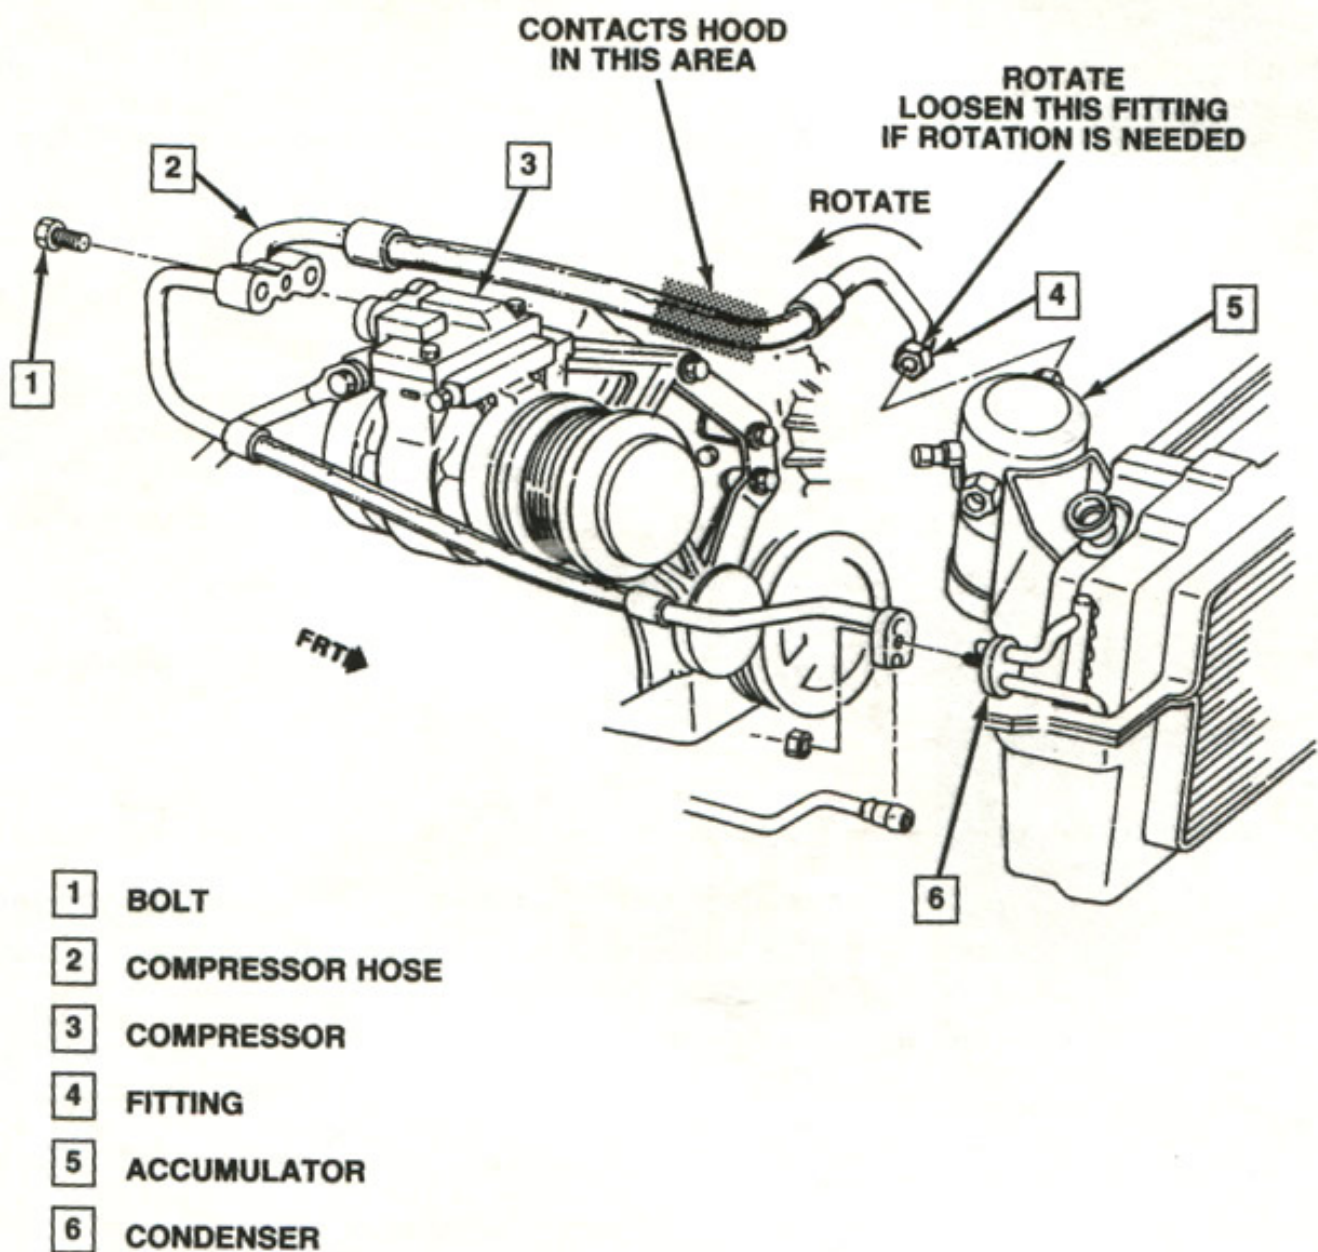
Some of the above vehicles, built prior to the breakpoint shown below, may exhibit a rub condition of the A/C hose to the underside of the hood. use the following procedure to check and address this condition. (Figure 1 shows hose disassembled for clarification only).

1. Check the area of A/C hose, as indicated in Figure 1, to see if it is contacting the hood. If there is no evidence of hose contact to hood, no further action is needed.
2. If the hose is contacting the hood but has not rubbed through the outer coating of hose, loosen the nut (item #4) on the accumulator (Item #5) and rotate the hose, in the direction indicated in Figure 1, to obtain clearance to the hood.
3. if the hose is rubbed through the outer coating, replace the hose assembly with one of the following service part numbers.

<u>Year</u>	<u>Part Number</u>
1988	10135634
1989	10135635

The 1989 breakpoint is as follows: VIN K5103849
