1965 Corvette: Service Bulletin: Transistorized Voltage Regulator Failures

Subject: Transistorized Voltage Regulator Failures

Source: Chevrolet Technical Service Bulletin

Bulletin Number: TSB #1115, Section VIy

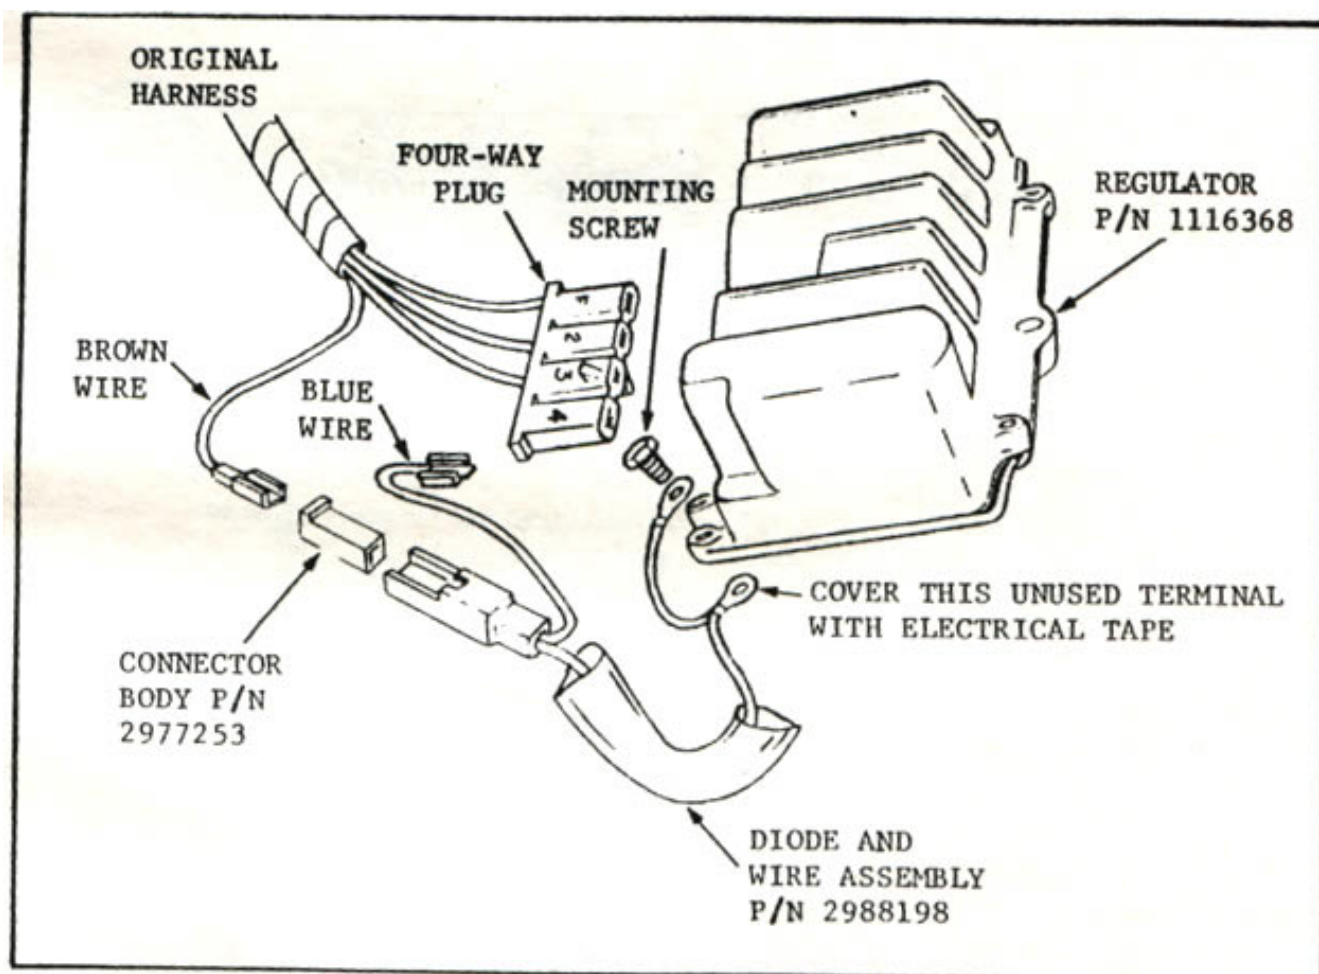
FIGURE 1 - DIODE AND WIRE ASSEMBLY (PART #2988198) INSTALLATION

1. Disconnect battery ground cable.
2. Remove four-way plug from regulator and remove regulator.
3. Remove the brown wire from the #4 location in the plug by using a small thin bladed tool to release the lock tang.
4. Obtain a Part #2988198 wire and diode assembly, and insert the spade terminal from the short blue wire into the #4 location in the regulator plug.
5. Reform the lock tang on the spade terminal of the brown wire (previously removed from the #4 position) and install a Part No. 2977253 connector body over the terminal. Plug this connector into the receptacle of the wire and diode assembly.

6. Install the regulator with the black ground "pig tail" attached by one of the mounting bolts (see fig. 1).
7. Cover the unused ground terminal of the diode lead (double black wires) with electrical tape.
8. Reinstall the regulator plug and the battery ground cable.
