1974 Corvette: Product Safety Campaign: Fuel Tank Return Line Tube Fitting Leakage

Subject: Product Safety Campaign No. 74C13 - Fuel Tank Return Line Tube Fitting Leakage - 1974 Corvette

Bulletin Number: 74-C-13, Section VIII

Date: March, 1974

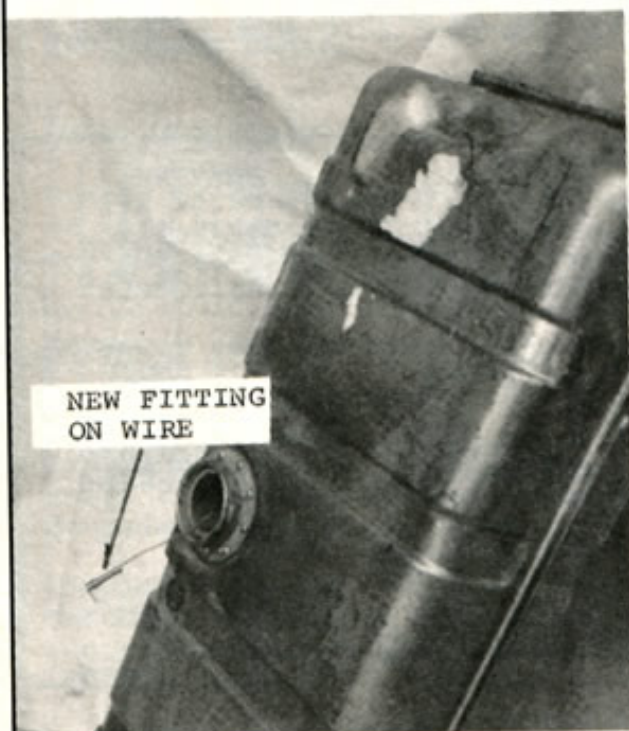
FIGURE 2

- 5) Using emery cloth also lightly clean up area to be soldered on the replacement fitting.
 - 6) Insert the replacement fitting (small end first) on the wire at the filler neck opening end, and bend the wire at the filler neck end 90° to retain the fitting on the wire. See Figure 2.
