2014 - 2016 Corvette: GM TechLink: Air Filter Box Seal Leak

Subject: Air Filter Box Seal Leak

Model and Year: 2014-2016 Corvette, Silverado, Sierra; 2015-2016 Escalade models, Yukon models; and 2016 CTS and Camaro equipped with a V8 engine (RPOs LT1, LT4, L83, L86, LV1, LV3)

Date: April 25, 2016

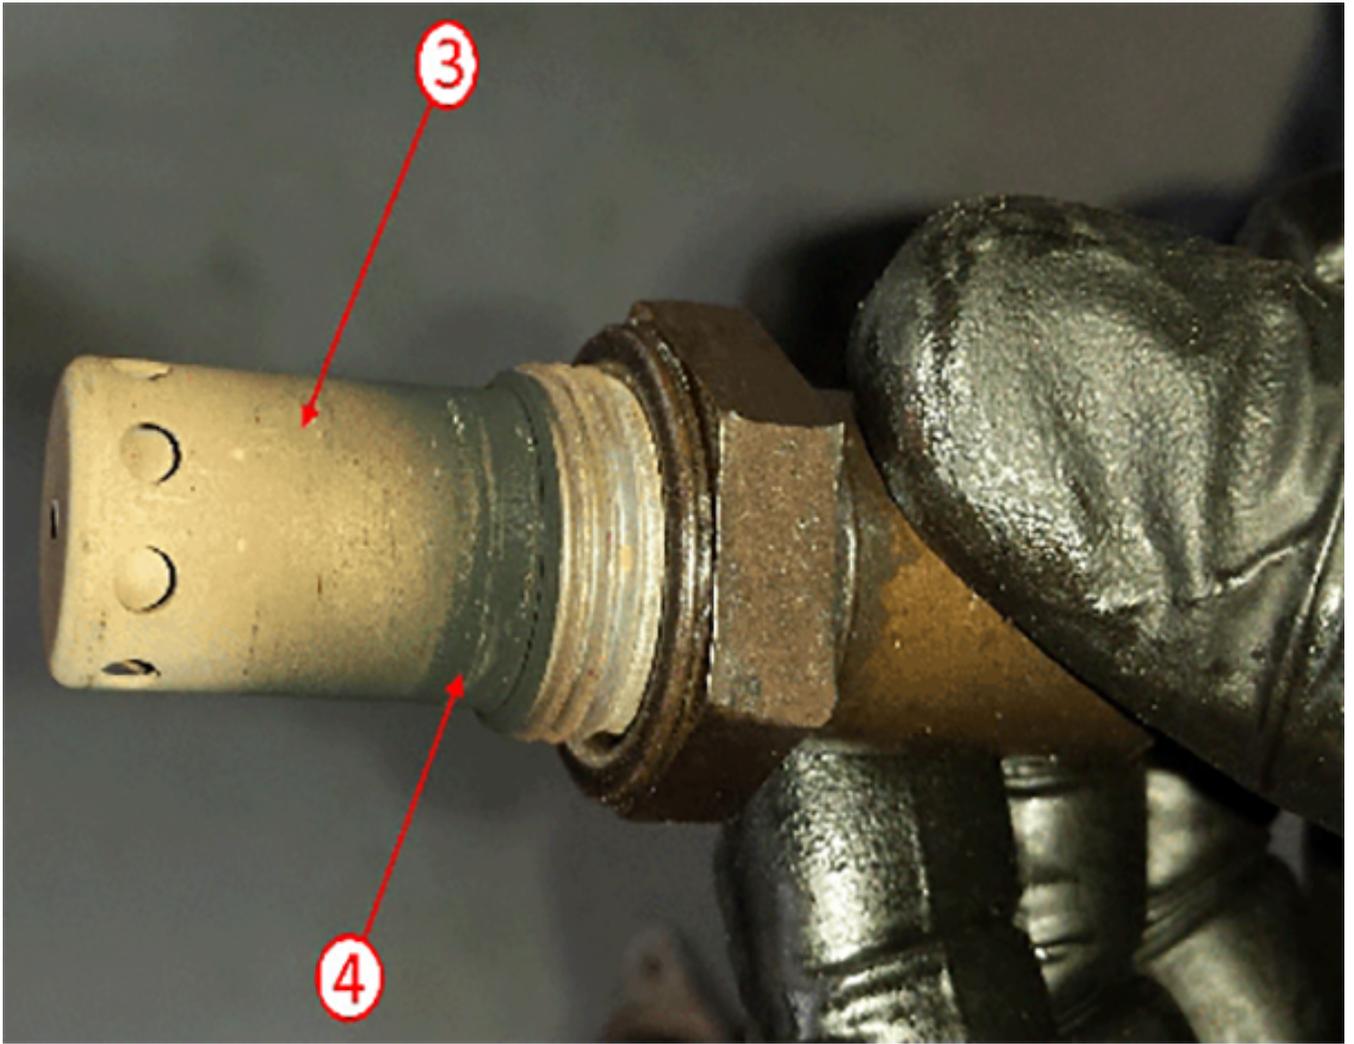
Fig. 15

On some 2014-2016 Corvette, Silverado, Sierra; 2015-2016 Escalade models, Yukon models; and 2016 CTS and Camaro equipped with a V8 engine (RPOs LT1, LT4, L83, L86, LV1, LV3), the MIL may be illuminated and DTCs P0420 (Catalyst System Low Efficiency) and P0430 (Catalyst System Low Efficiency Bank 2) may be set. These conditions may be caused by excessive dirt/debris entering the air filter box and bypassing the seal of the air filter, causing damage to the H02 sensor element (Fig. 15) and blocking the catalytic converter. (Fig. 16)

Do not replace any parts for these conditions until the air filter housing has been validated to be completely sealed.

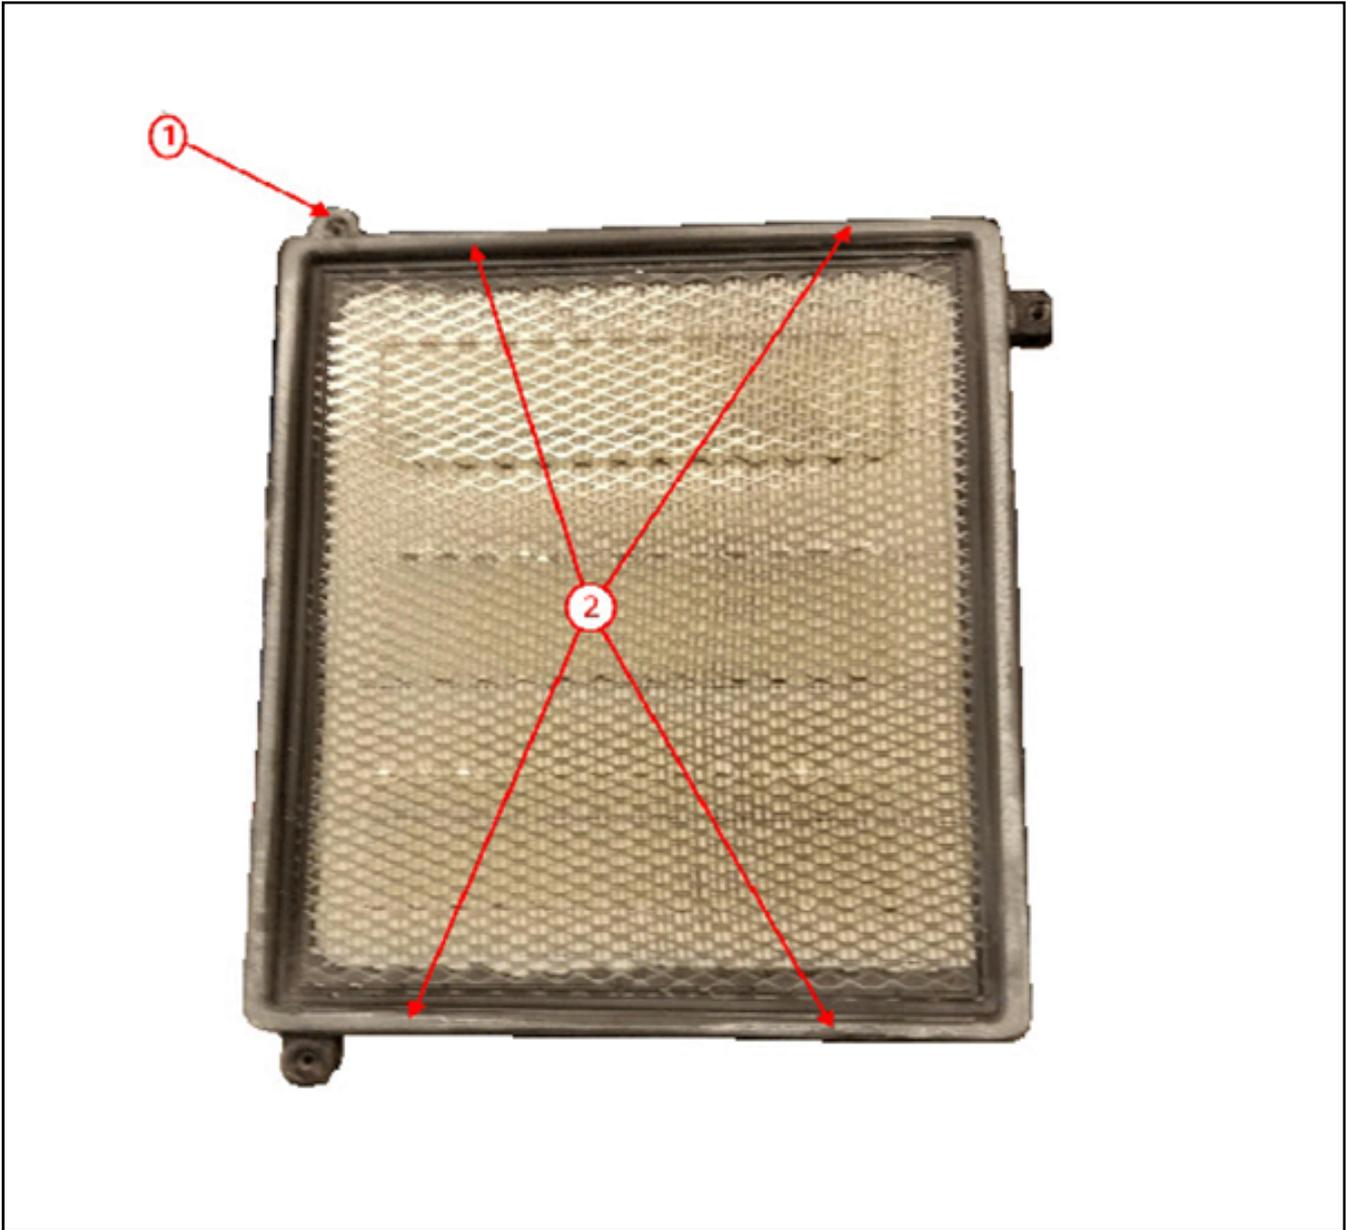
Fig. 17

Inspect the air housing cover for any missing tabs or fasteners. Also remove the air filter housing cover and inspect the seal around the filter as well as the air filter sealing surface for signs of not contacting the air filter seal. (Fig. 17)

If dirt/debris is bypassing the air filter due to a faulty seal, replace the air filter. If the air filter housing is not properly sealing, refer to the appropriate Service Information for additional diagnostic procedures.

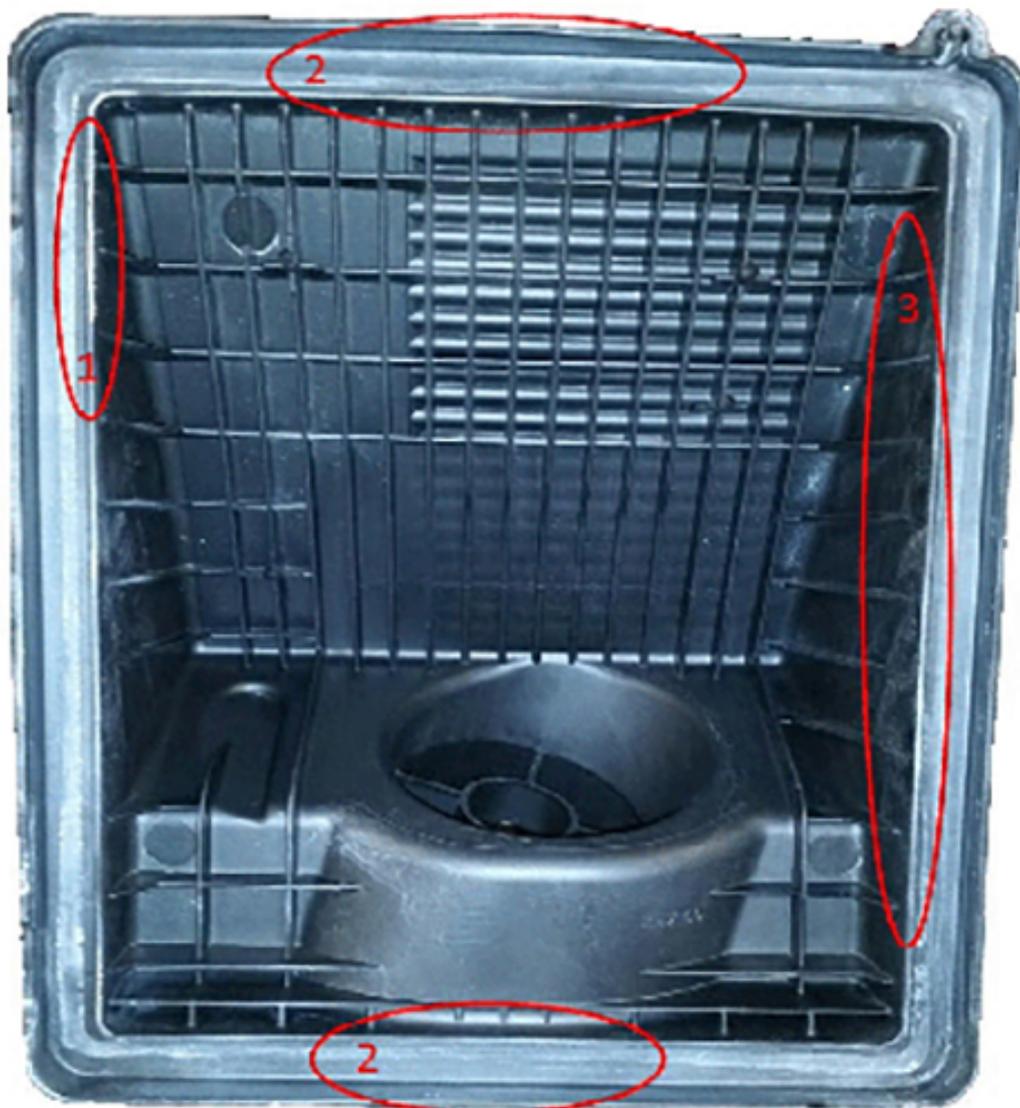
Fig. 18

In addition, look for dirt/debris in the air filter housing cover bypassing the air filter. (Fig. 18)
