# 2014 - 2016 Corvette: GM TechLink: Air Filter Box Seal Leak

**Subject:** Air Filter Box Seal Leak

**Model and Year:** 2014-2016 Corvette, Silverado, Sierra; 2015-2016 Escalade models, Yukon models; and 2016 CTS and Camaro equipped with a V8 engine (RPOs LT1, LT4, L83, L86, LV1, LV3)

**Source:** GM TechLink

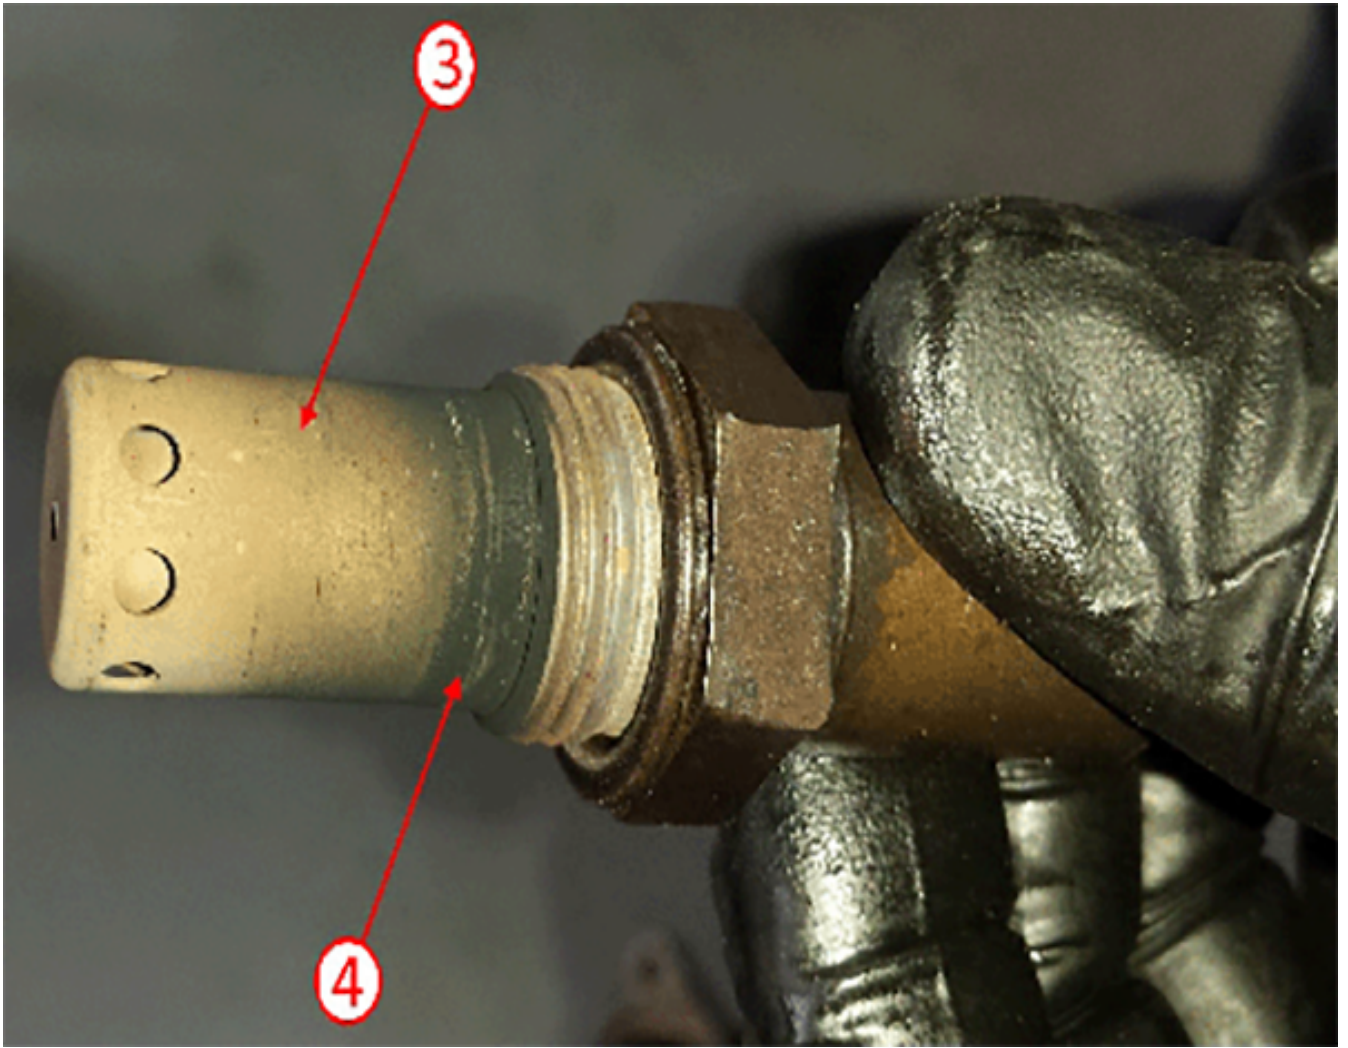
Fig. 15

On some 2014-2016 Corvette, Silverado, Sierra; 2015-2016 Escalade models, Yukon models; and 2016 CTS and Camaro equipped with a V8 engine (RPOs LT1, LT4, L83, L86, LV1, LV3), the MIL may be illuminated and DTCs P0420 (Catalyst System Low Efficiency) and P0430 (Catalyst System Low Efficiency Bank 2) may be set. These conditions may be caused by excessive dirt/debris entering the air filter box and bypassing the seal of the air filter, causing damage to the H02 sensor element (Fig. 15) and blocking the catalytic converter. (Fig. 16)

Do not replace any parts for these conditions until the air filter housing has been validated to be completely sealed.

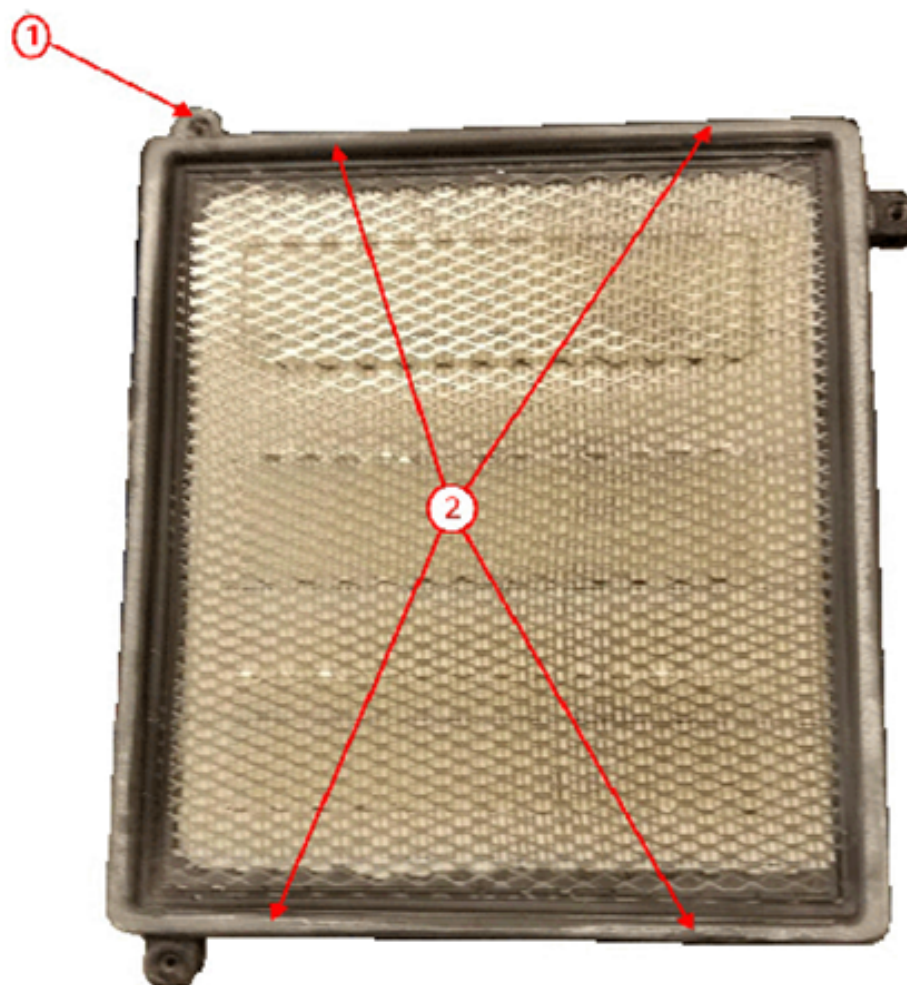
**Fig. 17**

Inspect the air housing cover for any missing tabs or fasteners. Also remove the air filter housing cover and inspect the seal around the filter as well as the air filter sealing surface for signs of not contacting the air filter seal. (Fig. 17)

If dirt/debris is bypassing the air filter due to a faulty seal, replace the air filter. If the air filter housing is not properly sealing, refer to the appropriate Service Information for additional diagnostic procedures.

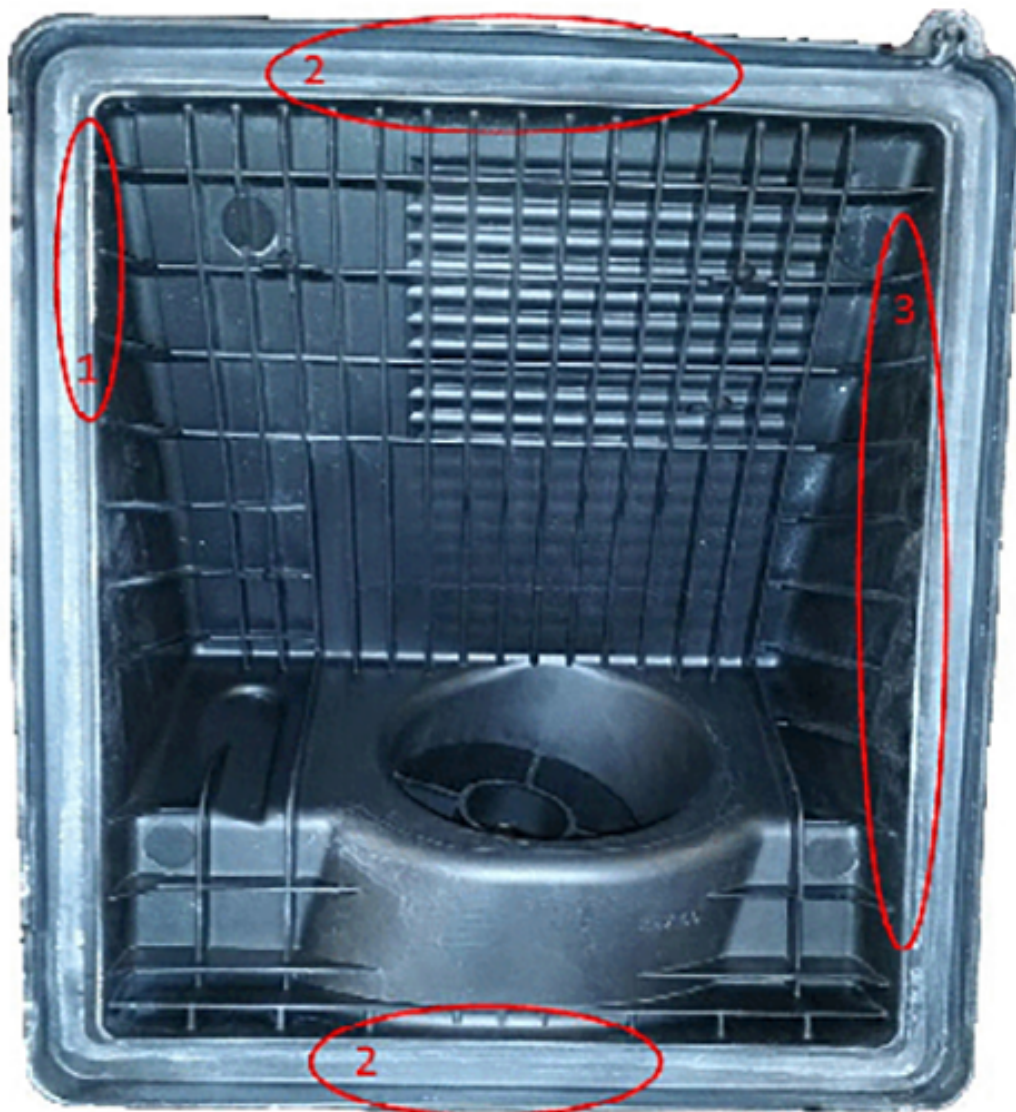
## Fig. 18

In addition, look for dirt/debris in the air filter housing cover bypassing the air filter. (Fig. 18)
