# 2014 - 2016 Corvette: Service Bulletin: #16-NA-170: Brake Pulsation and/or Vibration During Brake Apply

## #16-NA-170: Brake Pulsation and/or Vibration During Brake Apply - (July 20, 2016)

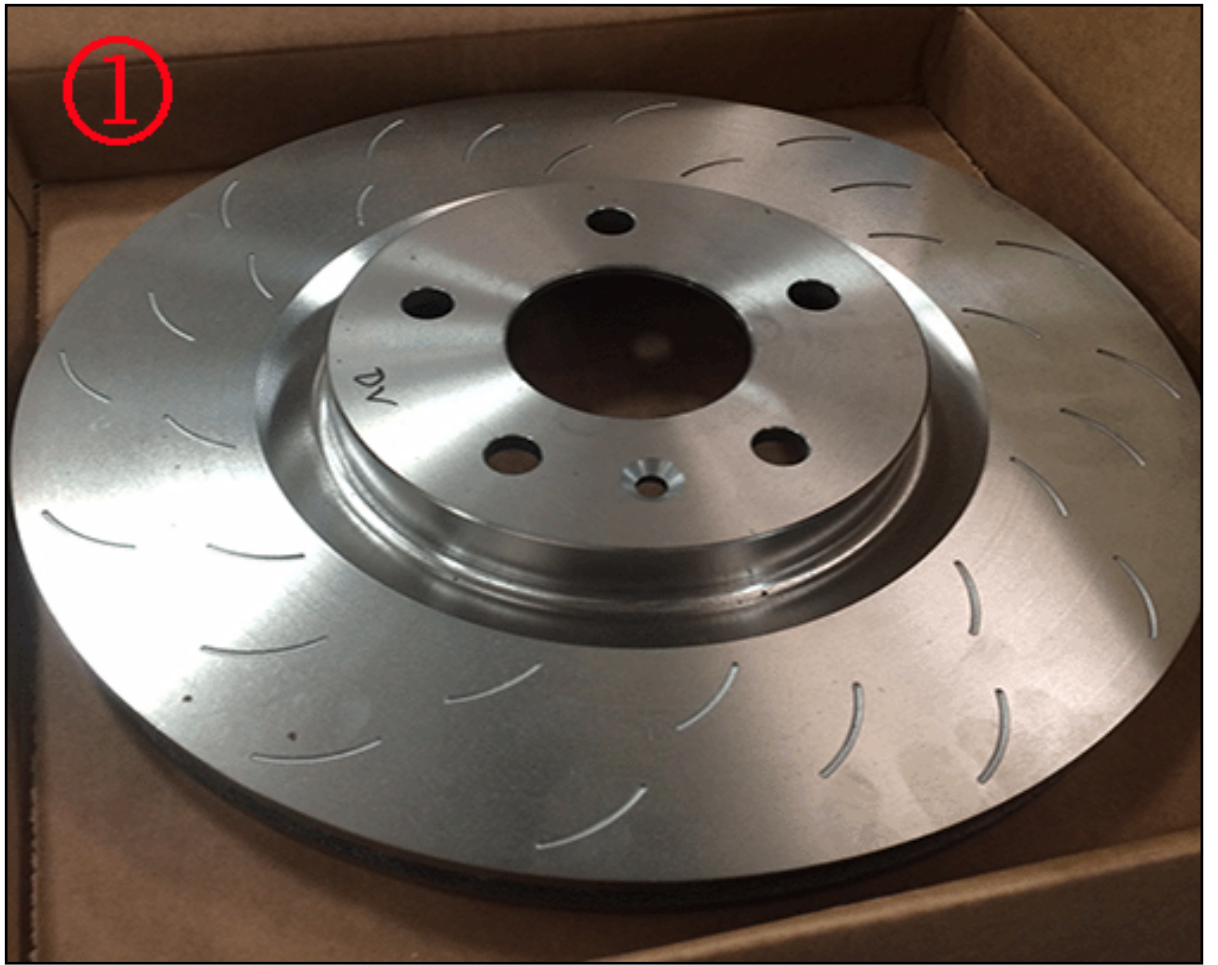
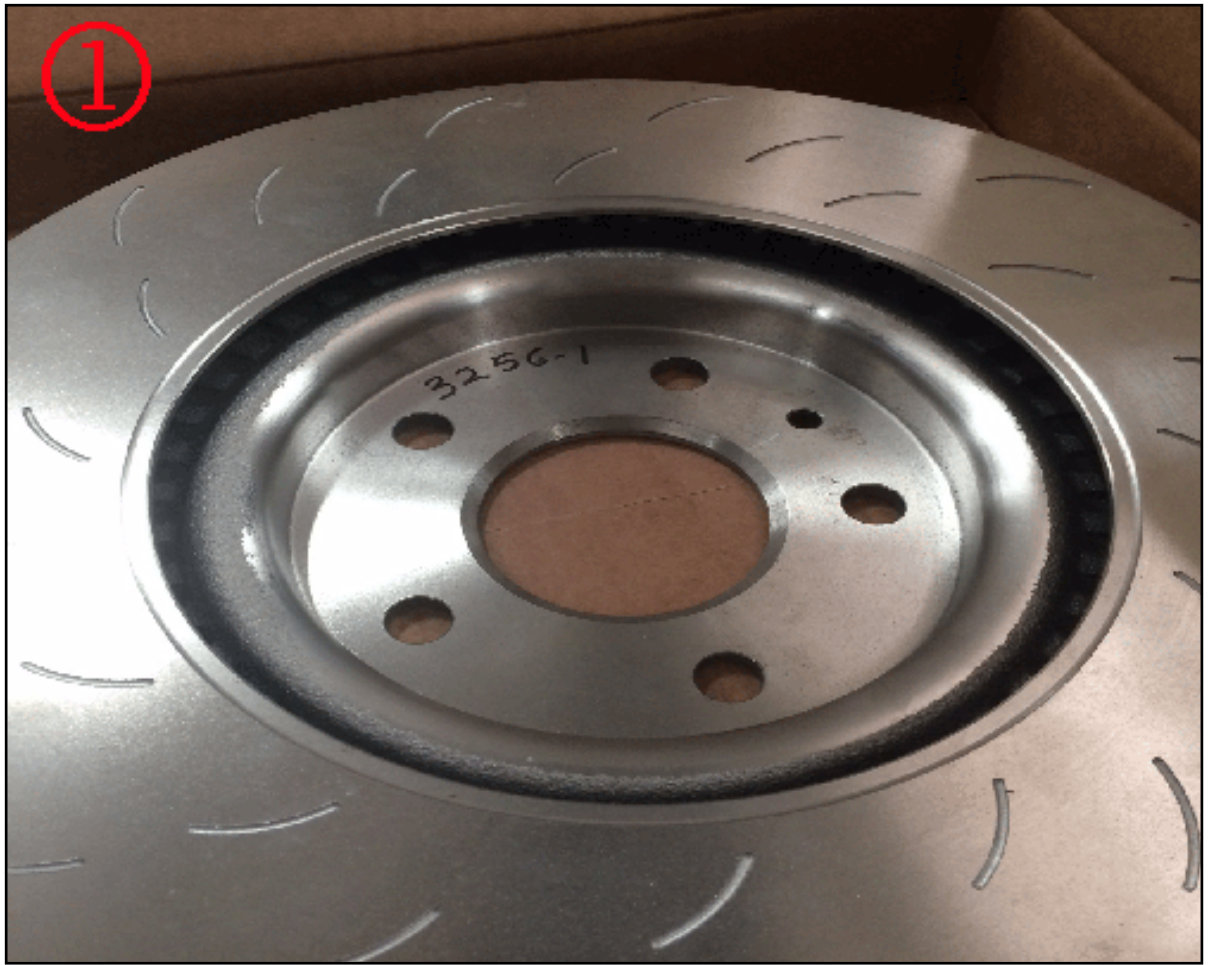
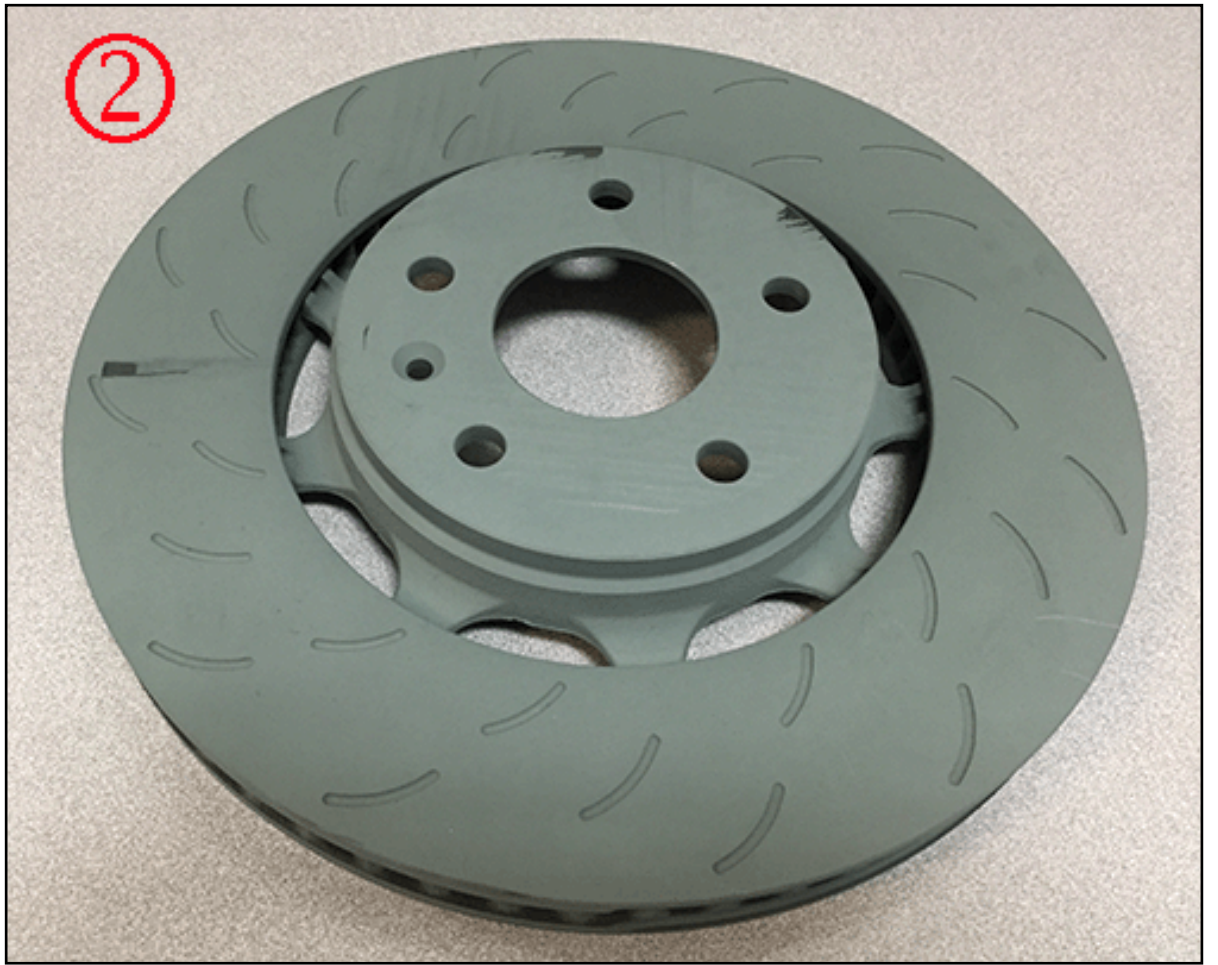
①

This condition may be due to excessive lateral runout (LRO) or interation between the inner top hat section to the rotor ring.

- For front rotors and vehicles built prior to May 31, 2016, replace old two piece design (2) with new one piece design (1).
- For rear rotors and vehicles built prior to July 23, 2015, replace old two piece design (2) with new one piece design (1).

**Important:** The rotors *MUST* be replaced as a pair due to a design change.

Refer to *Brake Rotor Assembled Lateral Runout Correction* and *Front and Rear Brake Rotor Replacement-Both Sides* in SI.
