## 2014 - 2016 Corvette: Service Bulletin: Diagnostic Tip for Malfunction Indicator Light (MIL) Illuminated, DTC P0420 and P0430 Set

### #16-NA-111: Diagnostic Tip for Malfunction Indicator Light (MIL) Illuminated, DTC P0420 and P0430 Set - (Jun 8, 2016)

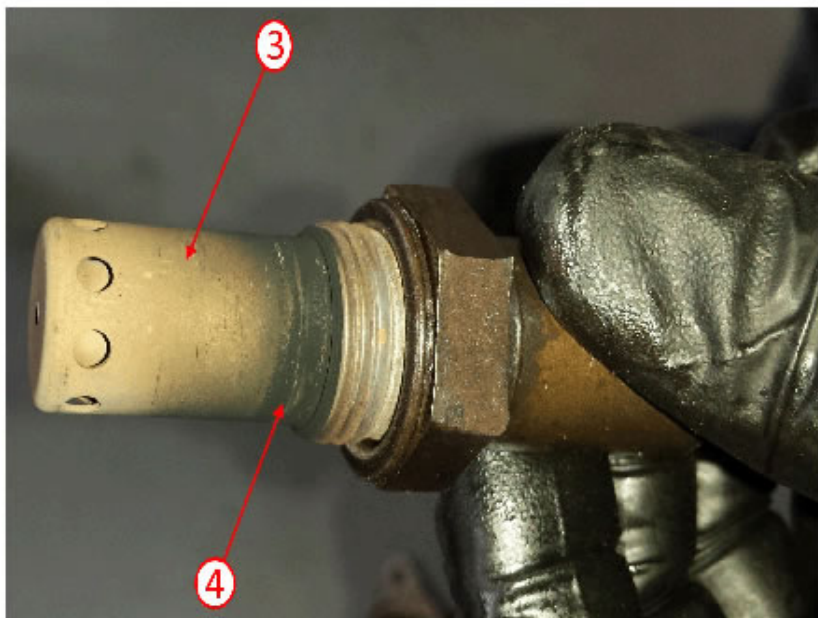
This may be caused by excessive sand and/or debris entering the air filter box and bypassing the seal of the air filter, due to not properly sealing, causing damage to the HO2 sensor element (3) and the catalytic converter to become blocked with sand and debris particles (1, 2).
--	---

*Do not* replace any of the parts until the air filter housing has been validated to be completely sealed.

If the condition is evident, inspection of the air box and air filter seal must be done.

Follow the Service Procedure steps in order to verify the sealing of the air filter to housing surface.

After validating the air box has been sealed, repair the P0420 and the P0430 codes *as needed*.

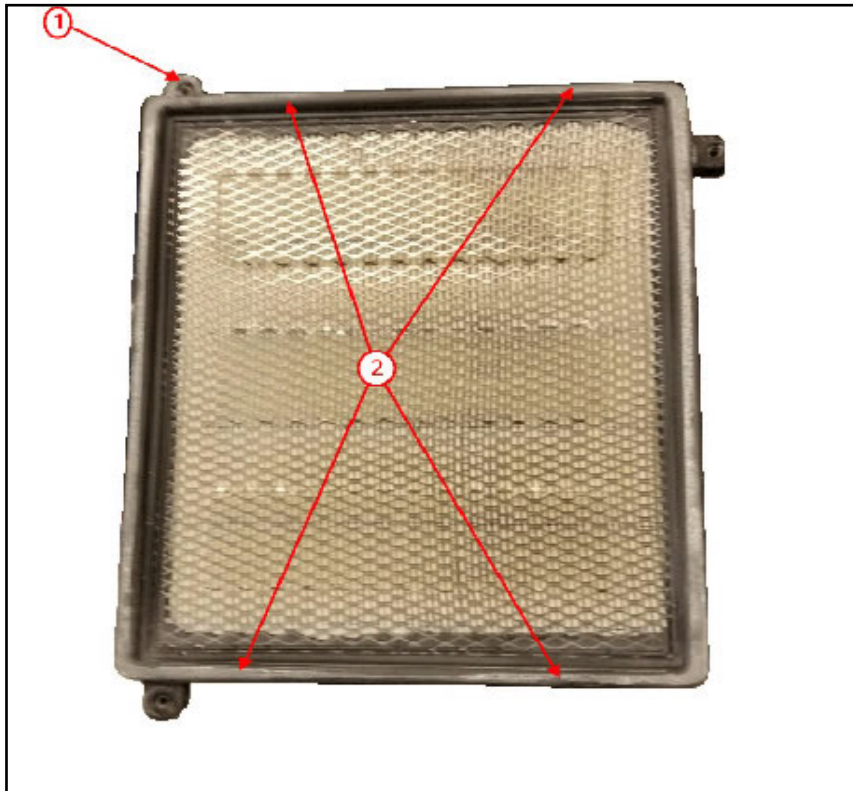
1. Inspect the all the air housing cover for any missing tabs and/or fasteners (1).
2. Remove the air filter housing cover and inspect the seal

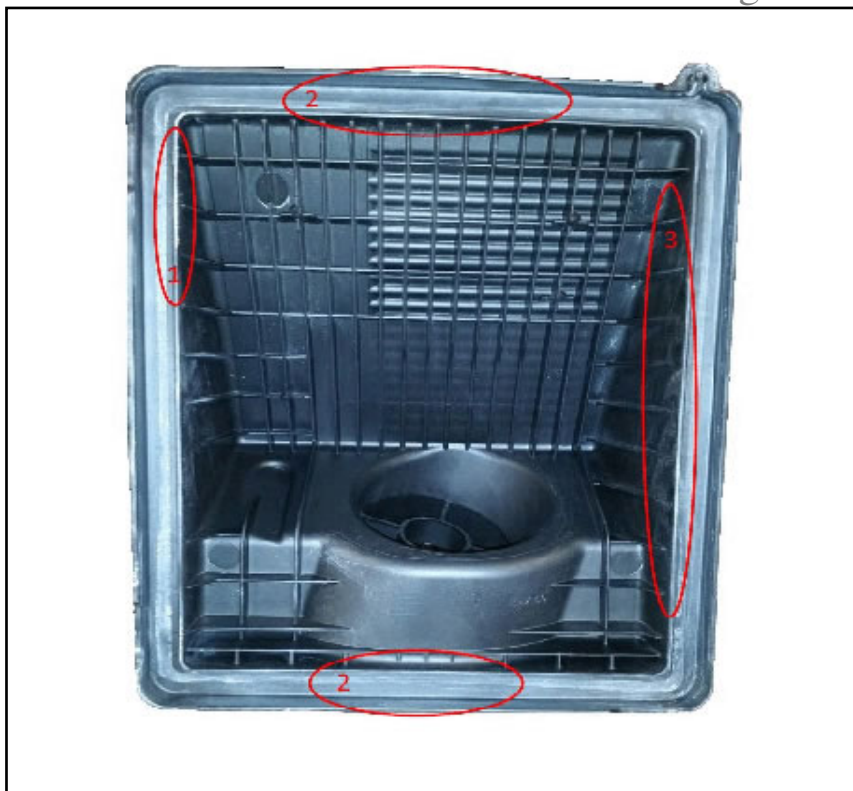
1. Inspect the air filter sealing surface for signs of not contacting the air filter seal (1, 2).
2. Inspect the air filter housing cover for dirt and/or debris bypassing the air filter (3).
3. Inspect the air cleaner outlet duct for any dirt and/or debris.
  - If dirt and debris has been found bypassing the air filter due to a faulty seal, replace the air filter as necessary.
  - If the air filter housing has been found not properly sealing, refer to the *Air Cleaner Assembly Replacement* in SI.
