2014 - 2016 Corvette: Service Bulletin: Diagnostic Tip for Malfunction Indicator Light (MIL) Illuminated, DTC P0420 and P0430 Set

#16-NA-111: Diagnostic Tip for Malfunction Indicator Light (MIL) Illuminated, DTC P0420 and P0430 Set - (Jun 8, 2016)

Diagnostic Tip for Malfunction Indicator Light (MIL) Illuminated, DTC P0420 and P0430 Set

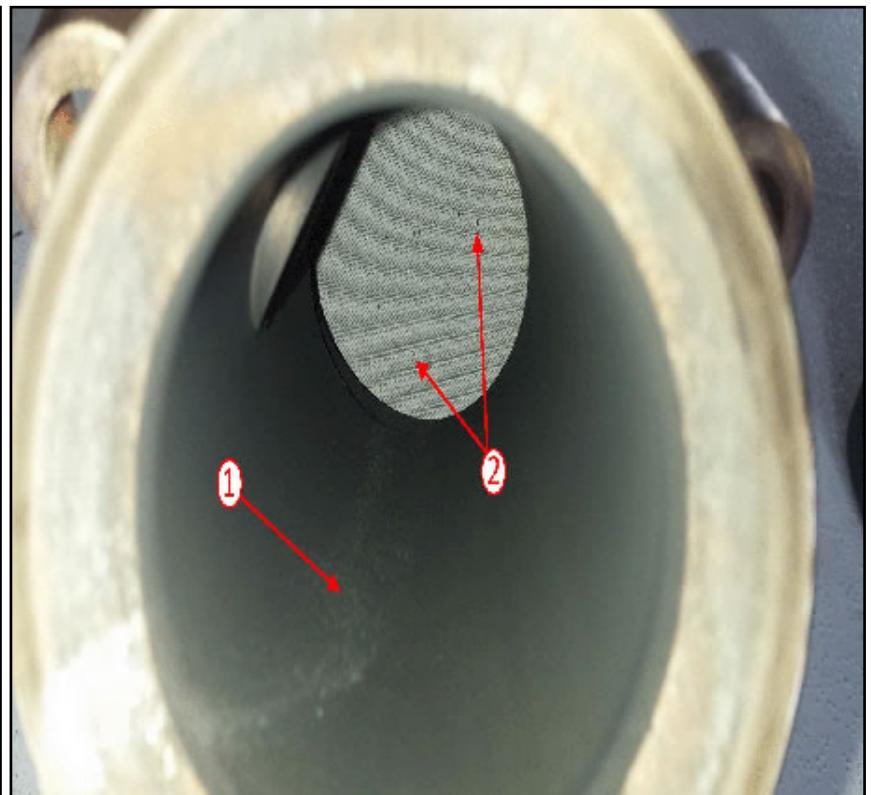
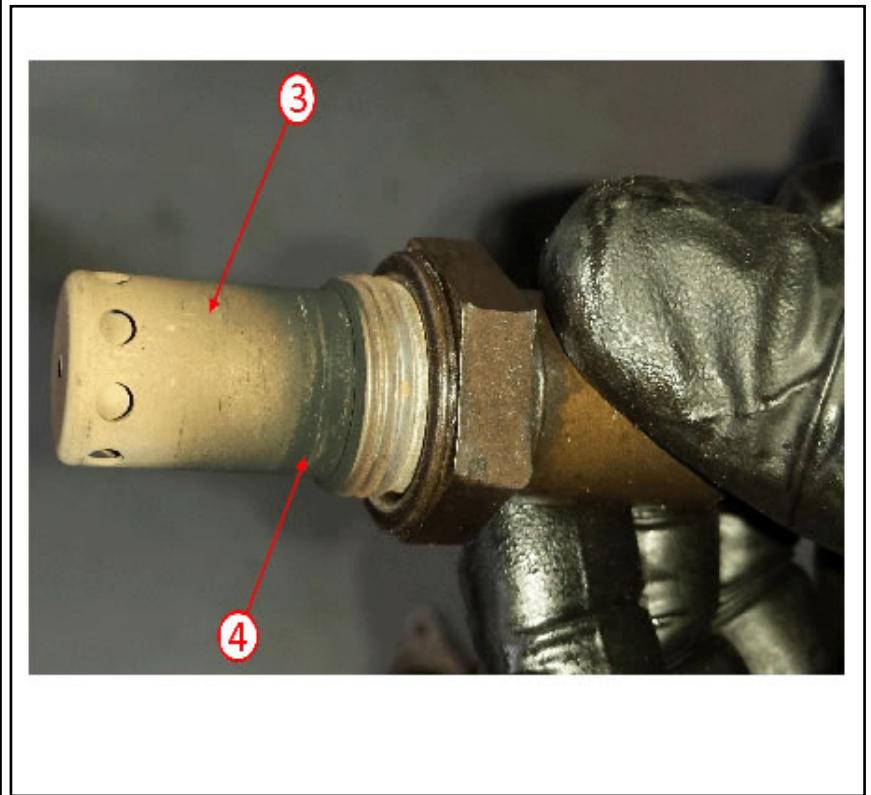
This may be caused by excessive sand and/or debris entering the air filter box and bypassing the seal of the air filter, due to not properly sealing, causing damage to the HO2 sensor element (3) and the catalytic converter to become blocked with sand and debris particles (1, 2).

Do not replace any of the parts until the air filter housing has been validated to be completely sealed.

If the condition is evident, inspection of the air box and air filter seal must be done.

After validating the air box has been sealed, repair the P0420 and the P0430 codes *as needed*.

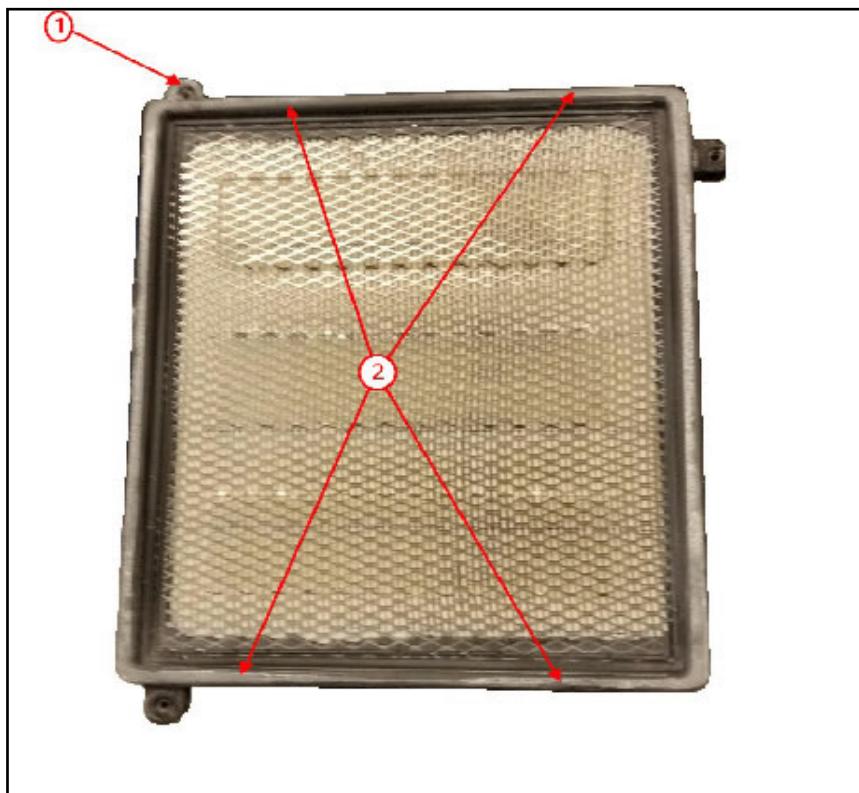
1. Inspect the all the air housing cover for any missing tabs and/or fasteners (1).
2. Remove the air filter housing cover and inspect the seal

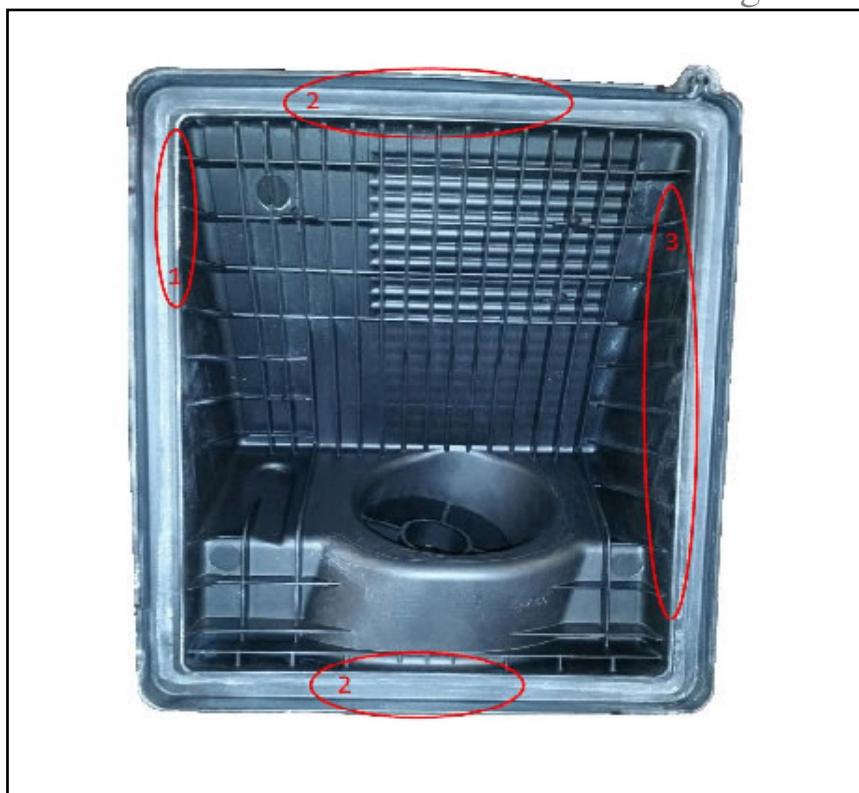
1. Inspect the air filter sealing surface for signs of not contacting the air filter seal (1, 2).
2. Inspect the air filter housing cover for dirt and/or debris bypassing the air filter (3).
3. Inspect the air cleaner outlet duct for any dirt and/or debris.
 - If dirt and debris has been found bypassing the air filter due to a faulty seal, replace the air filter as necessary.
 - If the air filter housing has been found not properly sealing, refer to the *Air Cleaner Assembly Replacement* in SI.
