2015 - 2017 Corvette Z06: Service Bulletin: #PIP5395B: Ticking Rattle Or Buzz Noise Heard The Best In The Passenger Compartment - (Mar 20, 2017)

#PIP5395B: Ticking Rattle Or Buzz Noise Heard The Best In The Passenger Compartment - (Mar 20, 2017)

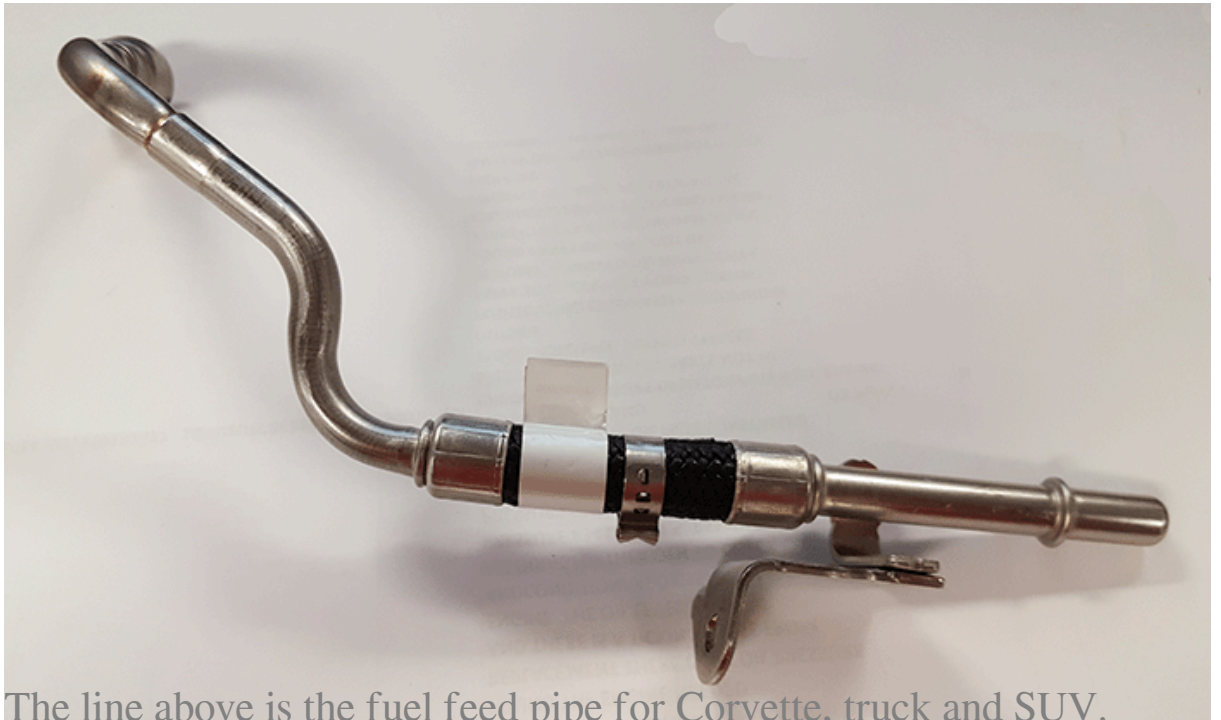
The line above is the fuel feed pipe for Corvette, truck and SUV.

This line connects the chassis fuel line to the high pressure fuel pump.

The fuel feed line between the high pressure fuel pump and chassis fuel line could be the cause allowing high pressure pulsation back to the low side of the fuel system. There is not a good way to test the check valve, the line will need to be replaced.

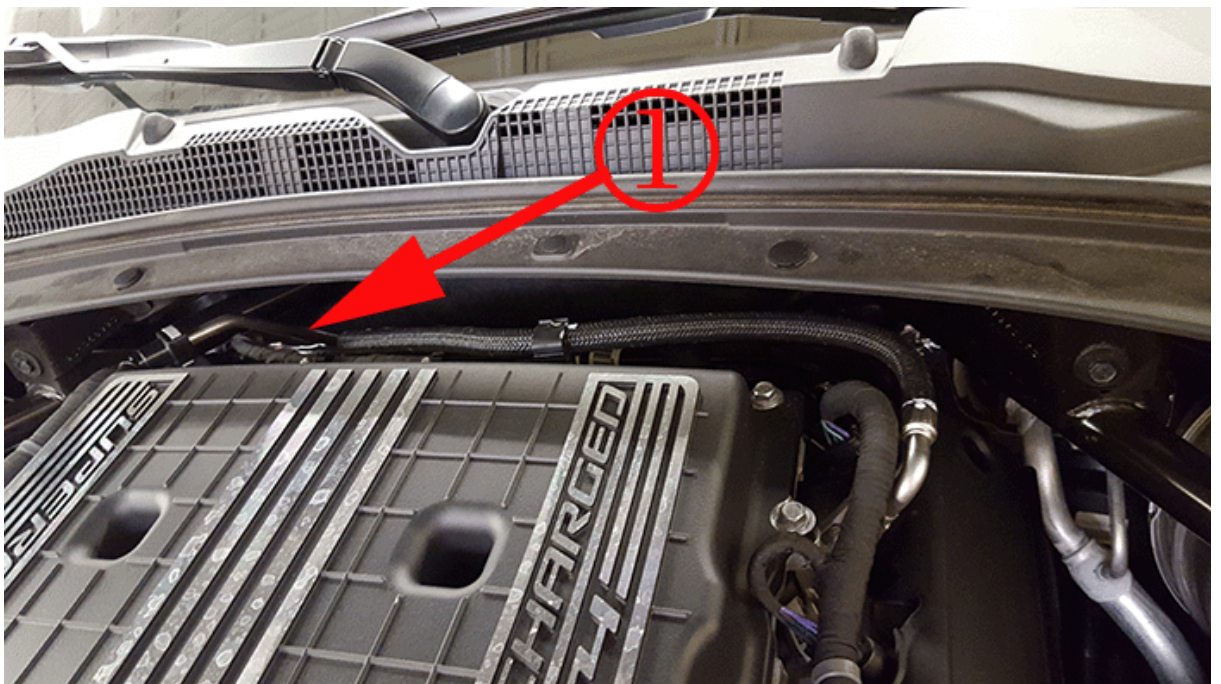
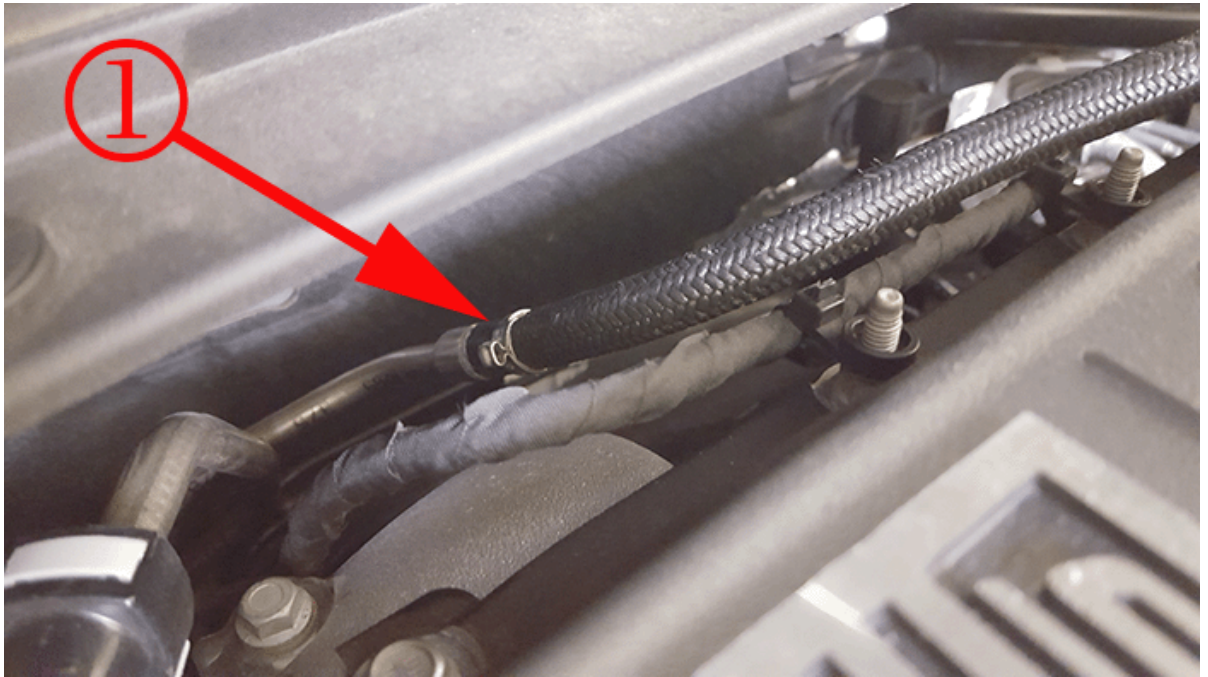
These pictures above shows the chassis fuel feed pipe for the LT4 supercharged ZL1 Camaro.

On LT1 Camaro and LT4 CTS-V this line would have a jumper line with quick disconnects at both ends.

One end will connect to the chassis line and the other to the high pressure pump feed line.
