2019 Corvette ZR1: Rear Spoiler Adjustment

May 30, 2019 - GM TechLink

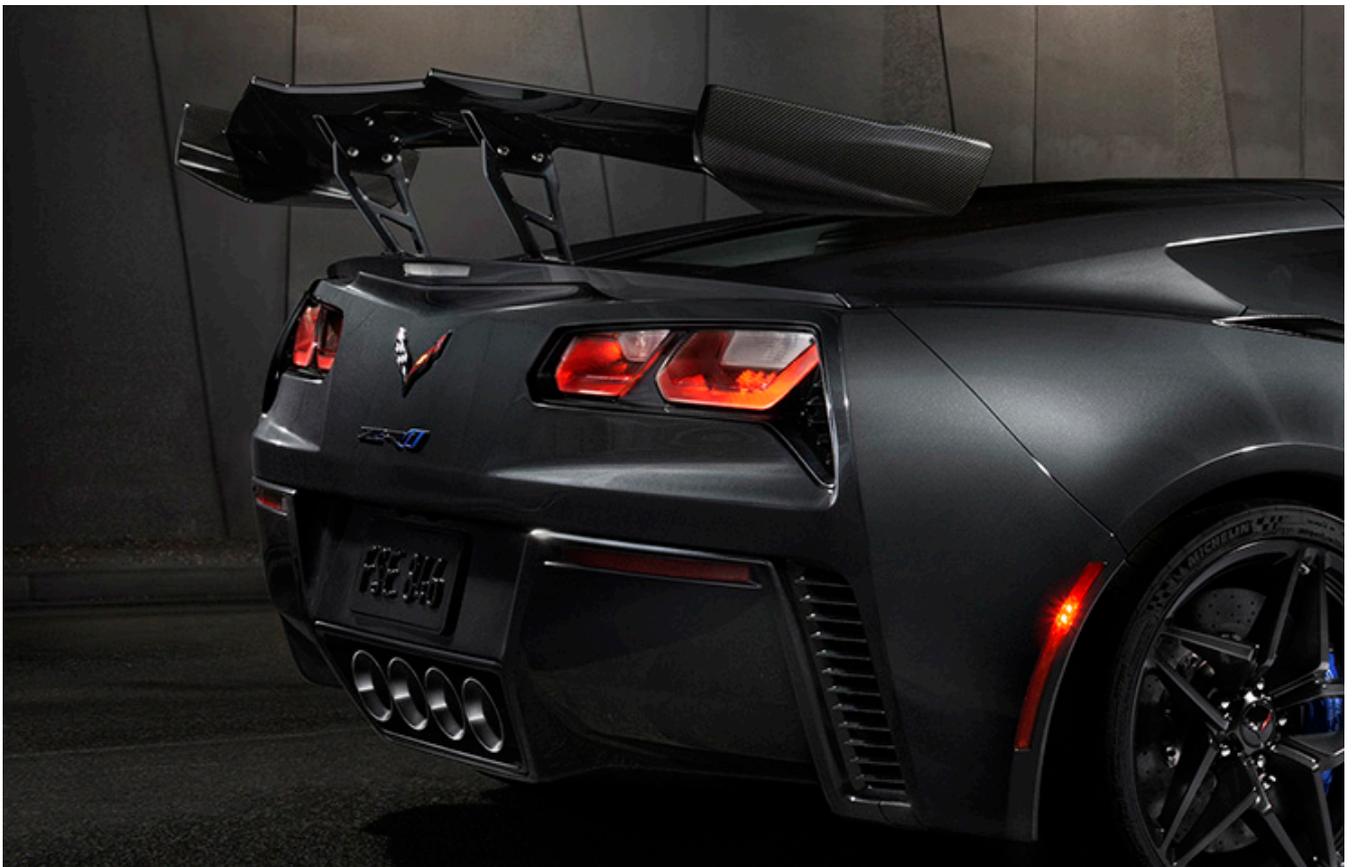
Fig. 18

The rear spoiler of the 2019 Corvette ZR1 (Fig. 18) is installed at the dealership during the Pre-Delivery Inspection (PDI). After installation of the rear spoiler, it may be noticeable that the spoiler has a crooked appearance. If this condition is evident, the Rear End Secondary Spoiler Bracket may be out of adjustment.

TIP: The rear spoiler (in both street and track configurations) is attached to the vehicle using unique fasteners. The vehicle is not shipped with the **special bit that is needed to attach the spoiler** to the vehicle. Obtain the appropriate bit to complete the installation. Refer to the Special Inspection Items box on the PDI form.

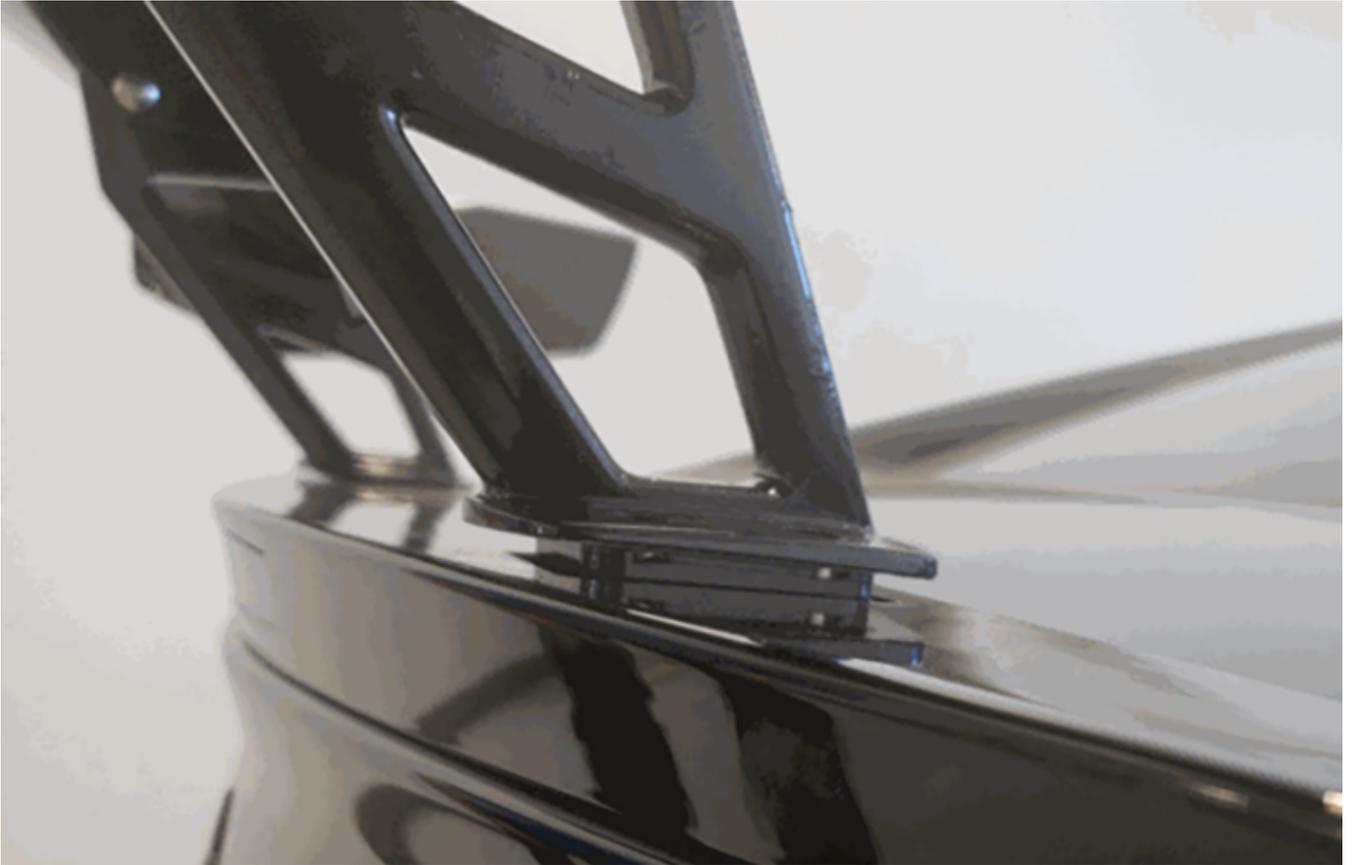
Fig. 22

If the mounting piers are not positioned with the minimum 3 mm gap, the fascia paint may be damaged by the spoiler stanchions. Shown is the correct amount of clearance between the stanchions and the rear fascia. (Fig. 22)
