2019 Corvette ZR1: Rear Spoiler Adjustment

May 30, 2019 - GM TechLink

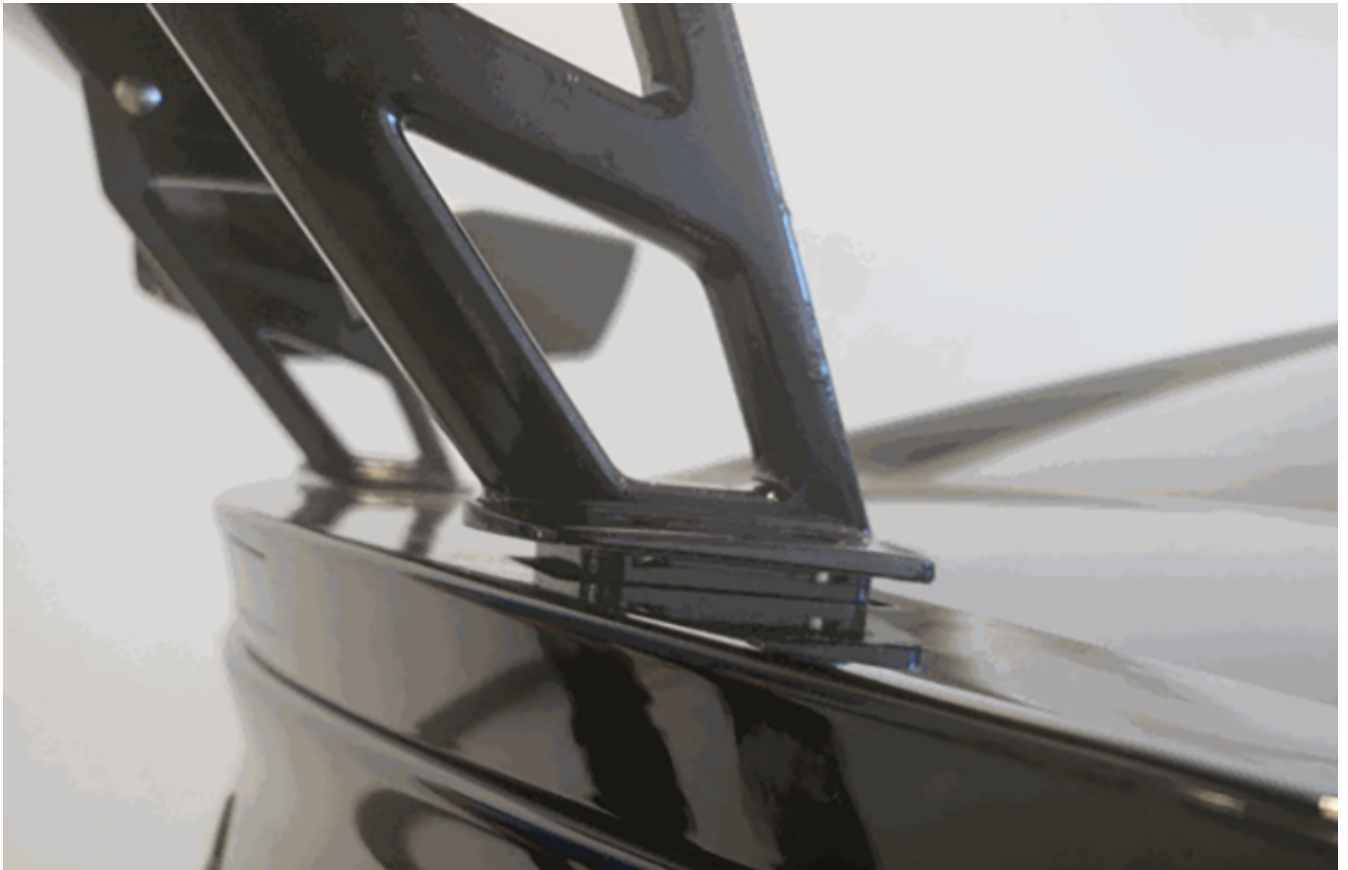
Fig. 22

If the mounting piers are not positioned with the minimum 3 mm gap, the fascia paint may be damaged by the spoiler stanchions. Shown is the correct amount of clearance between the stanchions and the rear fascia. (Fig. 22)
