2019 Corvette ZR1: Rear Spoiler Adjustment

May 30, 2019 - GM TechLink

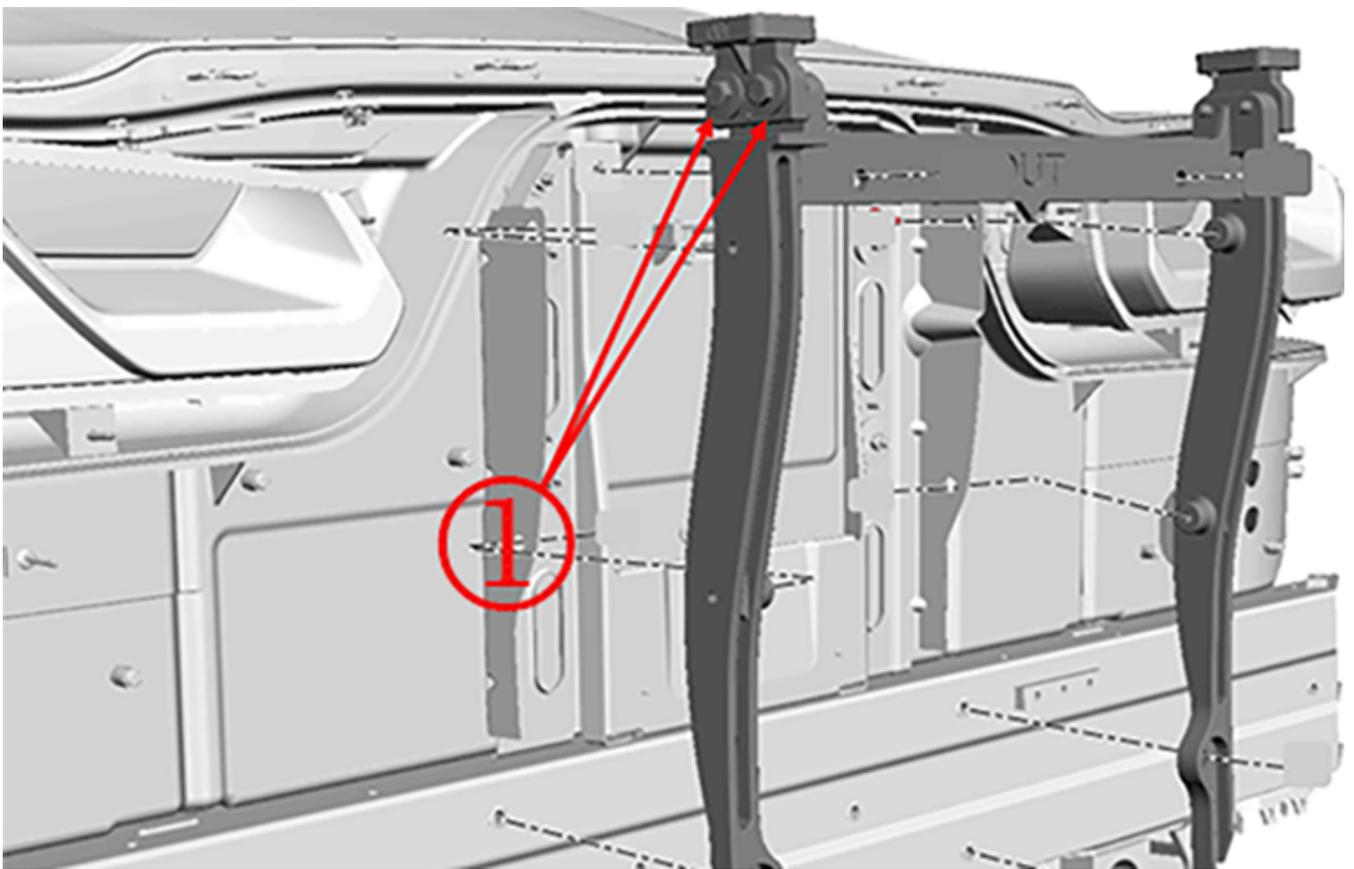
Fig. 19

To correct the position of the rear spoiler, remove the rear fascia and adjust the Rear End Secondary Spoiler Bracket (Fig. 19) as needed until the spoiler is level.

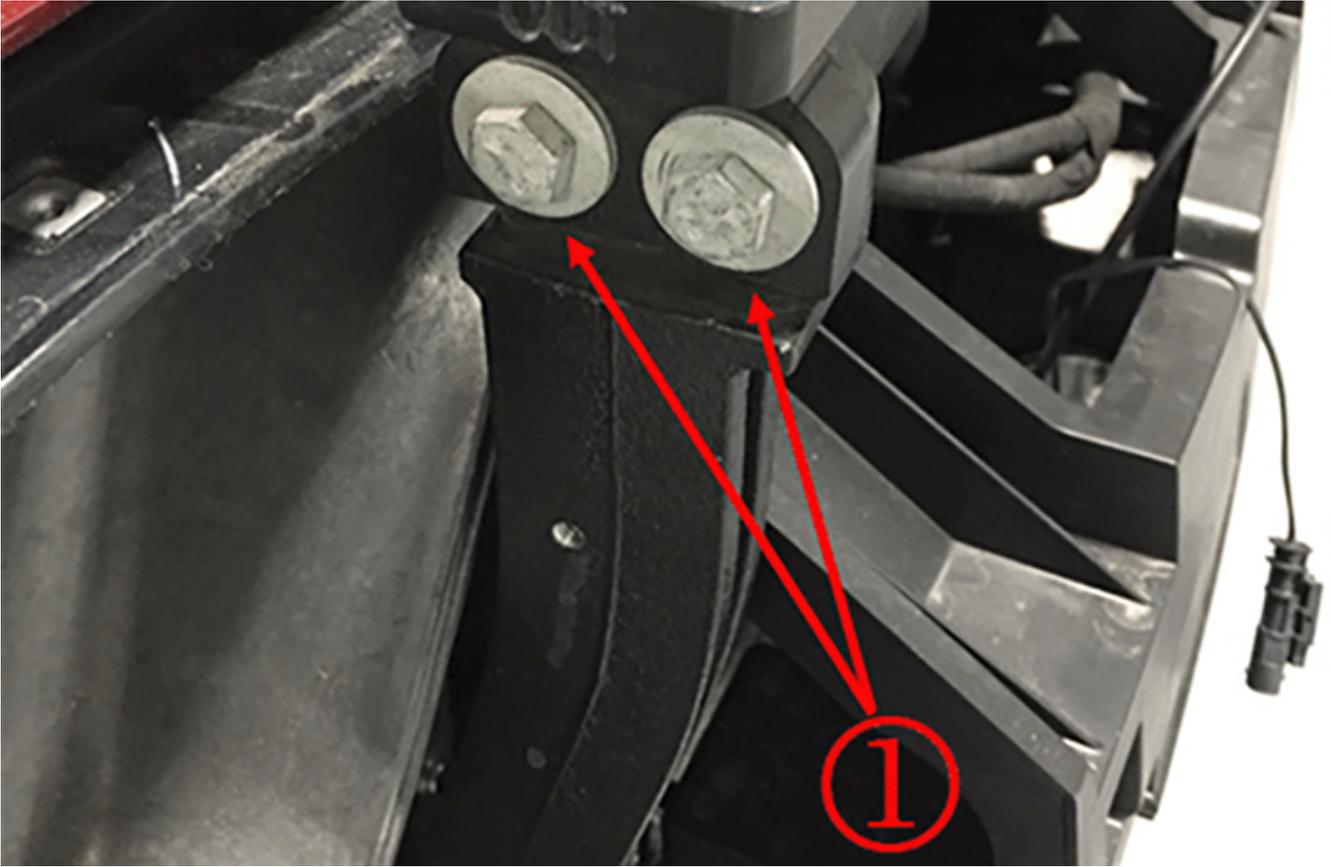
Fig. 20

The bolts that need to be loosened to perform the adjustment are located on the left side of the bracket. (Fig. 20)

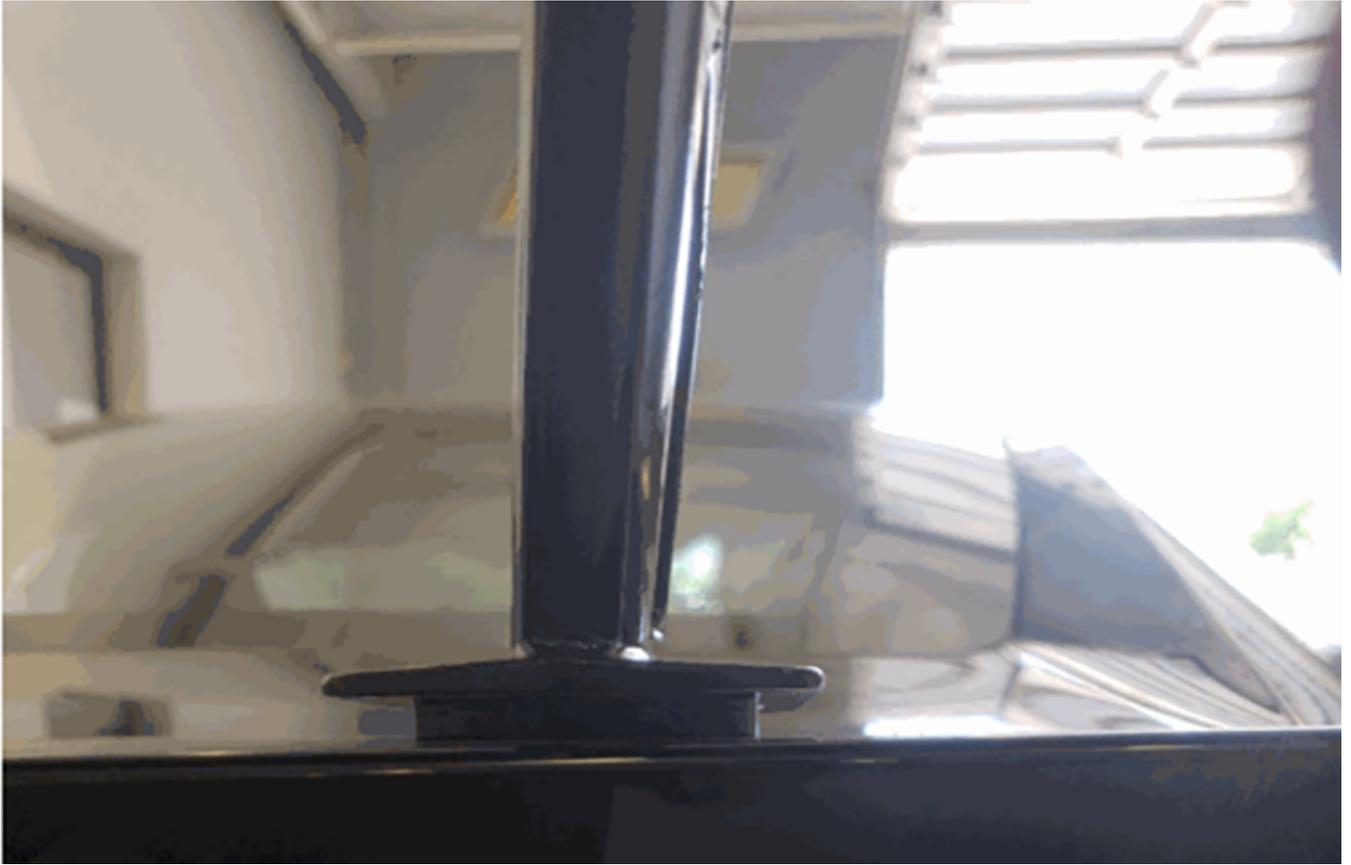
Fig. 21

Adjust the spoiler so that the spoiler mounting piers are even left to right and are a minimum of 3 mm above the rear fascia. (Fig. 21)

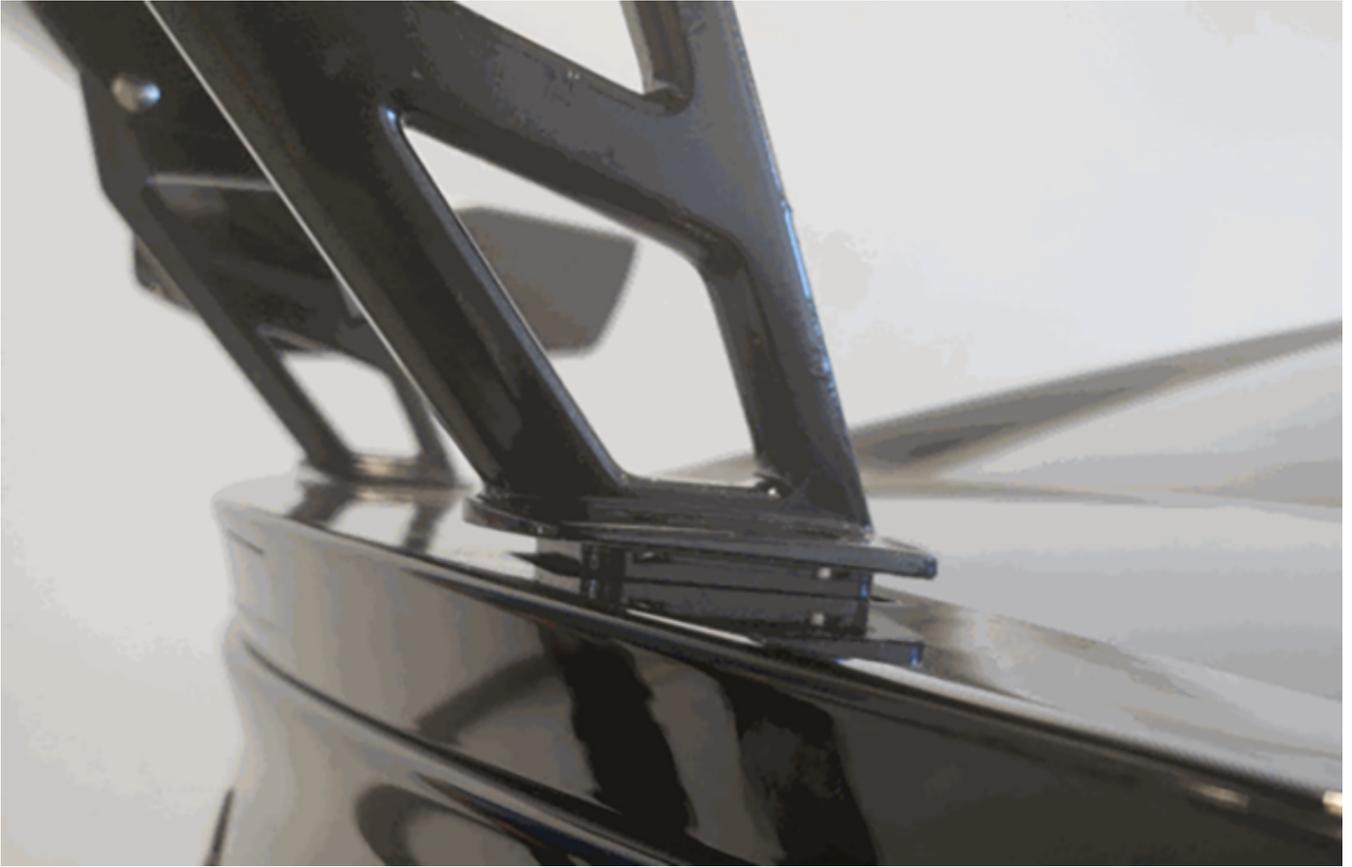
Fig. 22

If the mounting piers are not positioned with the minimum 3 mm gap, the fascia paint may be damaged by the spoiler stanchions. Shown is the correct amount of clearance between the stanchions and the rear fascia. (Fig. 22)
