# 2020 Corvette: Service Bulletin: #N202302840: Service Update - Door Paint Chipping

**Subject:** N202302840 — Door  
Paint Chipping  
**Models:** 2020 Chevrolet Corvette

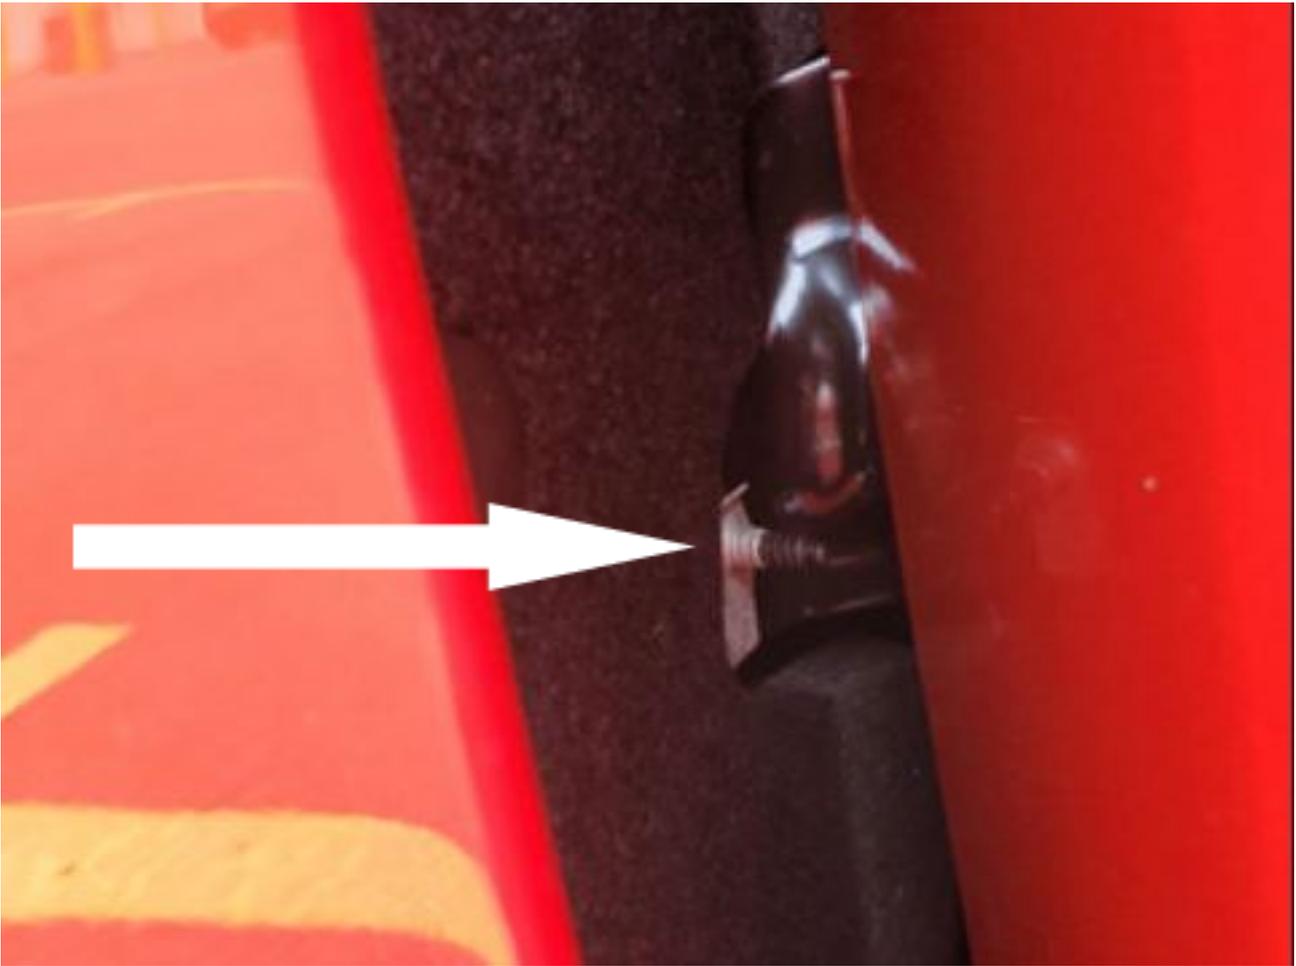
- If less than 1 full thread is showing, no further action is required.

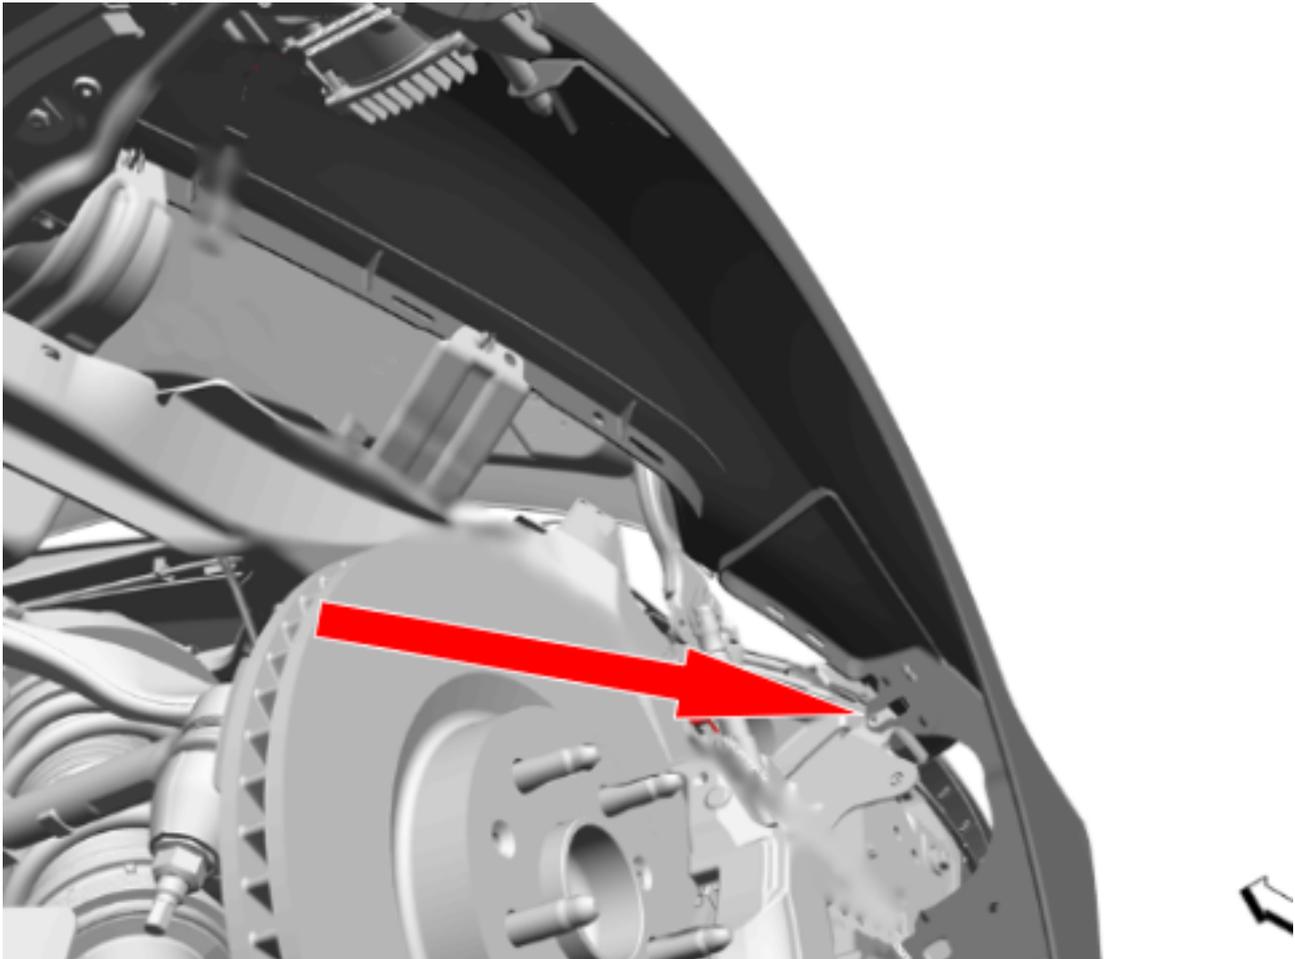
- If more than 2 threads are showing, proceed to step # 4.
- Partially remove the wheelhouse liner to access the rear fender mounting fasteners. Refer to *Front Wheelhouse Liner Replacement* in SI.
  1. Locate and remove the center fender to body fastener as shown.
  2. Install the shorter service fastener. Tighten  $9\text{ Nm}$  ( $80\text{ lb in}$ ).
  3. Reinstall the wheelhouse liner. Refer to *Front Wheelhouse Liner Replacement* in SI.
  4. Repeat steps 1-7 on the right side of the vehicle.
