2020 Corvette: Loose Carbon Patch in Air Cleaner Housing

GM TechLink
April 30, 2020

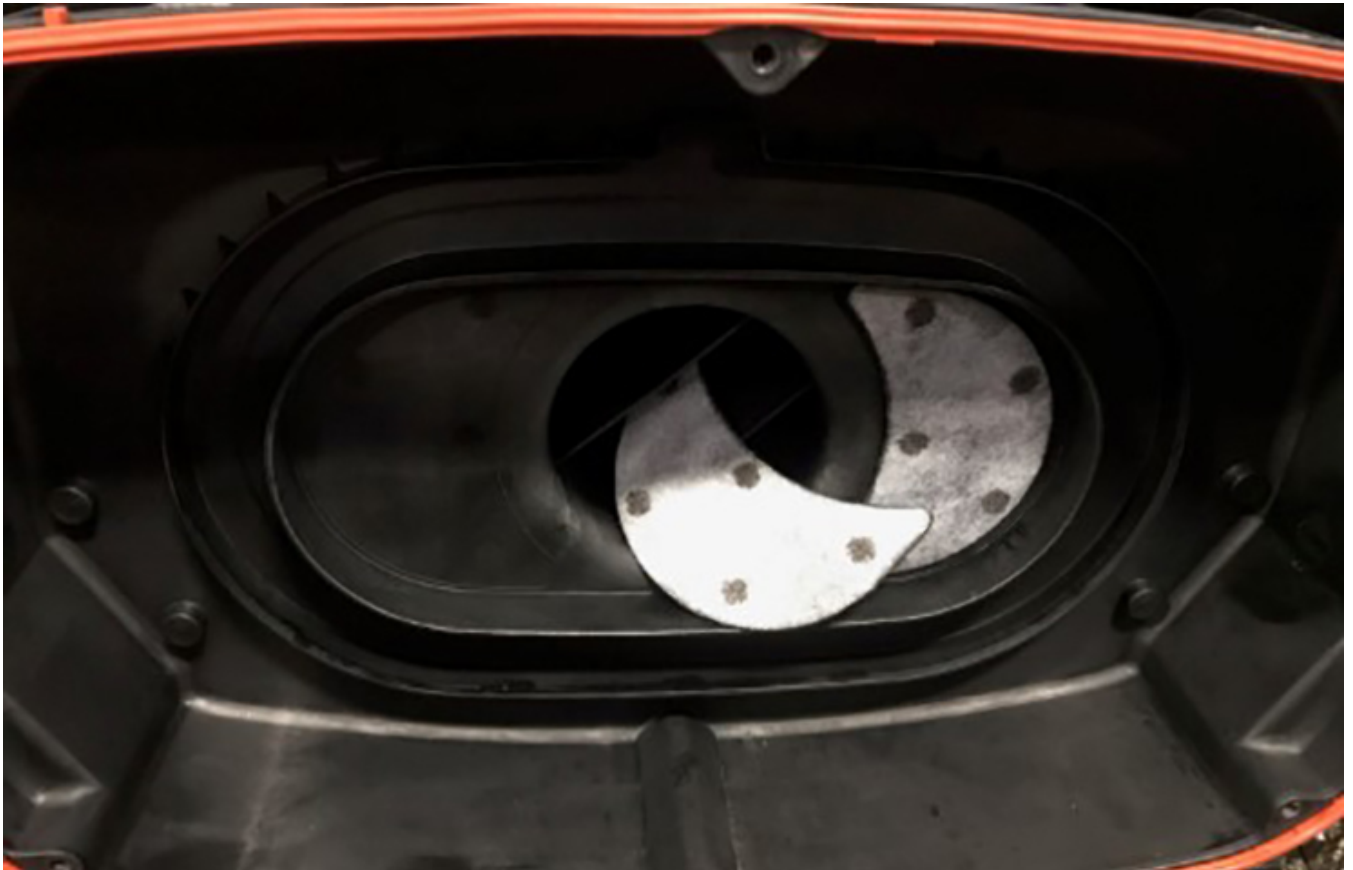
Fig. 11

A loose carbon patch in the air cleaner housing may be restricting air flow across the Mass Airflow (MAF) sensor on some 2020 Corvette models. (Fig. 11) DTCs P0101 (Mass Airflow Sensor Performance), P0171 (Fuel Trim System Lean) and P0174 (Fuel Trim System Lean Bank 2) may be set in the Engine Control Module (ECM).

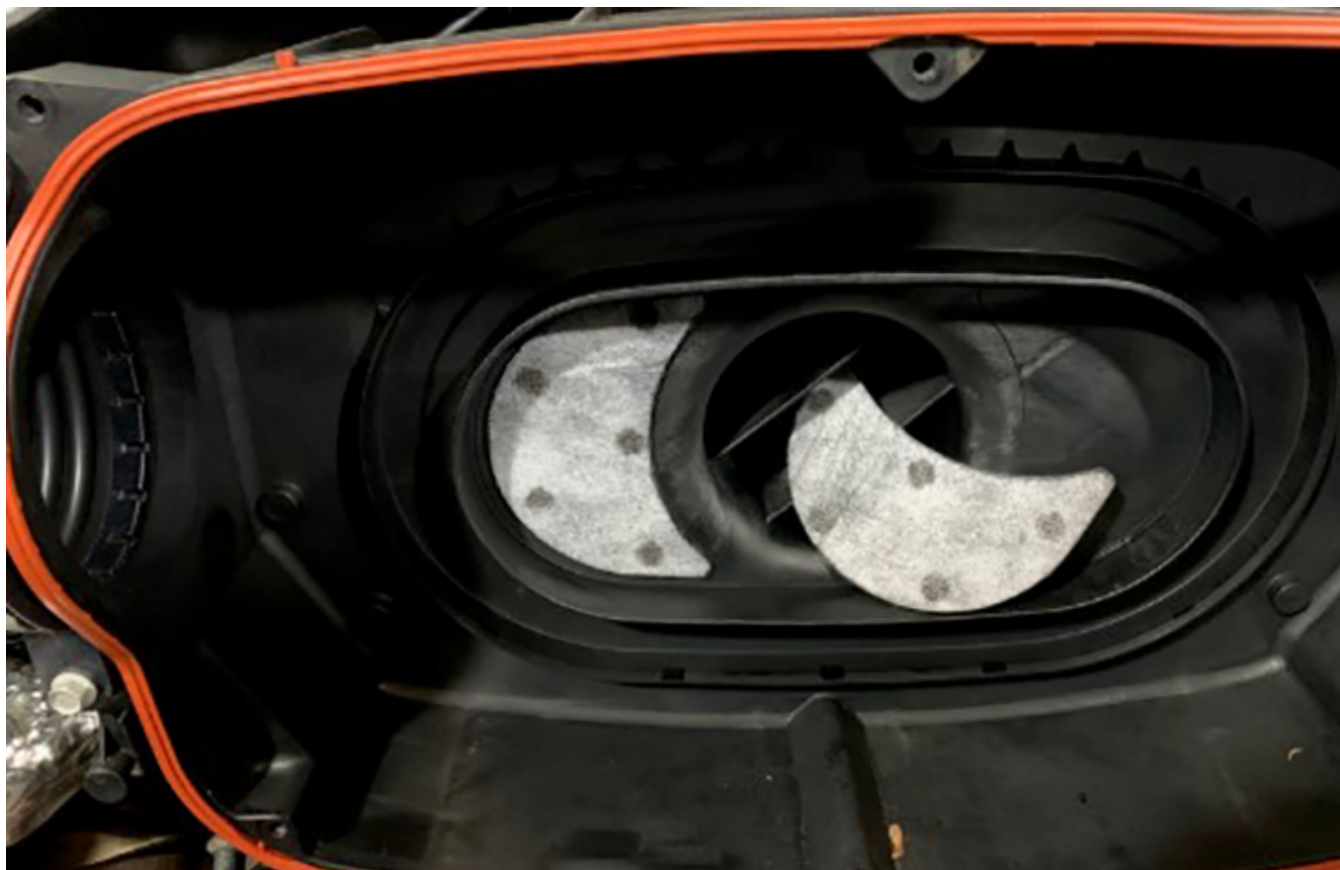
Fig. 12

If any of these DTCs are set, remove the air filter and inspect the carbon patches to determine if they are out of place. (Fig. 12)
