2020 Corvette: GM TechLink: Loose Carbon Patch in Air Cleaner Housing

GM TechLink

April 30, 2020

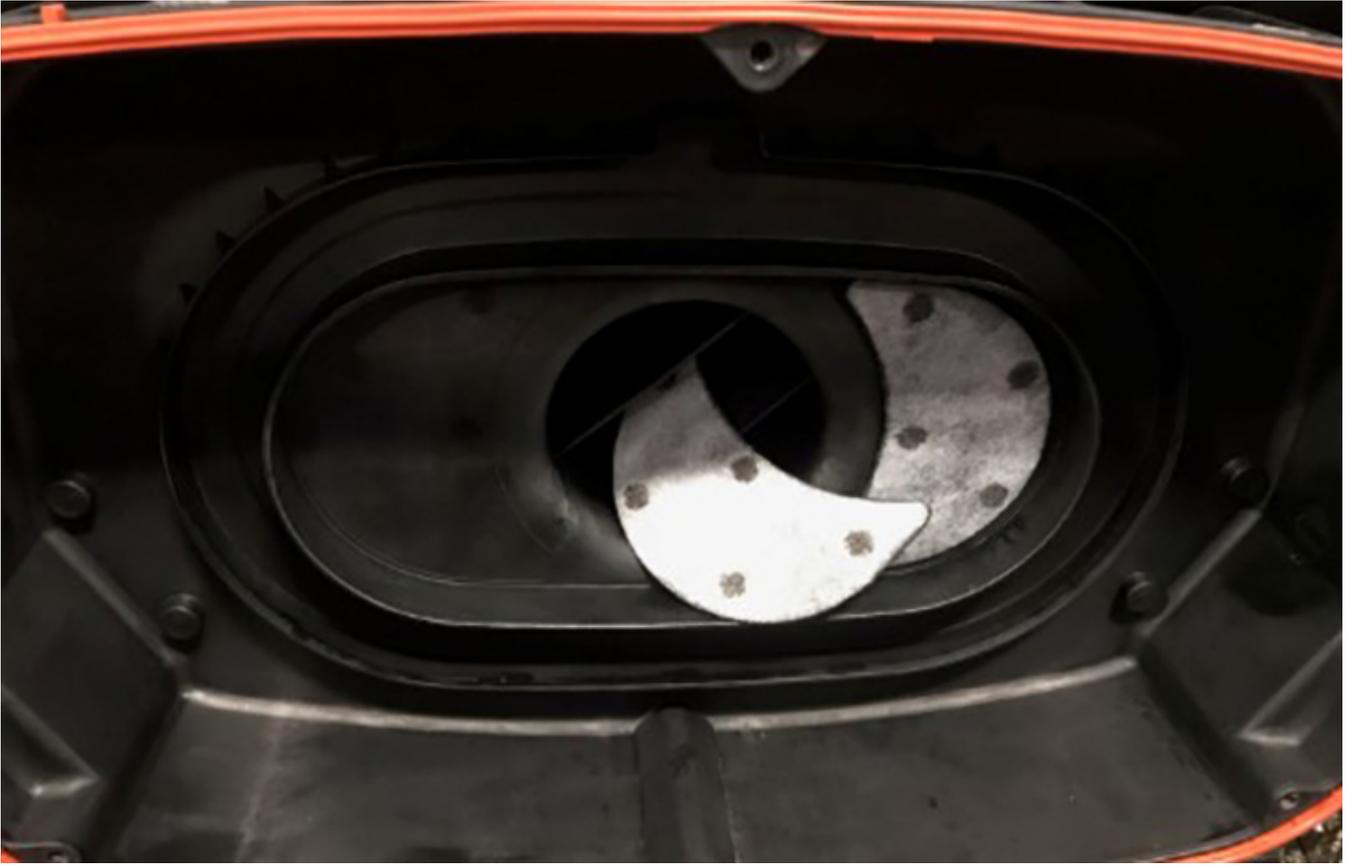
Fig. 11

A loose carbon patch in the air cleaner housing may be restricting air flow across the Mass Airflow (MAF) sensor on some 2020 Corvette models. (Fig. 11) DTCs P0101 (Mass Airflow Sensor Performance), P0171 (Fuel Trim System Lean) and P0174 (Fuel Trim System Lean Bank 2) may be set in the Engine Control Module (ECM).

In addition, depending on how the patch is positioned in the air cleaner housing, other DTCs may be set. Check the carbon patches in the air cleaner housing if any of the following DTCs are set: P0101, P1101, P0171, P0174, P0300, P2119, P2101, P219A, and P219B.

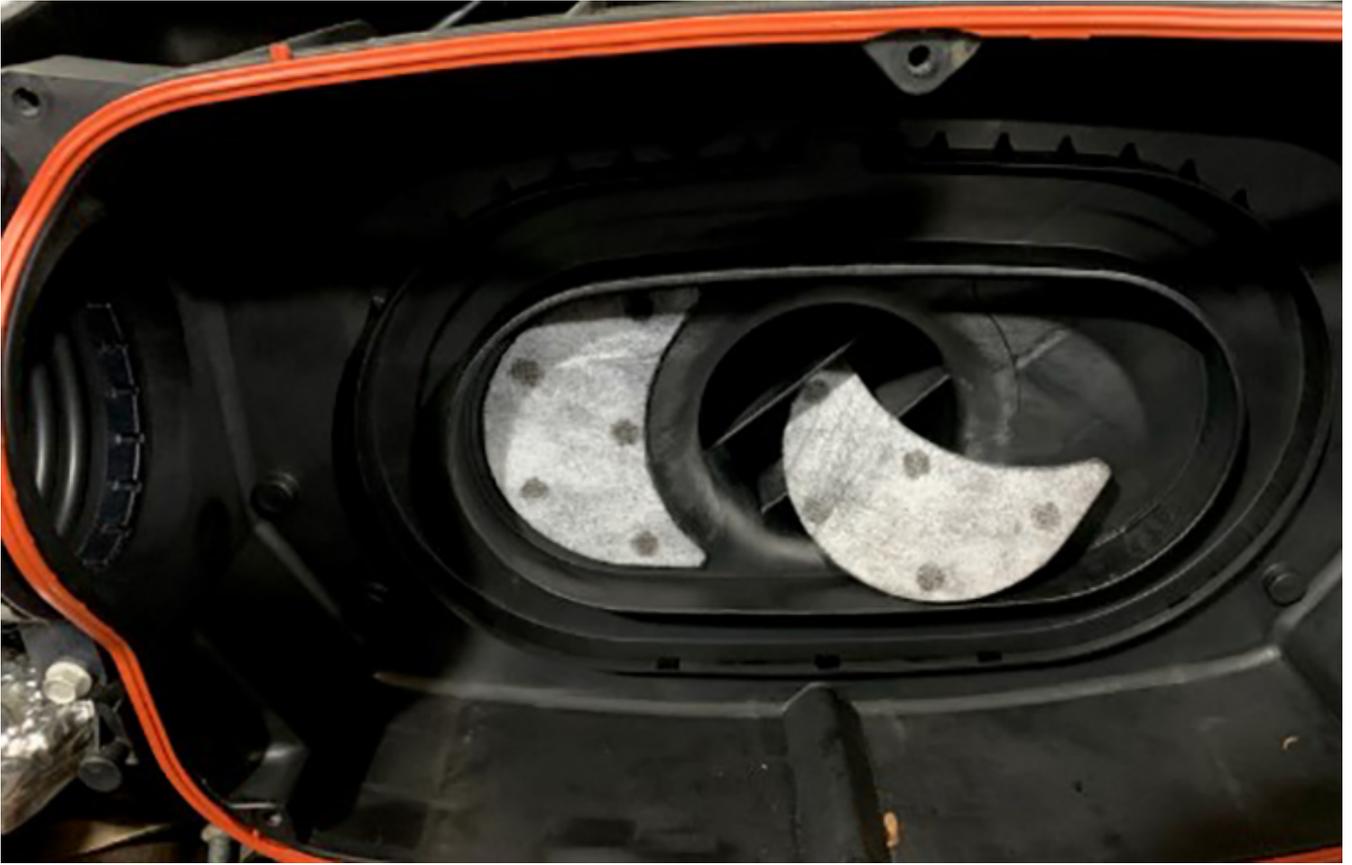
Fig. 12

If any of these DTCs are set, remove the air filter and inspect the carbon patches to determine if they are out of place. (Fig. 12)
