2014 - 2020 Corvette: Service Bulletin: #17-NA-271: Clicking Noise from Front Wheels While Turning at Slow Speeds

#17-NA-271: Clicking Noise from Front Wheels While Turning at Slow Speeds - (Oct 13, 2020)

Subject: Clicking Noise from
Front Wheels While
Turning at Slow Speeds

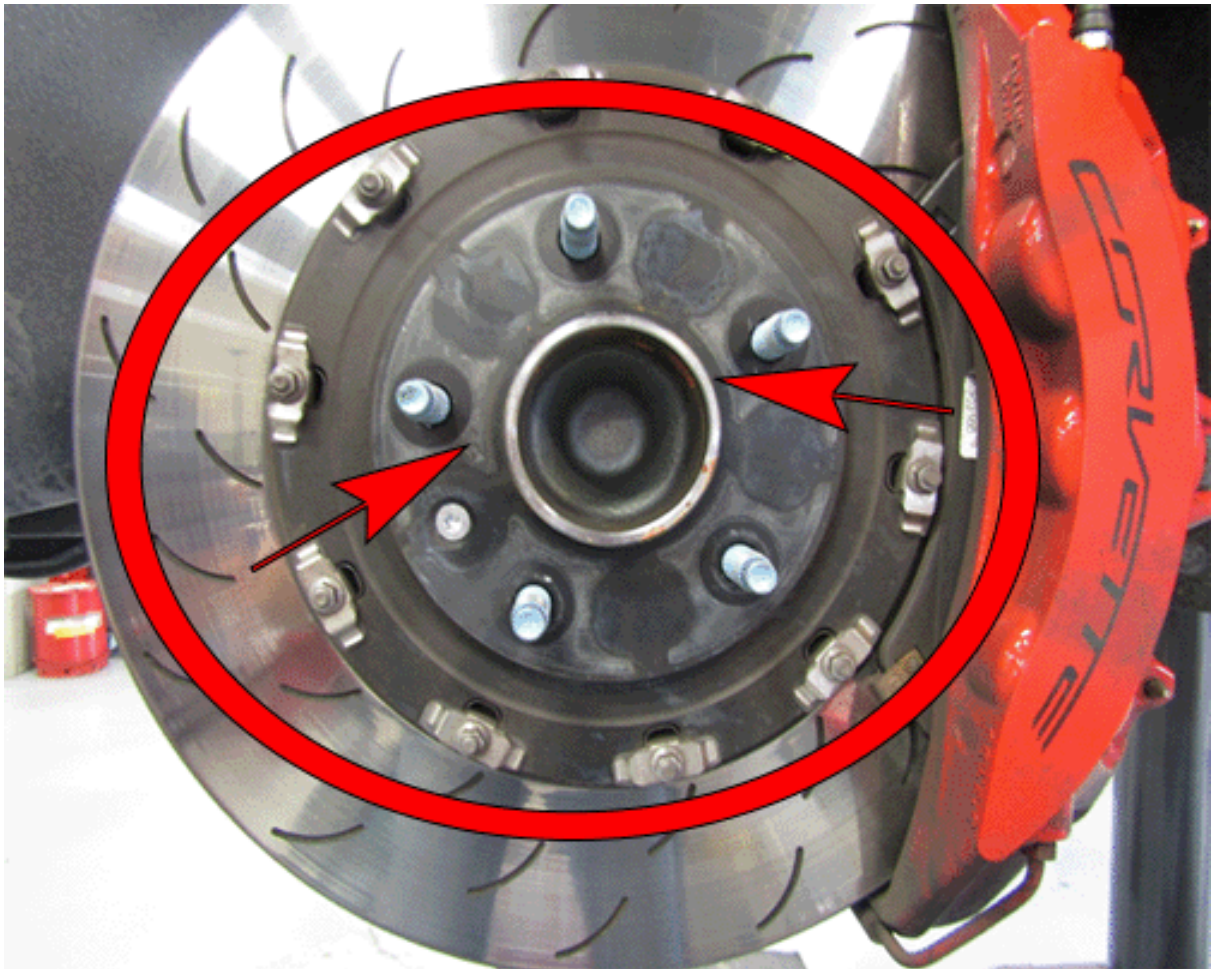
- Clean the wheel mounting surface of the brake rotors, or sometimes referred to as the brake rotor top hats, as follows:

- Using 3M red Scotch-Brite 7447 pad or equivalent with approved brake cleaner (ex. Part number 19370705 (U.S.), 88901247 (Canada)), wipe the wheel mounting surface of the rotor (brake rotor top hat) and the wheel pilot at the center of the rotor, removing any residual grey or black material that has accumulated on the rotors.

Note: All cleaning must be done by hand. *DO NOT* use pneumatic or power tools.
