# **1984 - 2021 Corvette: Service Bulletin: #PI0754D: Rear and Side Tempered Glass Spots (Quench Marks) - (Nov 6, 2020)**

**Subject:** Rear and Side Tempered Glass Spots (Quench Marks)

**Models:** 2021 and Prior GM Passenger Cars and Trucks

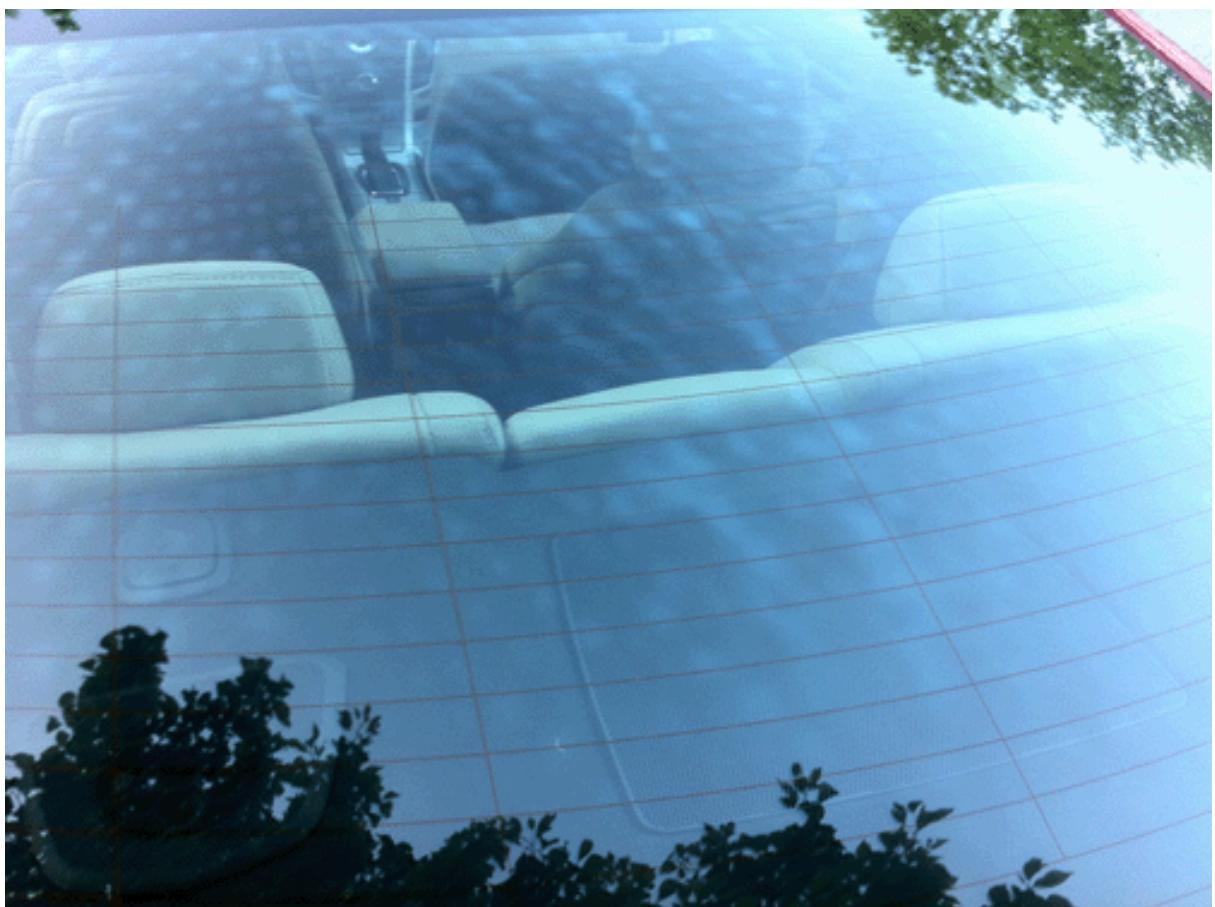
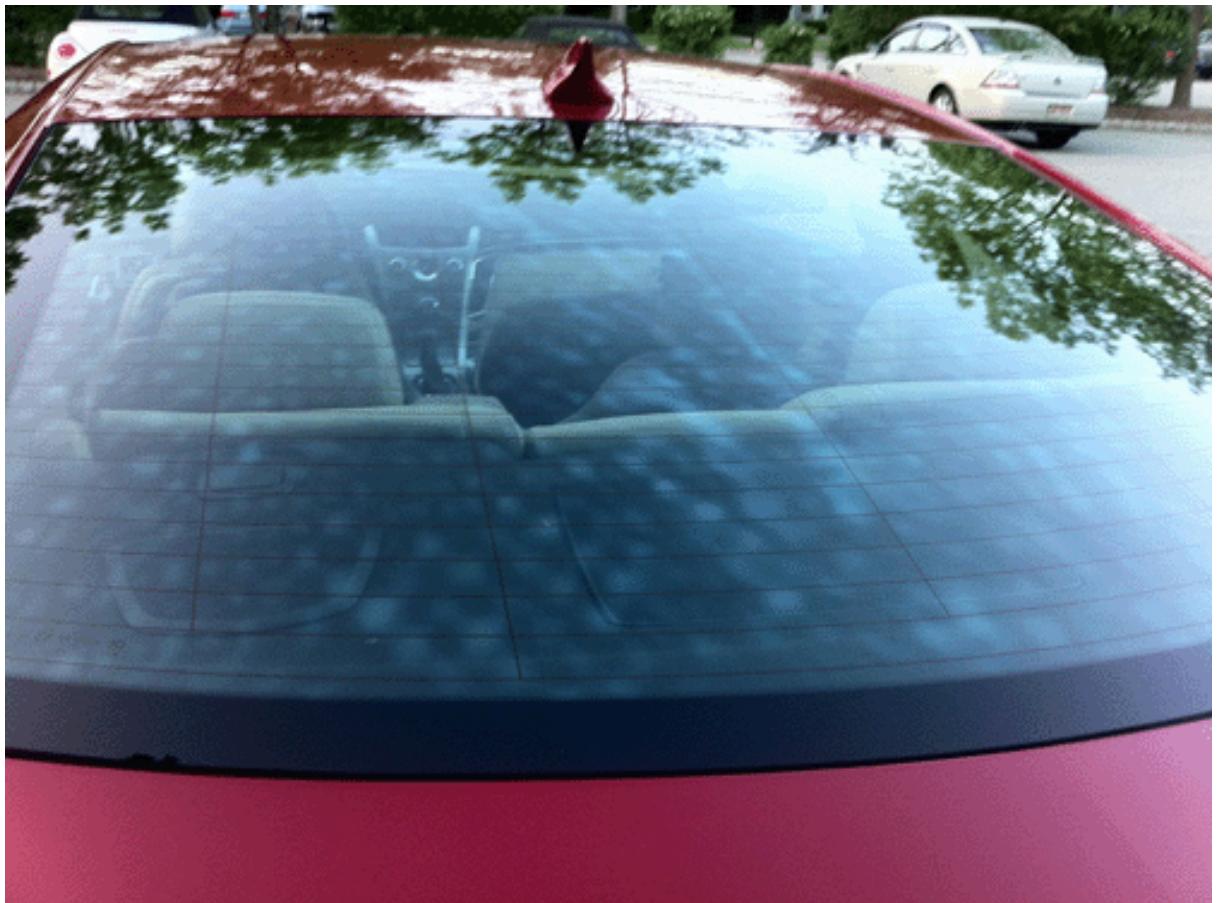
Some customers may comment on spots showing on the rear and side windows when the vehicle is in the sunlight. When wearing polarized glasses/sunglasses, these spots may be more magnified.

The spots are due to the manufacturing process and are “quench marks” in the glass. Quench marks are an unintentional side effect of the tempering process.

Technicians should explain to the customer that this is a normal condition and part of the manufacturing process for tempered glass. Do not replace the window(s) for this condition.

**Note:** This will not be seen on front windshields or laminated side glass.
