# **1984 - 2021 Corvette: Service Bulletin: #PI0754D: Rear and Side Tempered Glass Spots (Quench Marks) - (Nov 6, 2020)**

<b>Subject:</b>	Rear and Side Tempered Glass Spots (Quench Marks)
<b>Models:</b>	2021 and Prior GM Passenger Cars and Trucks
<b>Attention:</b>	This PI also applies to any of the above models that may be North America vehicles.

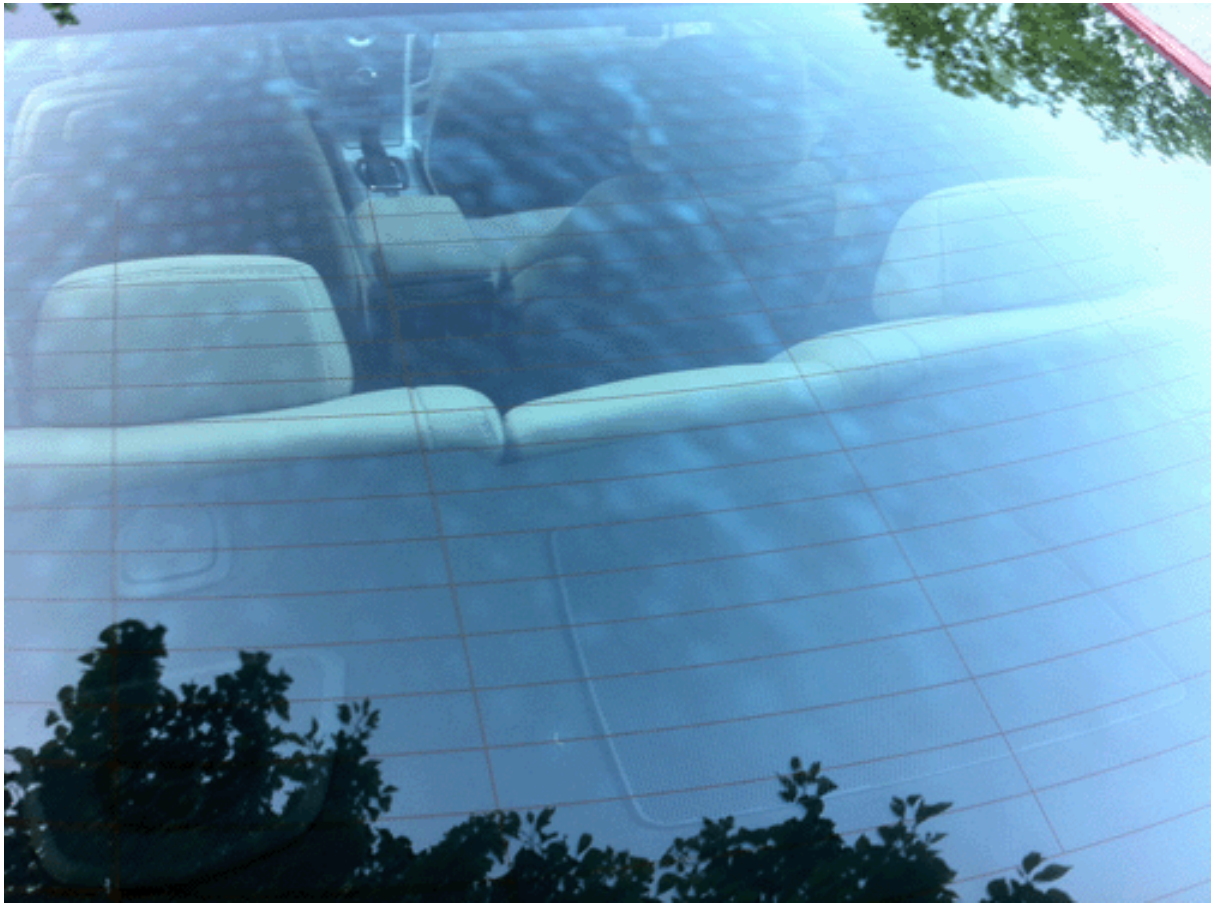
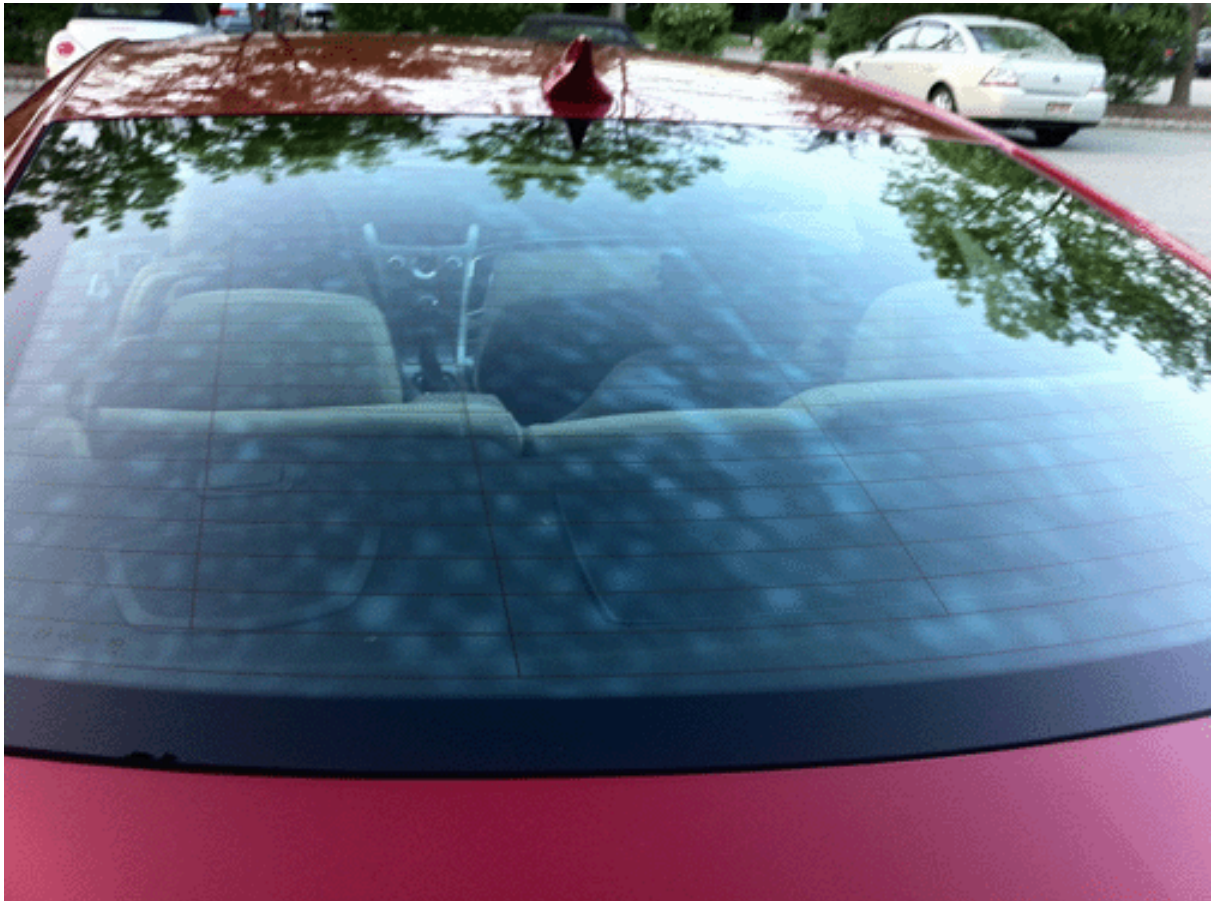
Some customers may comment on spots showing on the rear and side windows when the vehicle is in the sunlight. When wearing polarized glasses/sunglasses, these spots may be more magnified.

The spots are due to the manufacturing process and are “quench marks” in the glass. Quench marks are an unintentional side effect of the tempering process.

Technicians should explain to the customer that this is a normal condition and part of the manufacturing process for tempered glass. Do not replace the window(s) for this condition.

**Note:** This will not be seen on front windshields or laminated side glass.
