2020 - 2021 Corvette: Service Bulletin: #PIC6429: Addressing Customer Concerns on Brake Noises - (Jan 20, 2021)

Subject: Addressing Customer Concerns on
Brake Noises

| Brand: | Model: | Model Year: | VIN: | Engine: | Transmission: |
|---|---|---|---|---|---|
| Chevrolet | Corvette | 2020 - 2021 | All | All | All |

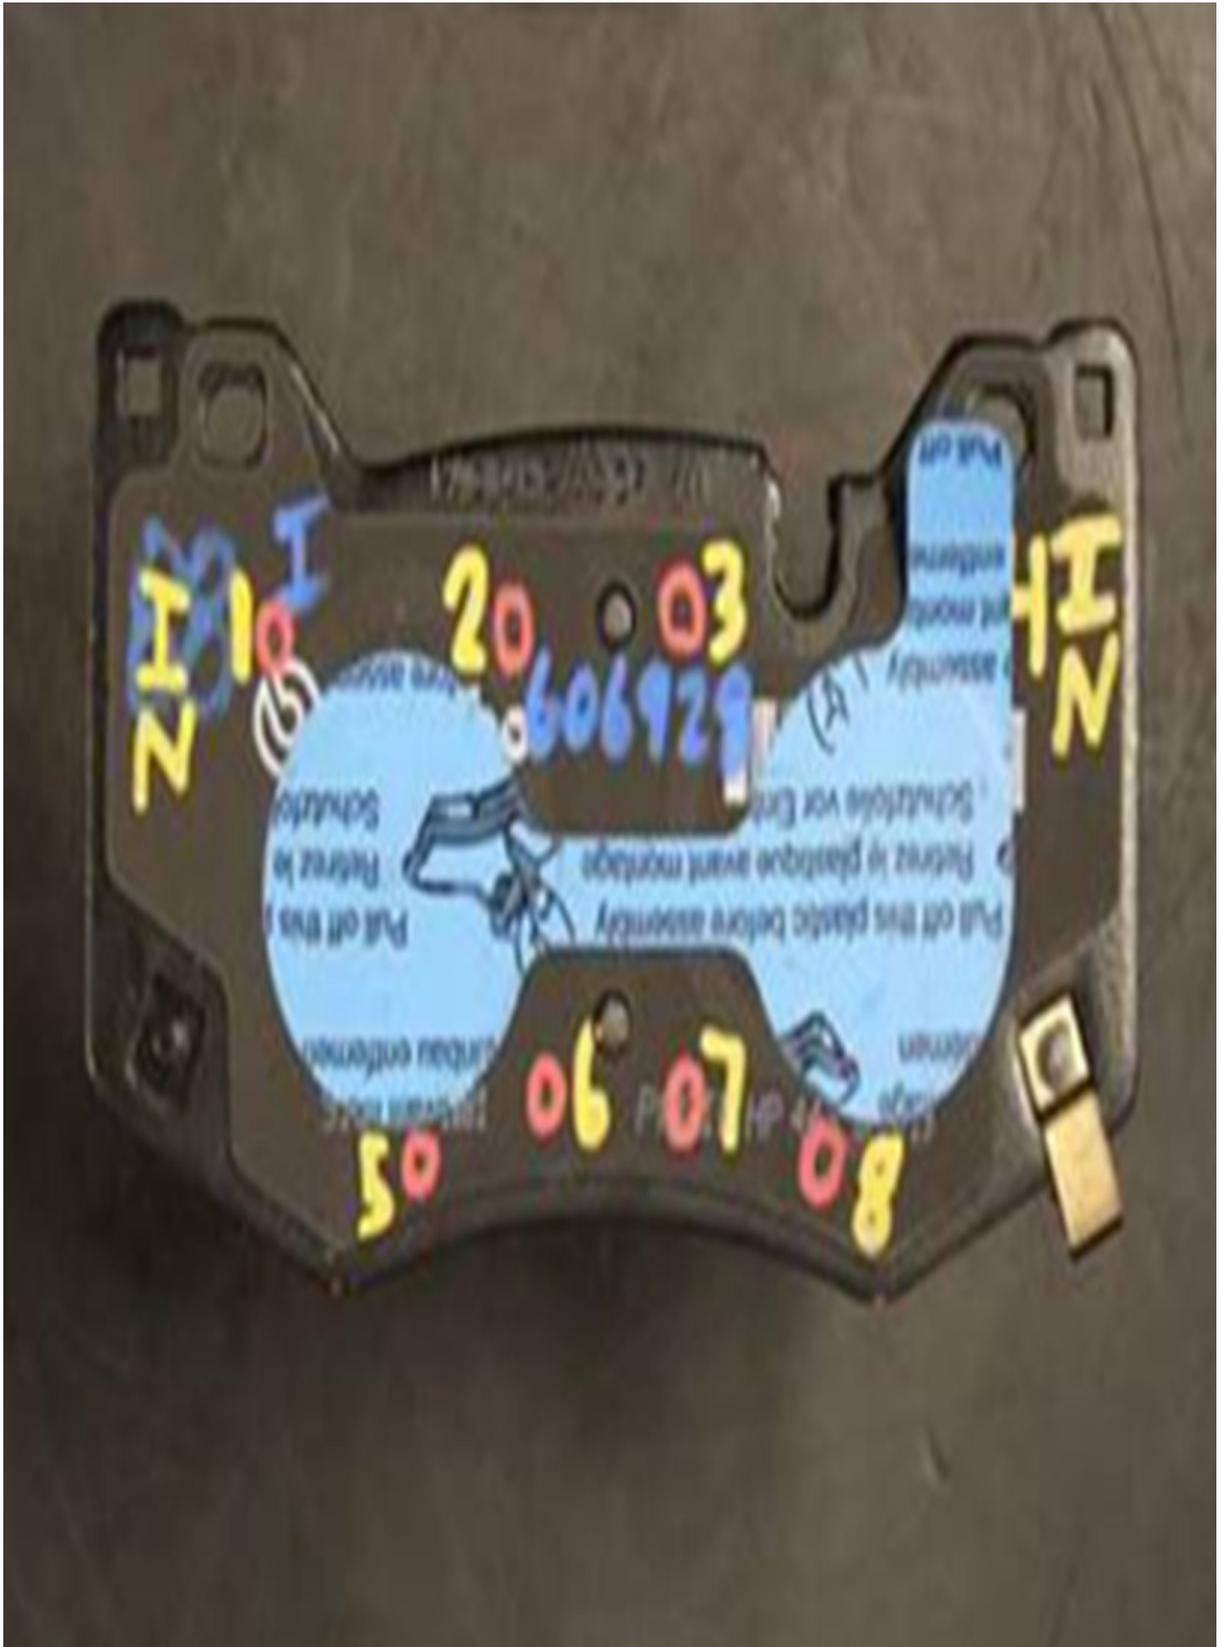
If the customer describes a brake noise coming from the vehicle, perform bulletin 17-NA-040 as described. When removing the front brake pads on a Z51-equipped vehicle, the servicing technician should notice that there is a piece of double-sided tape that secures the front brake pads firmly to the caliper pistons. See the photo below as an example. The blue area is this peel-and-stick double sided tape.

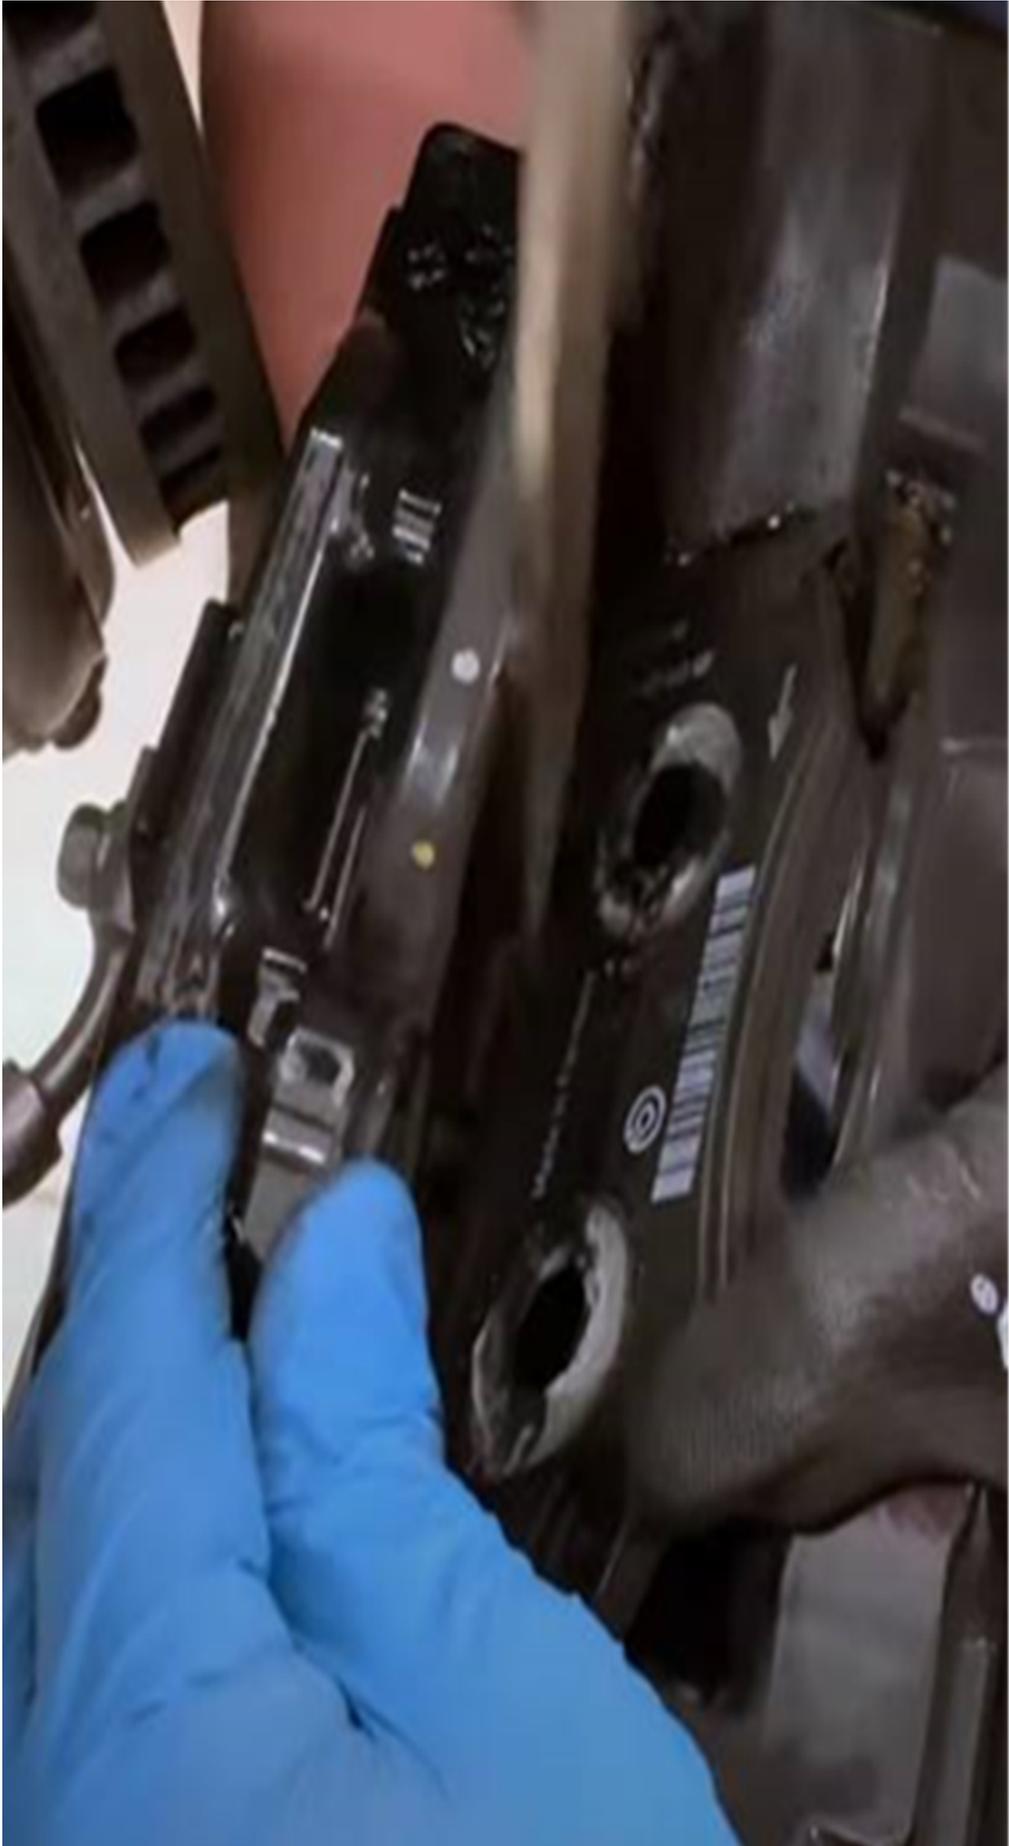
To apply the paste correctly, the pads must be removed from the calipers. See the photo below for an example of what the front brake pads look like once they have been separated from the caliper pistons.

This is normal when the front pads have been removed. When this has been done, remove as much of the remaining tape residue as possible. Then, apply the copper paste as directed in the bulletin. Once the copper paste has been applied correctly to the front brake pads, simply reinstall them into the calipers. There is no need to replace the front brake pads during this service because of the double-sided tape.

Important: At this point in reassembly, many technicians have a tendency to want to chamfer the edges of the brake pads slightly, in the hopes that this will eliminate or prevent future noises from occurring. This is not something that should be done, despite any direction to the contrary. "Taking the edge off" or chamfering the brake pads will not provide any noise benefit to the customer and it may actually create other issues with the brake system.
