2020 - 2021 Corvette - Service Update Bulletin: #N212327740: Service Update - HVAC Condensate Drain Hose Not Fully Installed - (Mar 10, 2021)

Subject: N212327740 — HVAC Condensate
Drain Hose Not Fully Installed

Models: 2020 – 2021 Chevrolet Corvette

Release Date: March 2021 **Revision:** 00

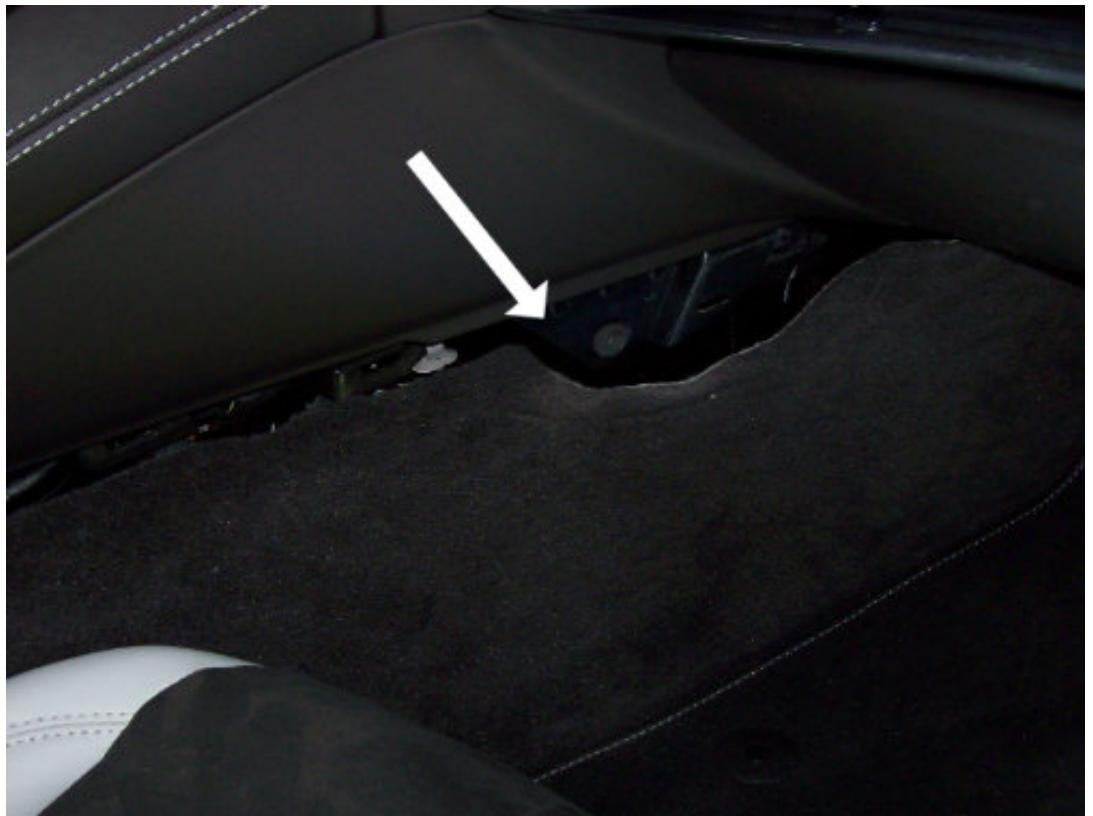
1. Remove the Front Floor Rear Console Side Trim Panel – Right Side. Refer to *Front Floor Rear Console Side Trim Panel – Right Side* in SI.

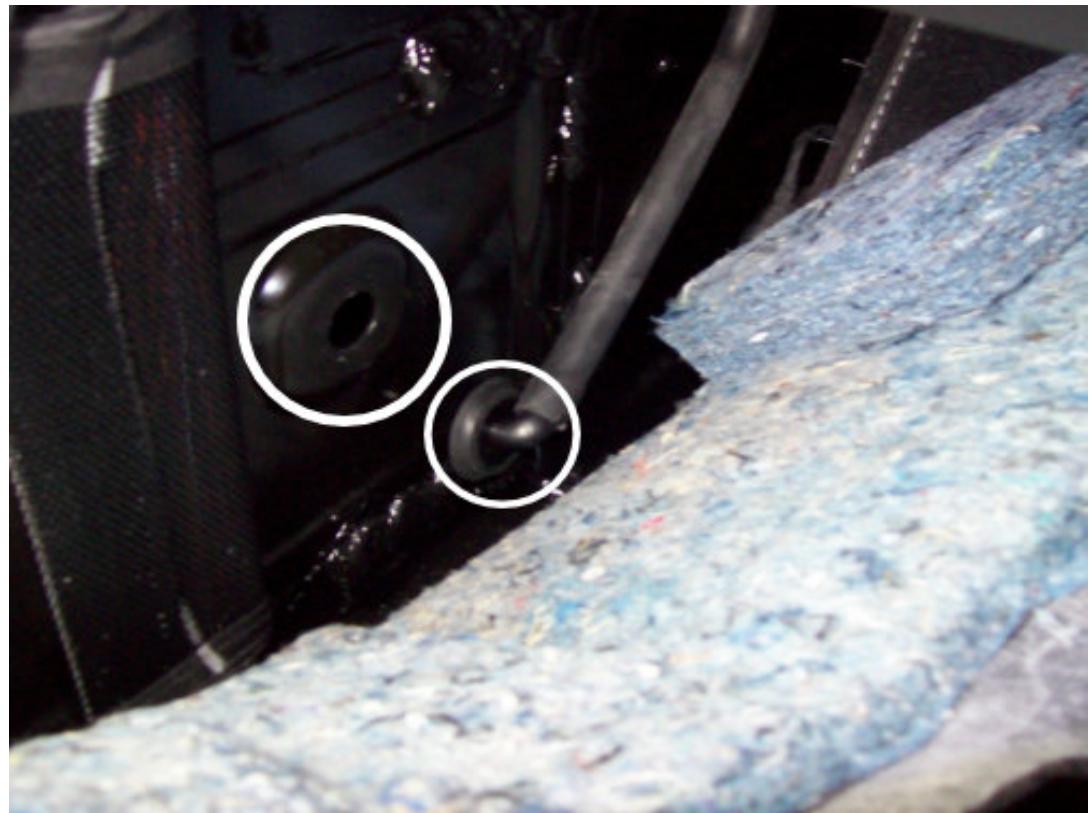
2. Pull back the carpet in the location shown to gain access to the A/C Evaporator Drain Tube.

3. The drain tube may be partially or fully disconnected from the body sheet metal as shown.
 - If the drain tube end is fully disconnected, reinsert the drain tube end into the body sheet metal and press firmly to be sure it is securely fastened.
 - If the drain tube end appears to be correctly seated in the body sheet metal, press firmly on it to confirm that it is securely fastened.
 - Shift the carpet back to the original location.
 - Reinstall the Front Floor Rear Console Side Trim Panel – Right Side. Refer to *Front Floor Rear Console Side Trim Panel – Right Side* in SI.
