# 2020 - 2021 Corvette - Service Update Bulletin: #N212327740: Service Update - HVAC Condensate Drain Hose Not Fully Installed - (Mar 10, 2021)

**Subject:** N212327740 — HVAC Condensate  
Drain Hose Not Fully Installed

**Models:** 2020 – 2021 Chevrolet Corvette

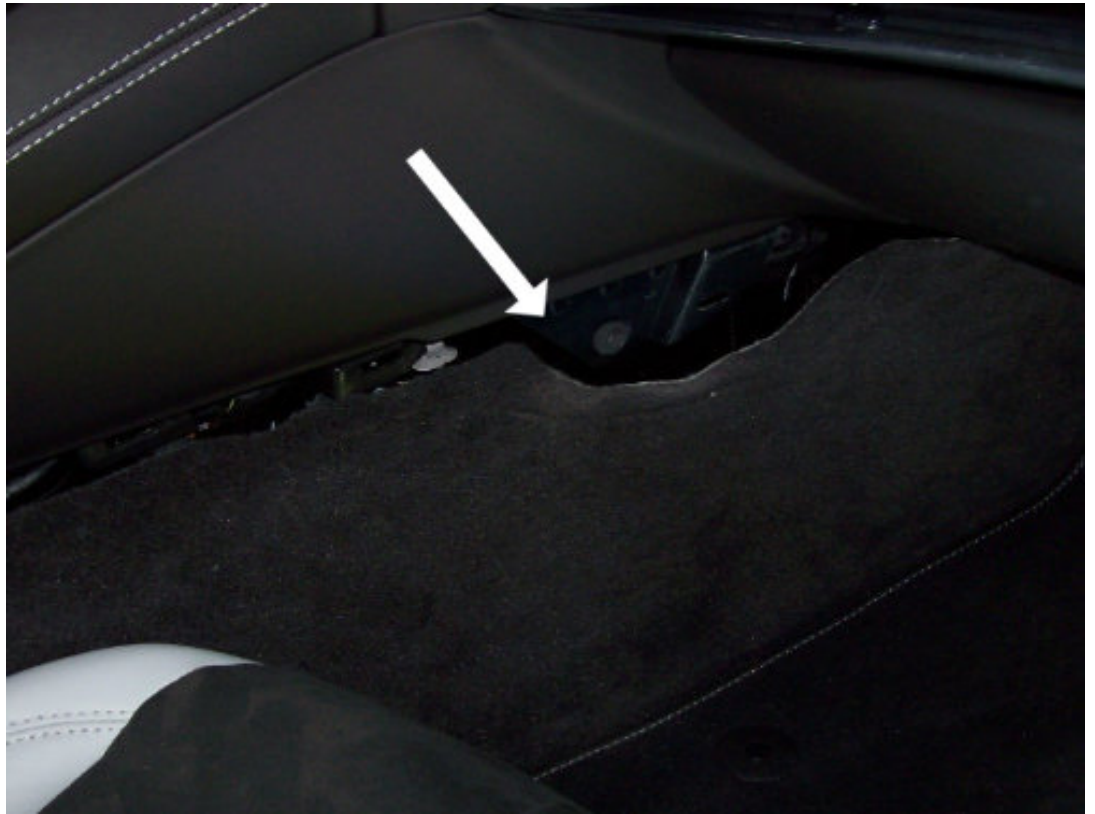
2. Pull back the carpet in the location shown to gain access to the A/C Evaporator Drain Tube.

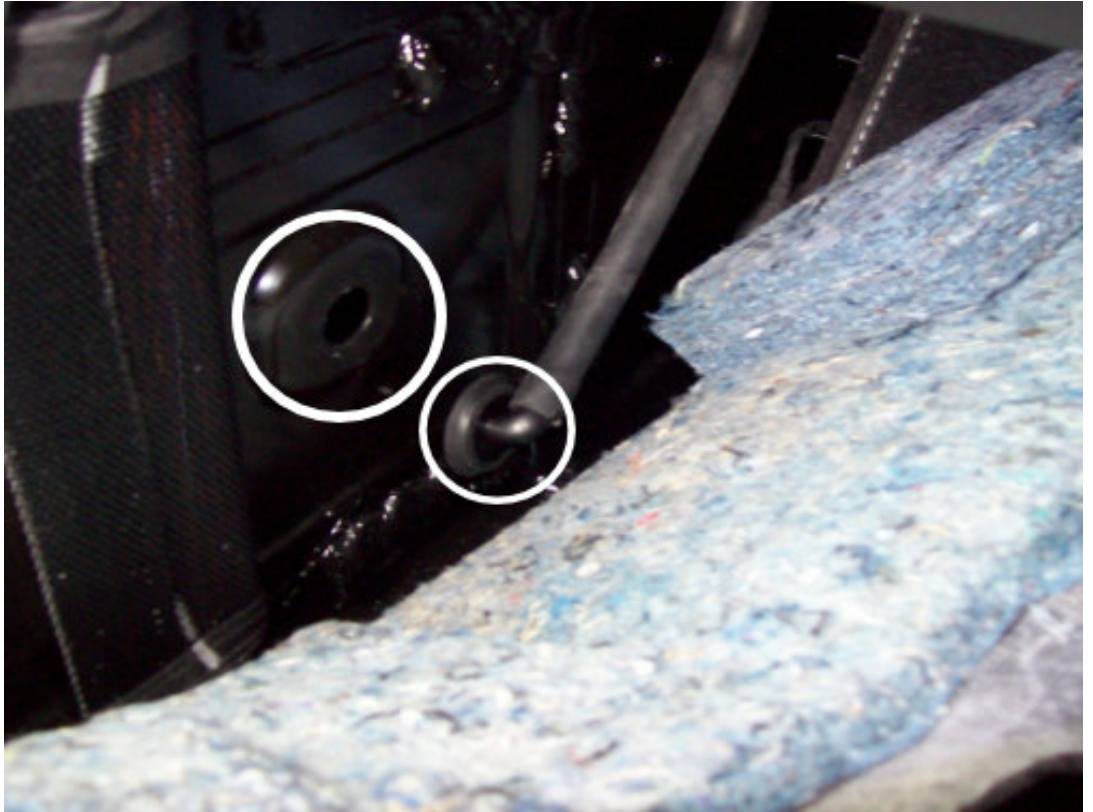
3. The drain tube may be partially or fully disconnected from the body sheet metal as shown.
  - If the drain tube end is fully disconnected, reinsert the drain tube end into the body sheet metal and press firmly to be sure it is securely fastened.
  - If the drain tube end appears to be correctly seated in the body sheet metal, press firmly on it to confirm that it is securely fastened.
- Shift the carpet back to the original location.
- Reinstall the Front Floor Rear Console Side Trim Panel – Right Side. Refer to *Front Floor Rear Console Side Trim Panel – Right Side* in SI.

Dealers are to fully install the HVAC condensate drain hose.
