# 1992 Corvette: Recall: Instrument Panel/Left Hand Lower Trim/Brake Pedal Interference

**Subject:** PRODUCT CAMPAIGN 92C10 - INSTRUMENT PANEL LEFT HAND LOWER TRIM PANEL/BRAKE PEDAL INTERFERENCE

**Model and Year:** 1992 CHEVROLET CORVETTE

**Bulletin Number:** 92C10 - (04/23/1992)

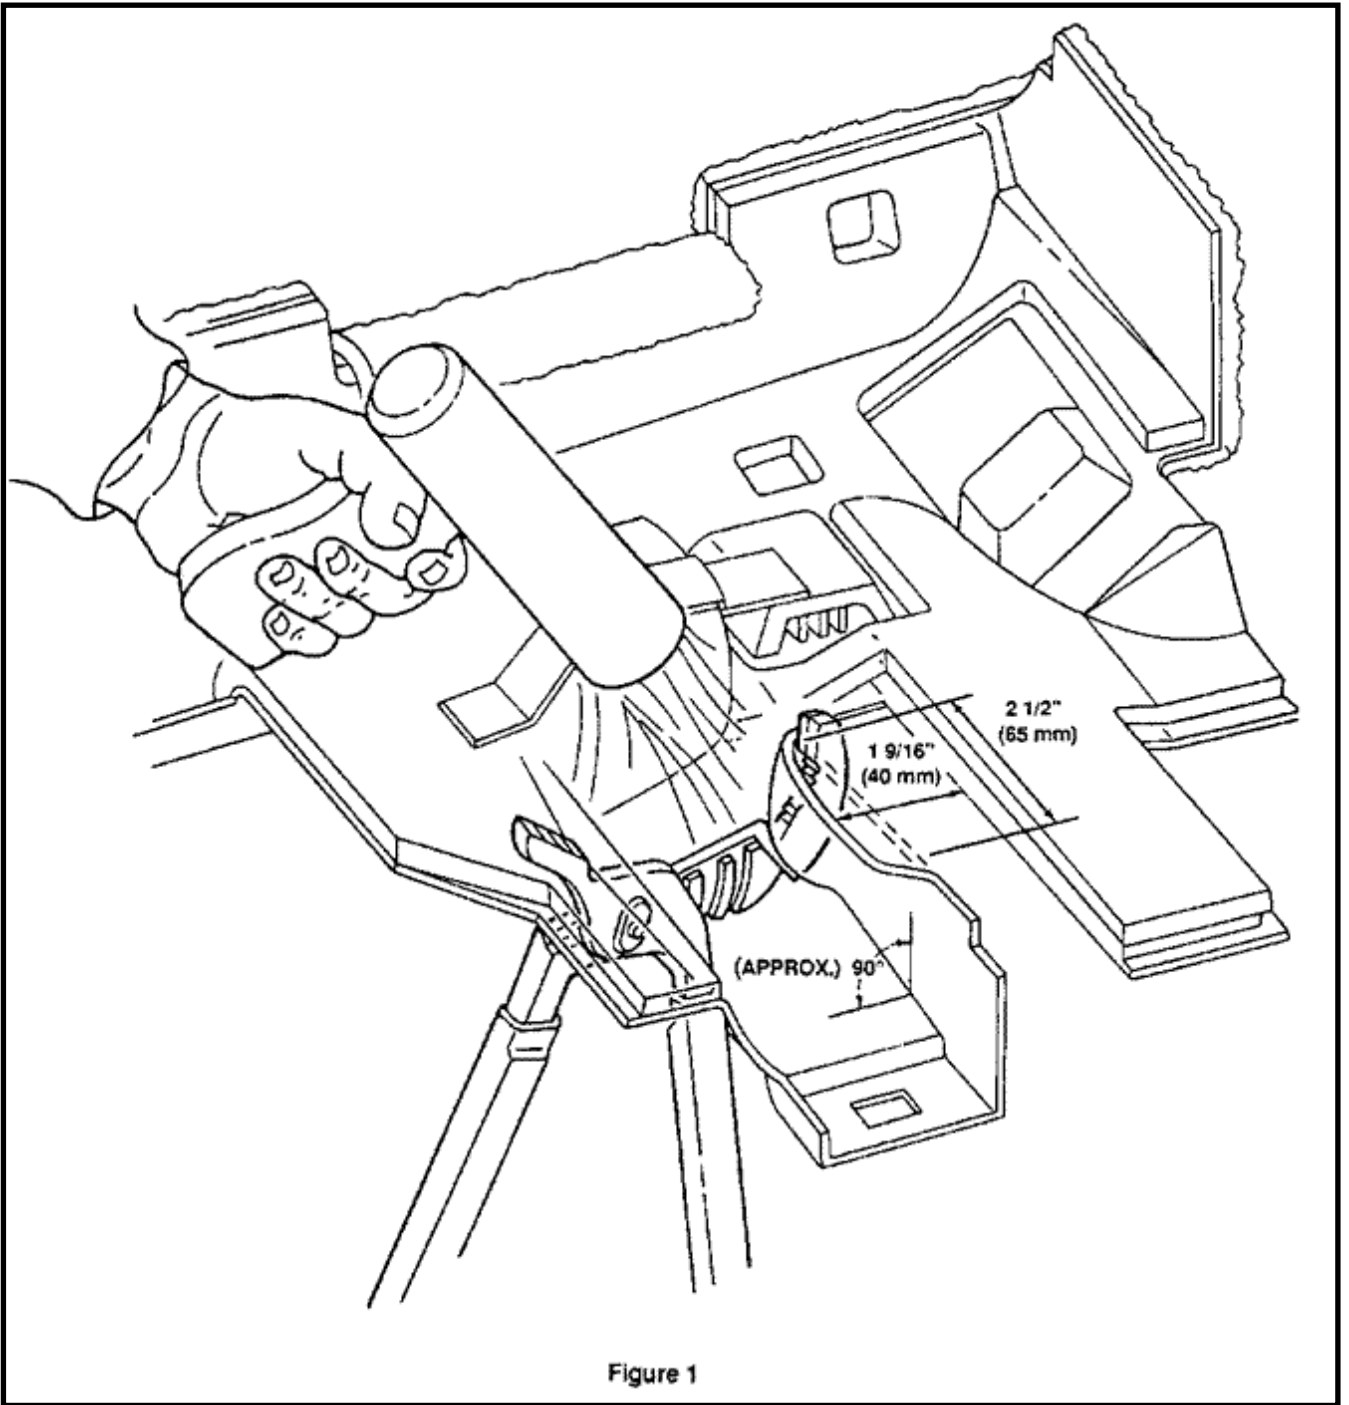
1. Remove I/P left-hand lower trim panel (per Preliminary Service Manual, Section 8C-33).
2. Lift away foam sound deadener from area shown in Figure 1 and tape out of way.
3. Using a heat gun, warm trim panel area shown in Figure 1. **USE CARE TO WARM COMPLETE AREA EVENLY.**
4. Using Channel Locks size 16 or larger, place near upper left-hand corner of I/P left-hand lower trim panel as shown in Figure 1. Quickly reform brake pedal opening to configuration and dimensions indicated in Figure 1. If necessary, Channel Locks may be moved downward during initial reforming and/or steps 3 and 4 may be repeated to obtain minimum clearance of 2mm between brake service pedal arm and I/P left- hand lower trim panel.

**Notice: To lessen Channel Lock imprint, place smooth shim stock or aluminum face cover between Channel Lock face and warmed surface of I/P left-hand lower trim panel.**

5. Reinstall I/P left-hand lower trim panel. Remeasure clearance between trim panel and brake pedal arm along entire length of pedal travel, using "INSPECTION" procedure on page 2.
6. Install Campaign Identification Label.
