# 2000 Corvette: Service Bulletin: Tech - Left Headlamp Door Does Not Stay Closed

**Number:** 00-08-42-002

**Subject:** Tech - Left Headlamp Door Does Not Stay Closed

**Model Year:** 2000

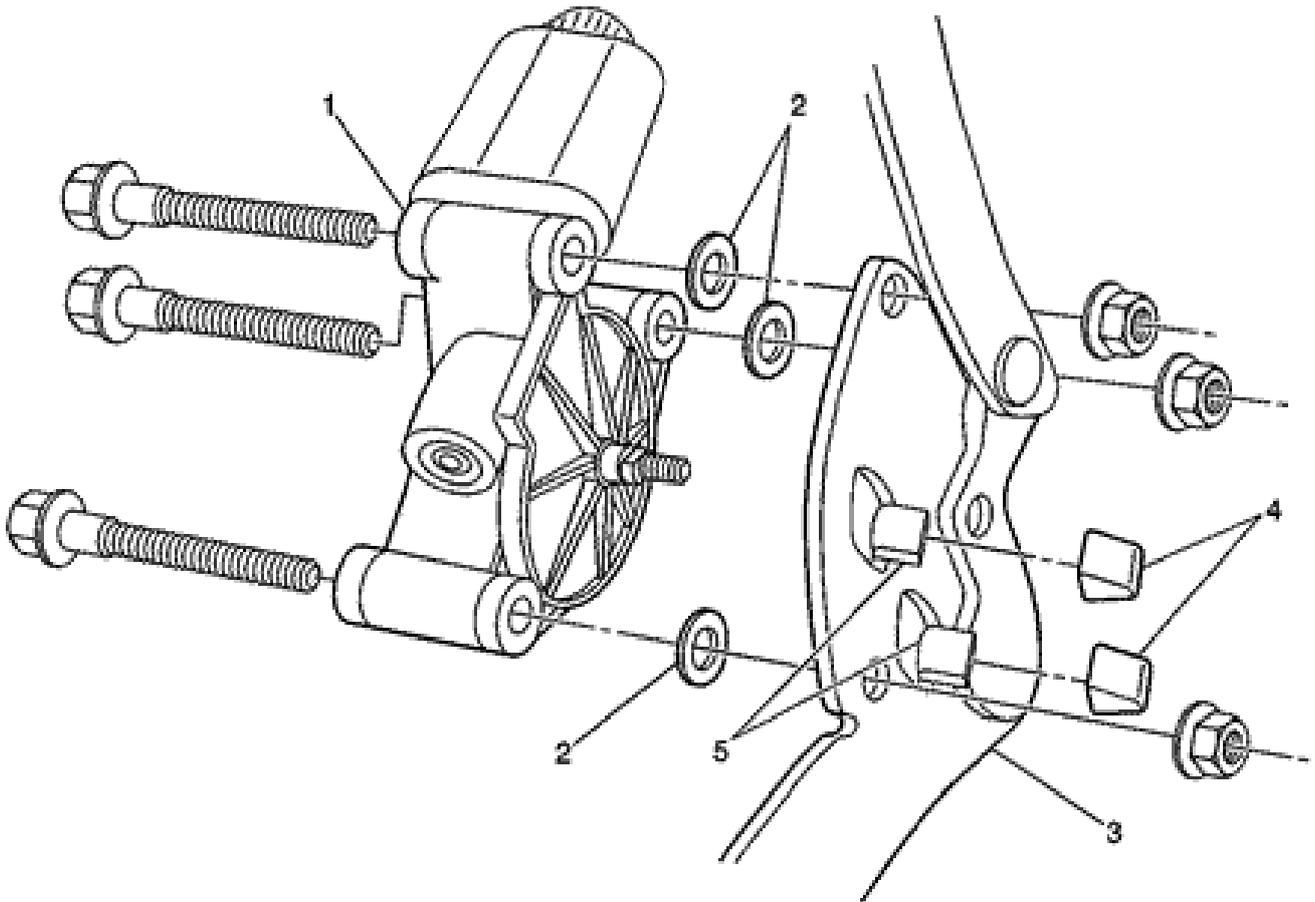
Some customers may comment that the left front headlamp door does not remain closed after the headlamps are turned off. Others may comment that the left headlamp door closes when the headlamps are turned off, but then reopens. In either case, the right headlamp door operates properly.

The following information applies to the left front headlamp door motor/actuator only. It does not apply to and should not be performed on the right front headlamp door motor/actuator.

Install one washer (2) between the left headlamp door motor/actuator (1) and the mounting bracket (3) at each of the three attaching bolt locations. Also replace the insulator (4) on each of the two mounting bracket travel stop tabs (5) as shown. For information on headlamp motor/actuator removal, see the Headlamp Motor/Actuator Replacement procedure in the Lighting sub-section of Body & Accessories in the appropriate Service Manual.
