# 1998 - 1999 Corvette: Service Bulletin: Tech - Service Engine Soon (SES) Light Illuminates (Repl Switch Assy)

**Number:** 99-07-30-013

with Hydra-Matic 4L60-E Transmission (RPO M30)

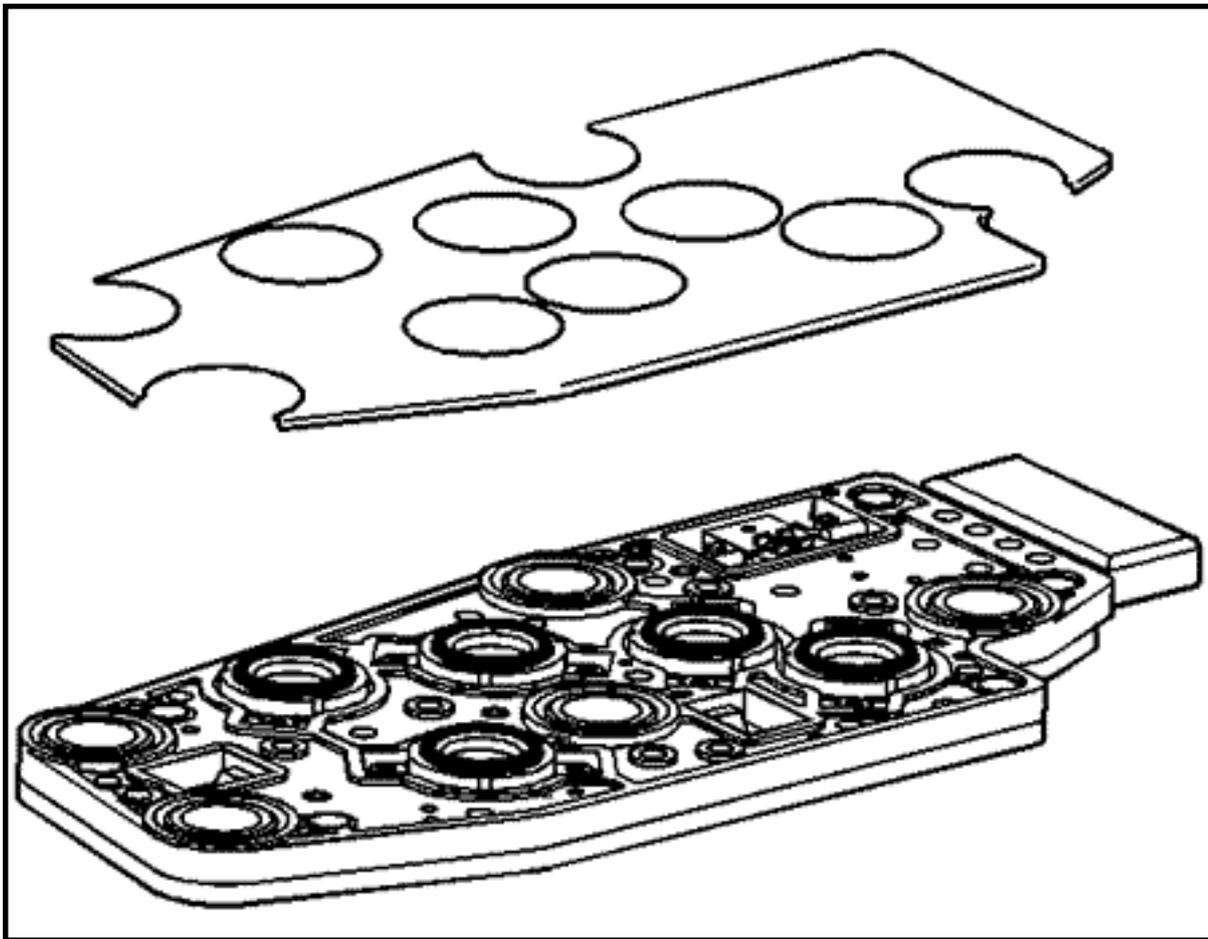
A new TFP switch assembly with a plastic shield has been released. The plastic shield is designed to protect the pressure switch from debris. This improvement will reduce the likelihood of a DTC P1810. This product change went into production on April 8, 1999 (Julian date 098). The existing TFP switch assembly remains relatively unchanged except for the addition of the new shield, creating a new part number for the assembly. The shield fits over the existing TFP switch assembly and is not sold separately.

Follow diagnostics for the P1810 Diagnostic Trouble Code in the Transmission Section of the appropriate Service Manual. If the diagnostics indicate that switch replacement is necessary, use the correct switch P/N as listed below.
