# 1990 - 1992 Corvette ZR-1: Service Bulletin: No Start Condition (Replace Starter)

Subject: NO START CONDITION (STARTER CORROSION-REPLACE

**Model and Year:** 1990-1992 Corvette, Engine Code J (LT5)

**Bulletin Number:** 92-307-6 - (09/21/1992)

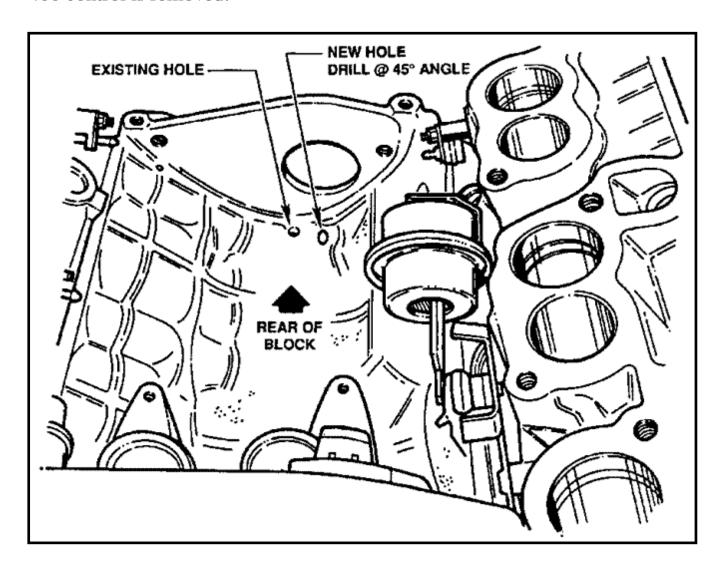
The starter on an LT5 engine is mounted in the engine "vee." A drain hole and drain tube are located at the rear of the engine valley. While washing the engine, debris may settle in the engine "vee" and block the drain system.

- 1. Remove the old starter.
- 2. Clean any blockage in existing drain system.
- 3. Drill a 3/8" diameter hole through the engine "vee" to the back of the engine, allowing drainage (see Figure 1).
