1988 - 1989 Corvette: Recall: Evaporative Emission Hoses

Subject: CAMPAIGN: EVAPORATIVE EMISSION HOSES

Model and Year: 1988-89 CHEVROLET CORVETTE

Bulletin Number: 89C25 - (08/23/1993)

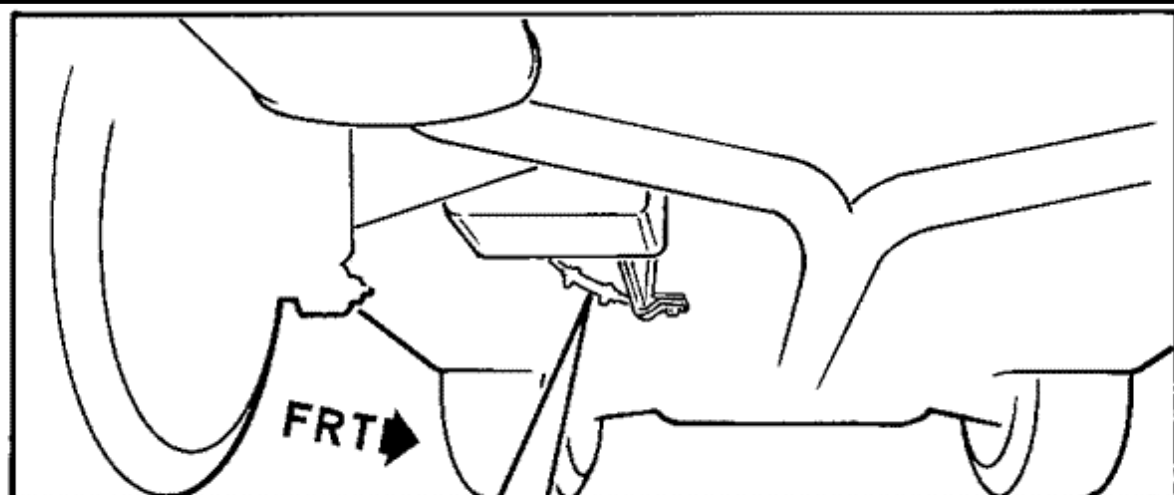
FIGURE 1

General Motors has determined that certain 1988-89 Chevrolet Corvette model vehicles may experience a condition in which two (2) suspect evaporative emission hoses may deteriorate, crack and leak.

2. Referring to Figure 1, locate rubber hose (approximately 2-9/16" long - 65mm) connecting fuel tank evaporative emission pipe to chassis fore-aft evaporative emission pipe.

3. Remove both hose clamps and hose. Hose clamps and hose will not be reused.
4. Inspect pipes and bend if required to insure ends of pipes are in line with one another.

5. Install two (2) new clamps (P/N 01622744) and new hose (P/N 09442928) onto pipe ends. Insuring hose is positioned an equal distance over both ends. Position clamps onto hose and secure.

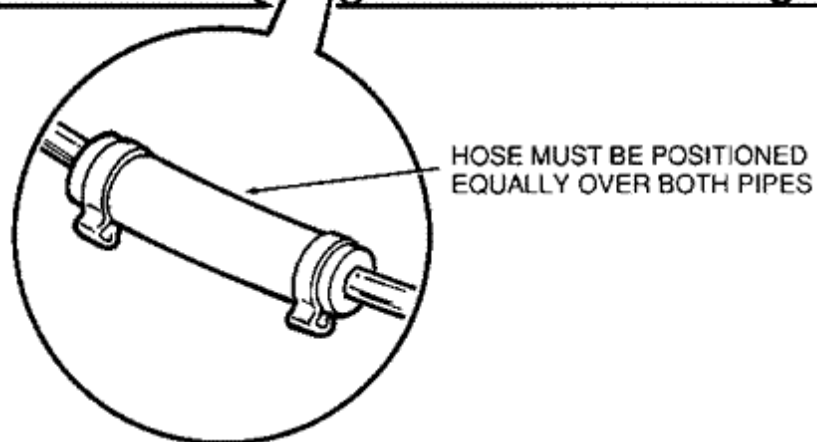
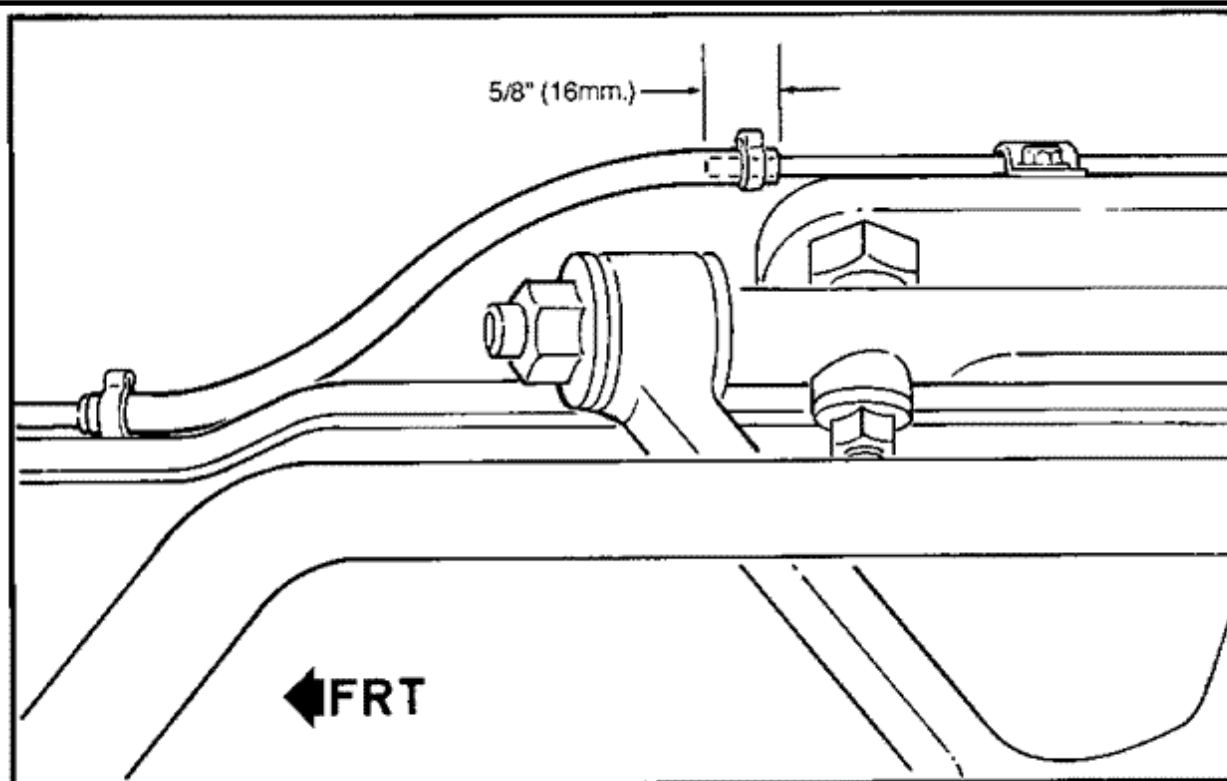
FIGURE 2

6. Lower vehicle.
7. Underhood, locate the evaporative emission hose connecting chassis fore/aft evaporative emission pipe to evaporative emission line shown in Figure 2.

8. Remove both hose clamps and hose. Hose clamps and hose will not be reused.
9. Install new large clamp (P/N 10028454) over nylon evaporative emission line, and install new small clamp (P/N 01622744) over chassis pipe.

10. Install larger end of new hose (P/N 10248651) over nylon evaporative emission line and install the opposite end approximately 1/2" over the fore/aft chassis pipe as illustrated in Figure 2.

Notice: If hose appears taut when assembled as indicated above, repositioning of chassis fore/aft pipe may be required to alleviate condition.

11. Position clamps onto hose and secure.
12. Install Campaign Identification Label.
