1996 Corvette: Service Bulletin: 3 - 2 Part Throttle Downshift Flare

Subject: Service Bulletin: 3 - 2 Part Throttle Downshift Flare (Replace 3 - 2 Solenoid)
Model and Year:

Bulletin Number: 67-71-47

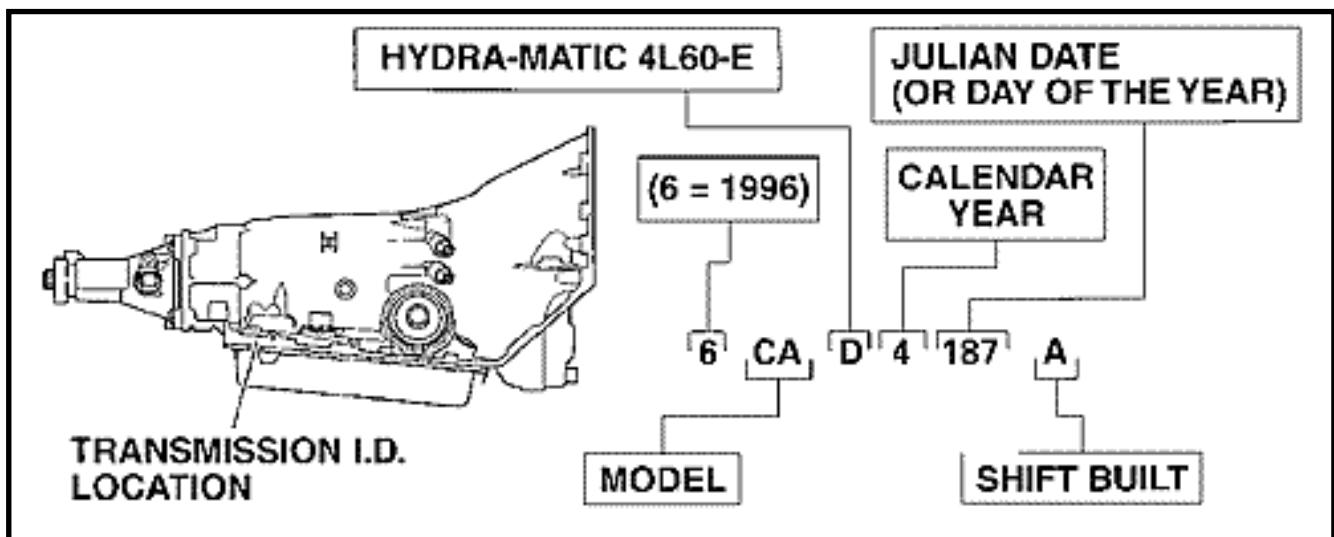
FIGURE 1 - HYDRA-MATIC 4L60-E TRANSMISSION IDENTIFICATION INFORMATION
FIGURE 2 - HYDRA-MATIC 4L60-E TRANSMISSION IDENTIFICATION INFORMATION FOR TWO-PIECE CASE
FIGURE 3 - LOCATION AND IDENTIFICATION OF THE 3-2 CONTROL SOLENOID ON THE CONTROL VALVE BODY

(FIGURES 1 AND 2)

SOME OWNERS OF THE ABOVE MODELS WITH A HYDRA-MATIC 4L60-E TRANSMISSION (BUILT BEFORE MAY 24, 1996/JULIAN DATE 6145) MAY EXPERIENCE AN ENGINE SPEED FLARE OF 1000-2000 RPM, DURING A PART THROTTLE DOWNSHIFT AT 19-31 MPH. THIS CONDITION WILL NOT SET ANY DTC'S (DIAGNOSTIC TROUBLE CODES).

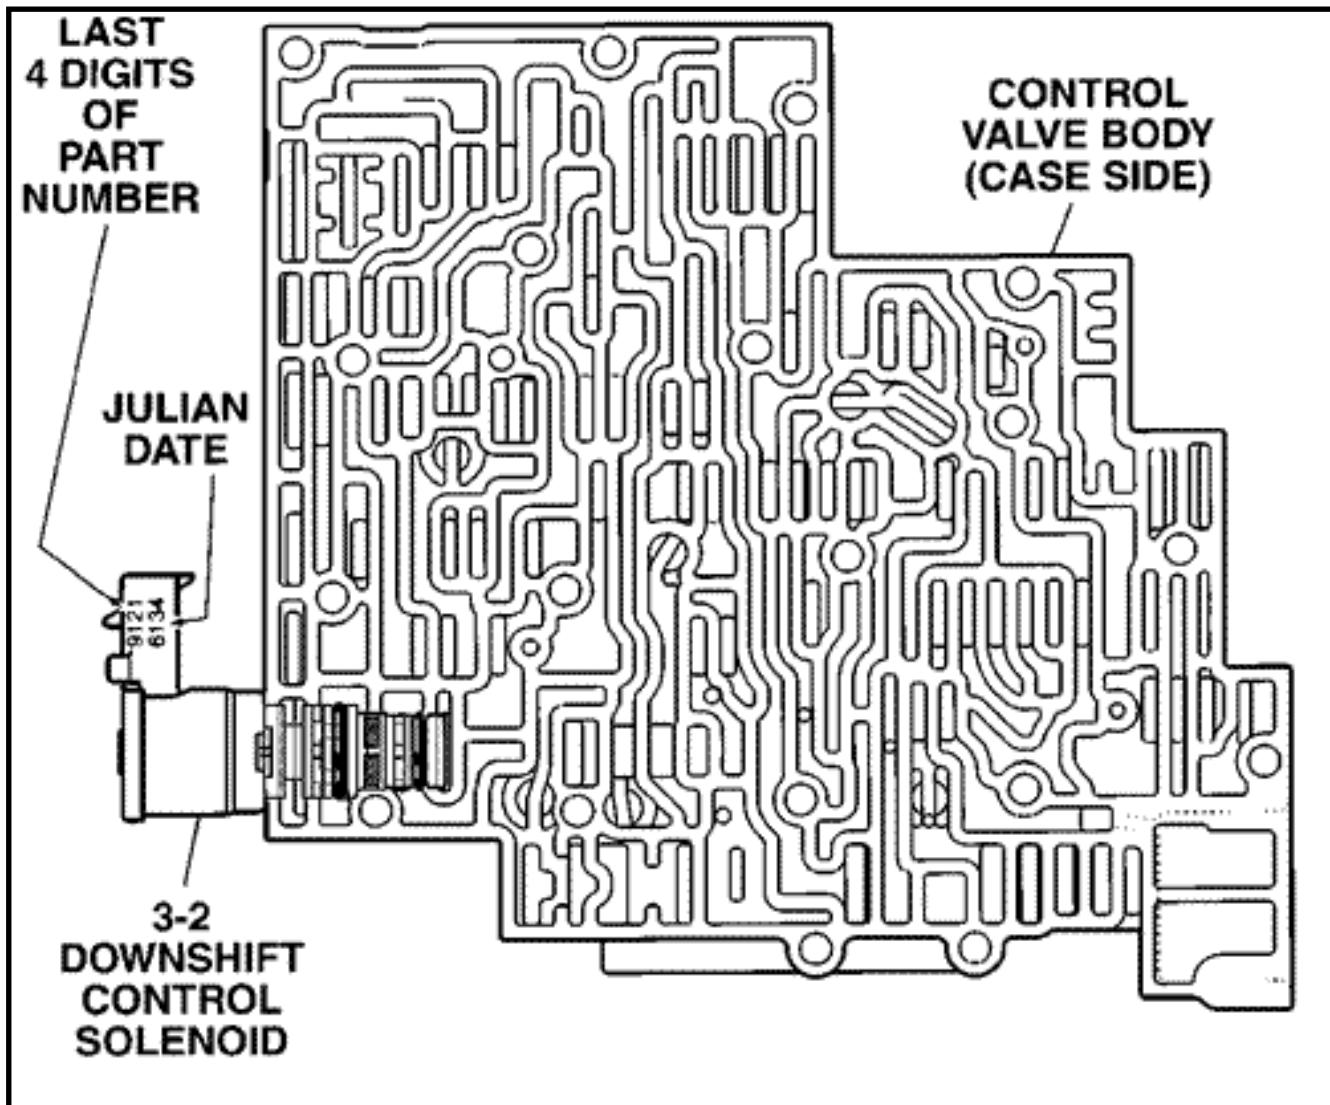
EXHAUST SEAT ON THE 3-2 CONTROL SOLENOID BACKING OUT.

(FIGURE 3)

REPLACE THE 3-2 CONTROL SOLENOID. JULIAN DATE ON THE SOLENOID WILL BE MAY 13, 1996 (6134) OR LATER.
