1982 - 1991 Corvette: Service Bulletin: Evaluating Peened Spacer Plate (Service Information)

Subject: EVALUATING PEENED SPACER PLATE (Service Information)

Model and Year: 1982-1991 ALL PASSENGER CARS AND TRUCKS WITH AUTOMATIC TRANSAXLES AND TRANSMISSIONS (EXCEPT GEO)

Bulletin Number: 91-396-7A - (08/08/1991)

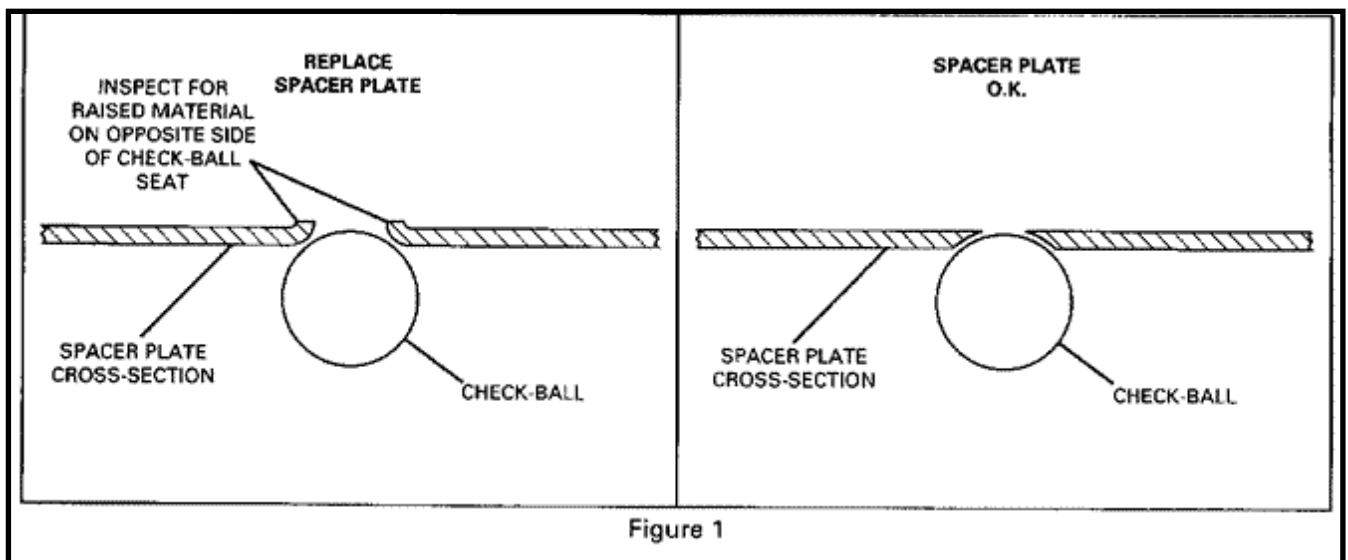
1. The spacer plate must be inspected 100% for raised material on the opposite side of the check-ball seat (see Figure 1) . If the material on the opposite side is raised, the peening is too severe and the spacer plate must be replaced.
2. To verify that the spacer plate is peening evenly and the ball is sealing correctly, seat the check-ball on the spacer plate. Shine a beam of light on the

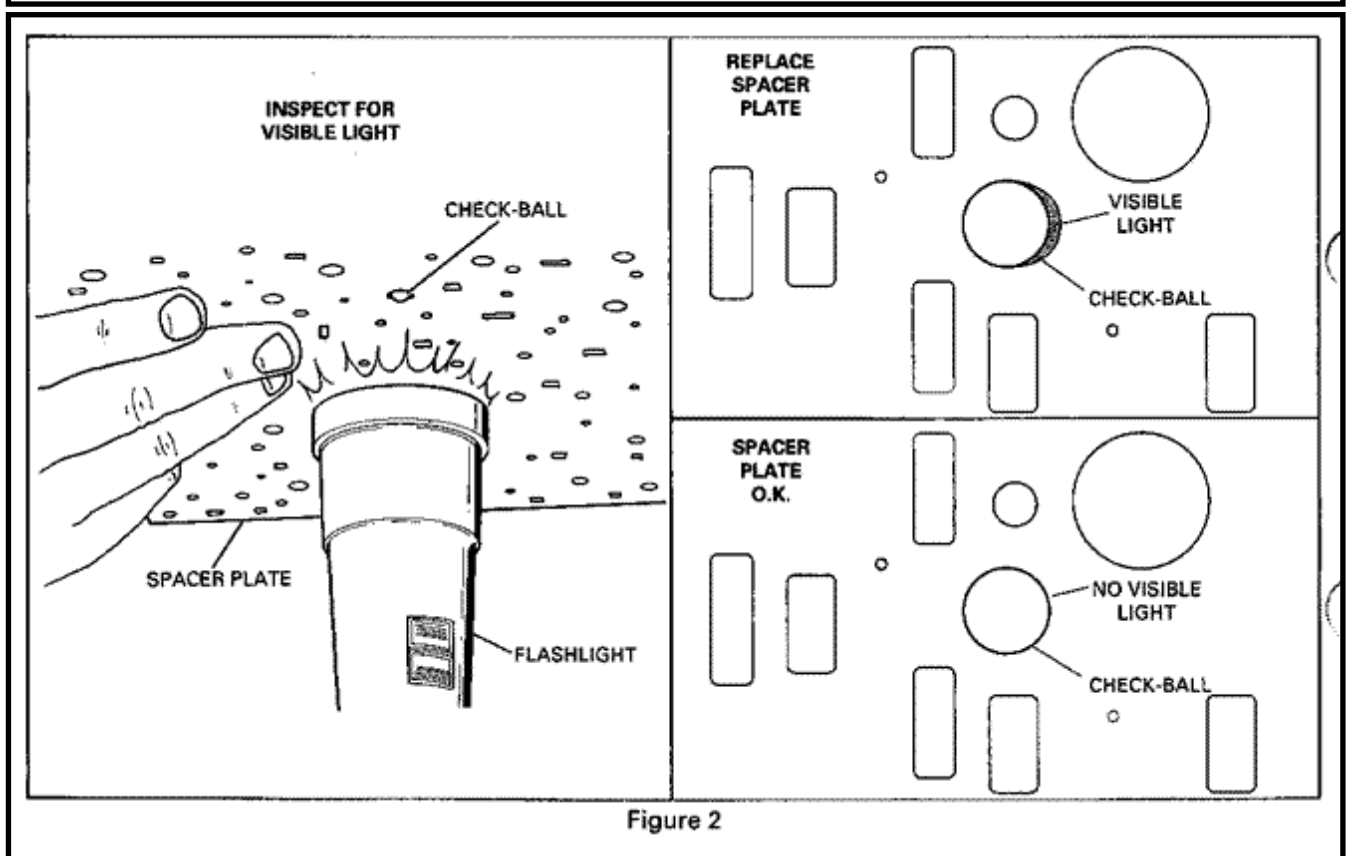
opposite side and inspect for light between the spacer plate and check-ball (see Figure 2). No trace of light should be present. If light can be seen, a proper seal does not exist, and the spacer plate must be replaced.
