1982 - 1991 Corvette: Service Bulletin: Evaluating Peened Spacer Plate (Service Information)

Subject: EVALUATING PEENED SPACER PLATE (Service Information)

Model and Year: 1982-1991 ALL PASSENGER CARS AND TRUCKS WITH AUTOMATIC TRANSAXLES AND TRANSMISSIONS (EXCEPT GEO)

Bulletin Number: 91-396-7A - (08/08/1991)

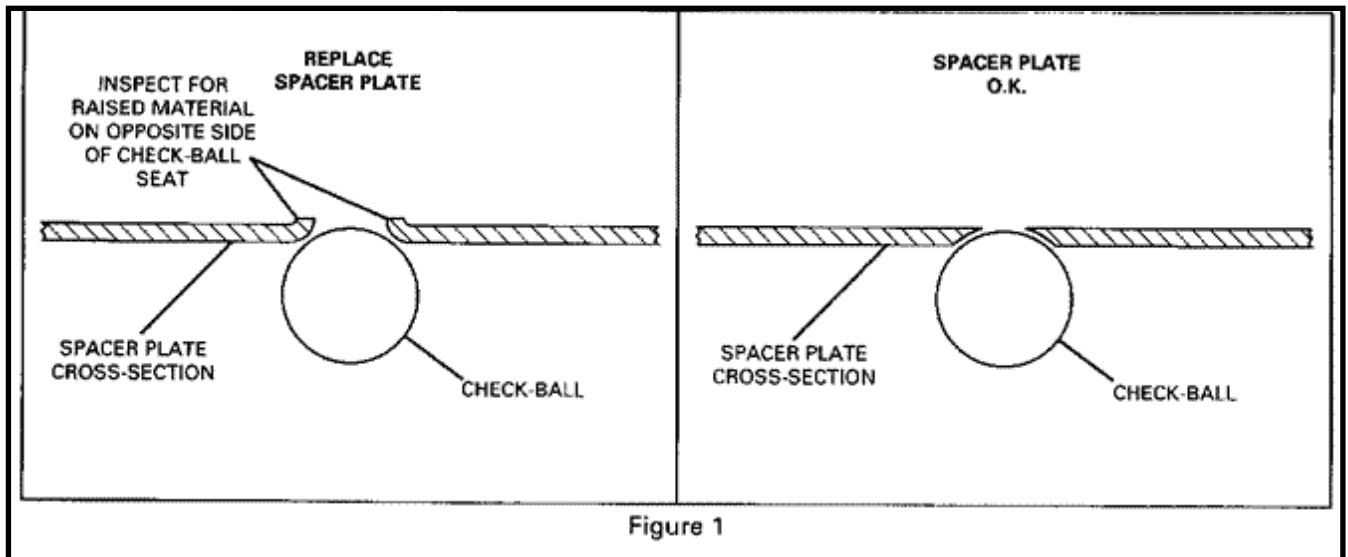
Figure 1

1. The spacer plate must be inspected 100% for raised material on the opposite side of the check-ball seat (see Figure 1) . If the material on the opposite side is raised, the peening is too severe and the spacer plate must be replaced.
2. To verify that the spacer plate is peening evenly and the ball is sealing correctly, seat the check-ball on the spacer plate. Shine a beam of light on the

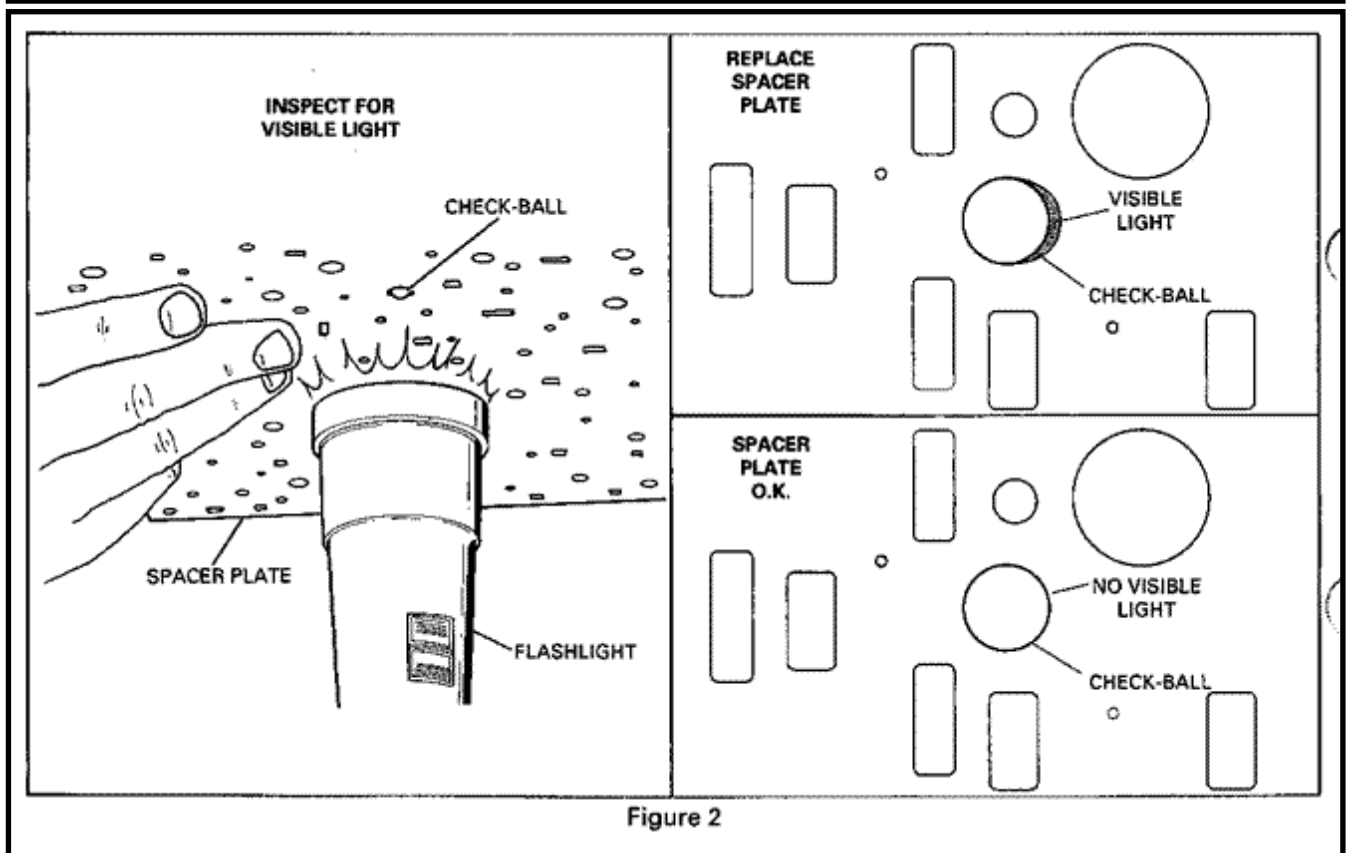
Figure 2

opposite side and inspect for light between the spacer plate and check-ball (see Figure 2). No trace of light should be present. If light can be seen, a proper seal does not exist, and the spacer plate must be replaced.
