## 1969 - 1976 Corvette: Service Bulletin: Air Conditioning Compressor Drive Belt to Radiator Hose Interference

Subject: Air Conditioning Compressor Drive Belt to Radiator Hose

**Model and Year:** 1976 and Past Model Corvette Equipped with the 350

**Source:** Chevrolet Dealer Service Technical Bulletin **Bulletin Number:** 76-T-21, Section VI - (May 1976)

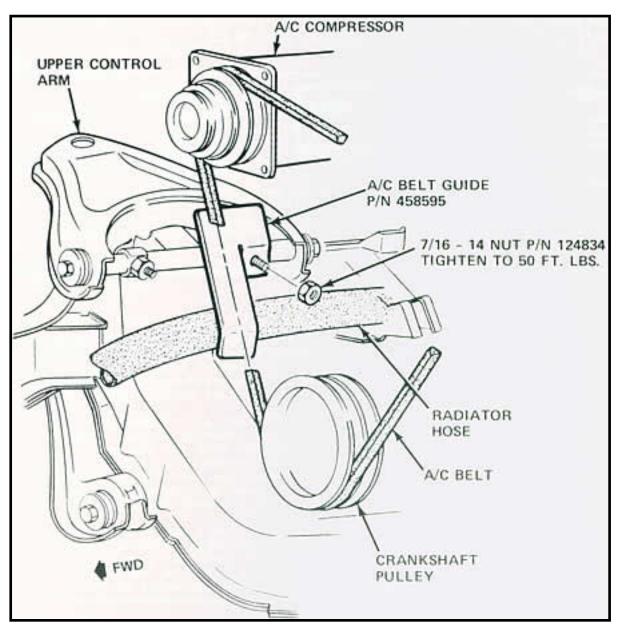
Some 1976 and past model Corvettes equipped with the 350 cubic inch engine and air conditioning may experience an interference condition between the radiator outlet (lower) hose and the air conditioning compressor drive belt. This belt chafing condition could damage the hose and may cause eventual coolant loss.

Belt to host interference has been eliminated by installing a belt guide, part number 458595, at the assembly plant. This guide is mounted over the rear attaching bolt for the upper right side control arm. The guide is between the belt and hose and prevents the belt from chafing the hose (see illustration on the following page). The belt guide went into production on vehicle identification number 6S416060 December 18, 1975.

This condition can be corrected on past model and vehicles built prior to the VIN cutoff by installing the belt guide as shown on the illustration. The belt guide can be obtained from GMPD. Use nut, part number 124834, to attach guide over the top of the existing rear upper control arm nut and torque to 50 ft.-lbs.
