1956 Corvette Service Bulletin: Clutch Disc - Springs - Periodic Vibration

Source: Chevrolet Technical Service Bulletin

Bulletin No: DR #266

Date: October 5, 1956

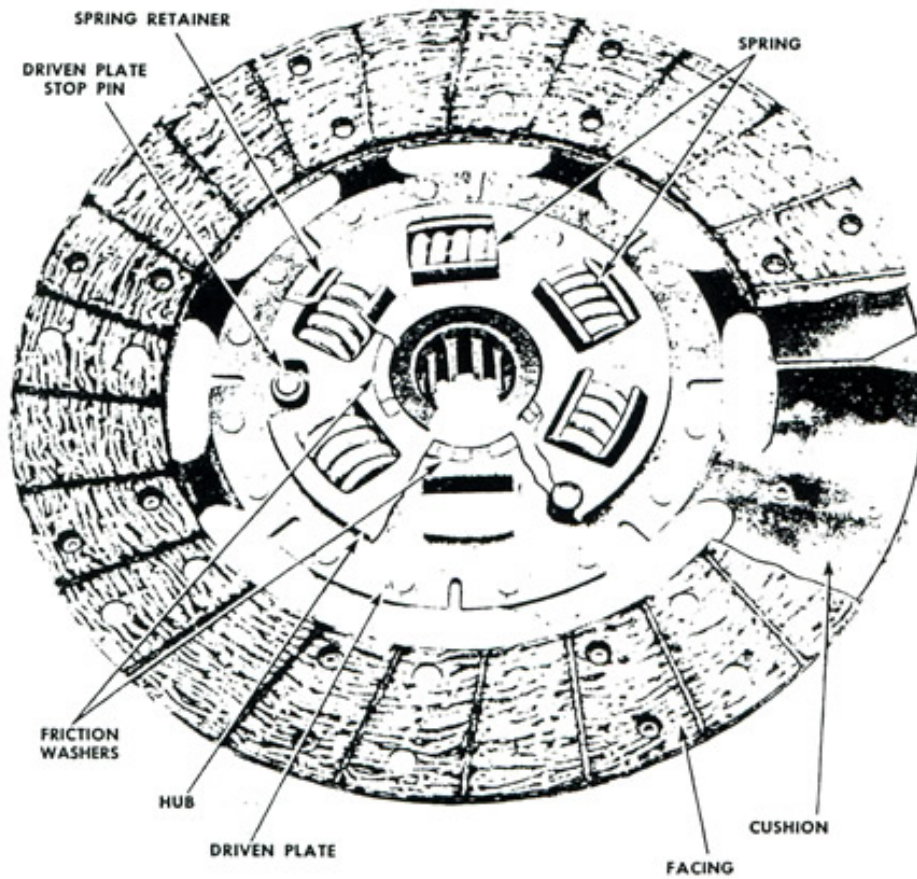
Figure 1
1956 CLUTCH IDENTIFICATION

To control periodic vibration as outlined above, dampers are incorporated in the clutch disc assemblies, Figure 1 on page 2 shows cutout illustration of the construction of a clutch disc assembly. The number of coil springs, size, and other details, will vary in some discs; however, this is a typical example.

One-piece friction washers are also installed on both sides of the driven plate hub. These create friction between the moving parts of the assembly, this friction is predetermined and is maintained in production to make the assembly function properly.

It is important to keep transmission lubricant or any other lubricant out to prevent any variation in friction which will change the tuning characteristics of the assembly and permit periodic vibration.

IMPORTANT that the clutch disc assembly be replaced using a new clutch disc as listed in the chart for that particular model. Make sure there is no grease on the new clutch disc hub and dampers or the transmission main drive gear splines. If grease is present on the splines, the main drive gear bearing retainer should be corrected as necessary.

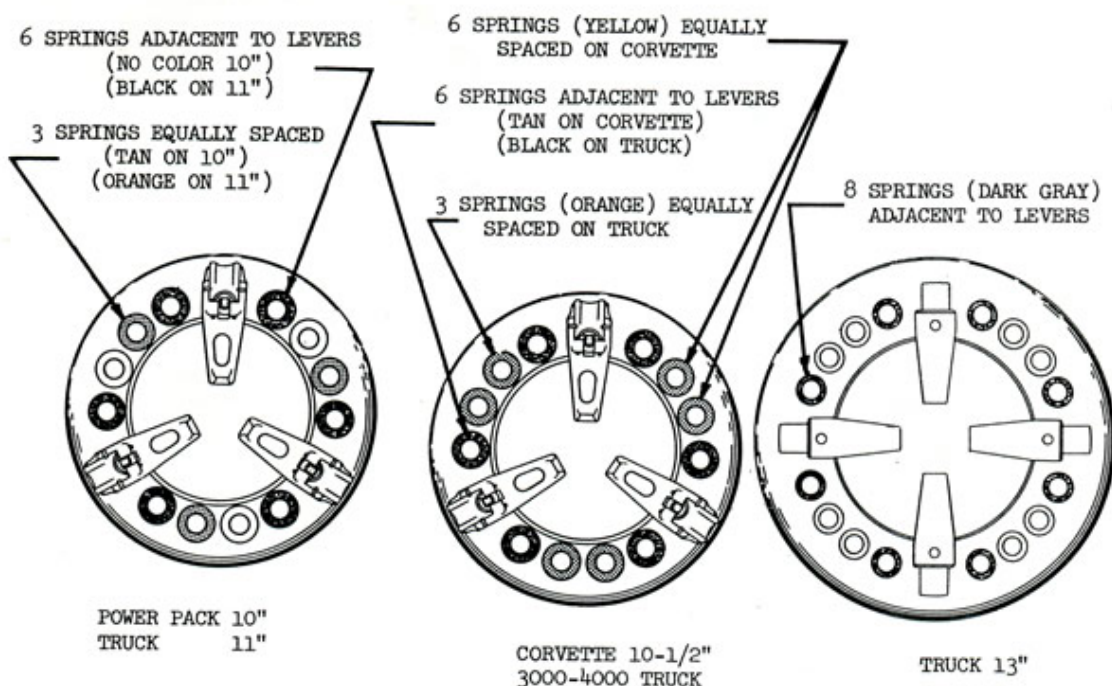
* See illustration on page 4 for location of the various coil springs in the pressure plate.

In some cases early Power Pack Clutches, coil spring type (6 red and 3 lavender coil springs) were found to be low in capacity. Where this condition exists, they should be changed to "6 No Color" and "3 Tan" as covered in chart. For extreme use on high performance units "9 No Color" springs or Corvette clutch cover and pressure plate assembly is recommended, although a considerably higher pedal effort will result form use of such assemblies.
