1956 Corvette Service Bulletin: Clutch Disc - Springs - Periodic Vibration

Model and Year: 1956 Passenger Car and Truck

Bulletin No: DR #266

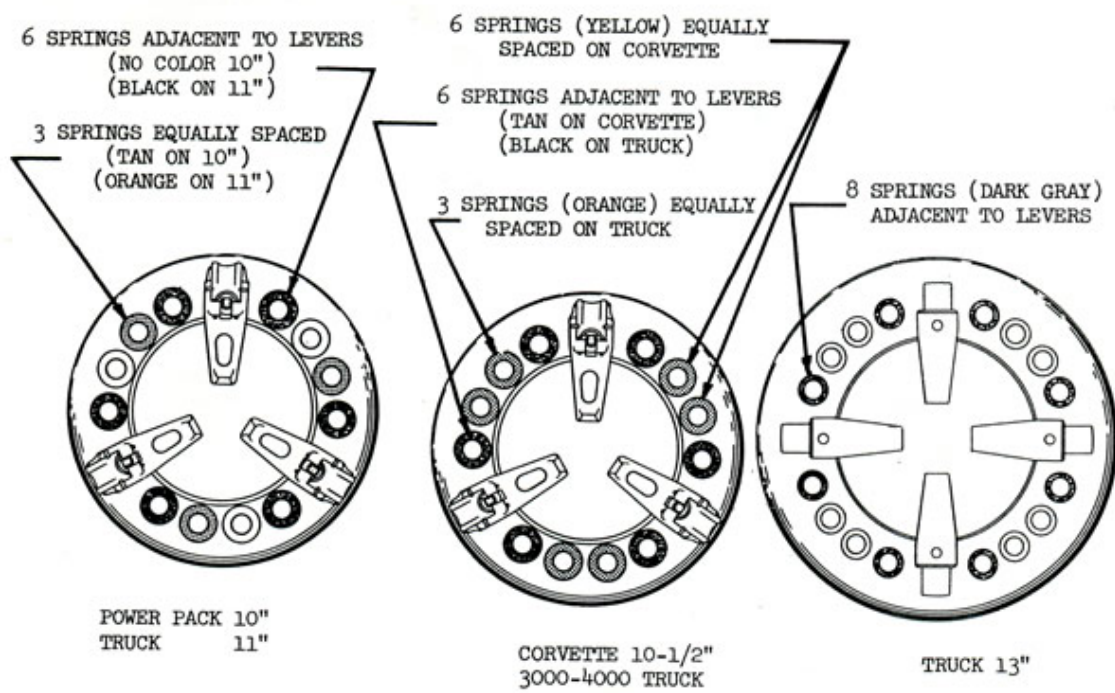
In some cases early Power Pack Clutches, coil spring type (6 red and 3 lavender coil springs) were found to be low in capacity. Where this condition exists, they should be changed to "6 No Color" and "3 Tan" as covered in chart. For extreme use on high performance units "9 No Color" springs or Corvette clutch cover and pressure plate assembly is recommended, although a considerably higher pedal effort will result form use of such assemblies.

* See illustration on page 4 for location of the various coil springs in the pressure plate.
