# 1956 Corvette Service Bulletin: Clutch Disc - Springs - Periodic Vibration

**Source:** Chevrolet Technical Service Bulletin

**Bulletin No:** DR #266

**Date:** October 5, 1956

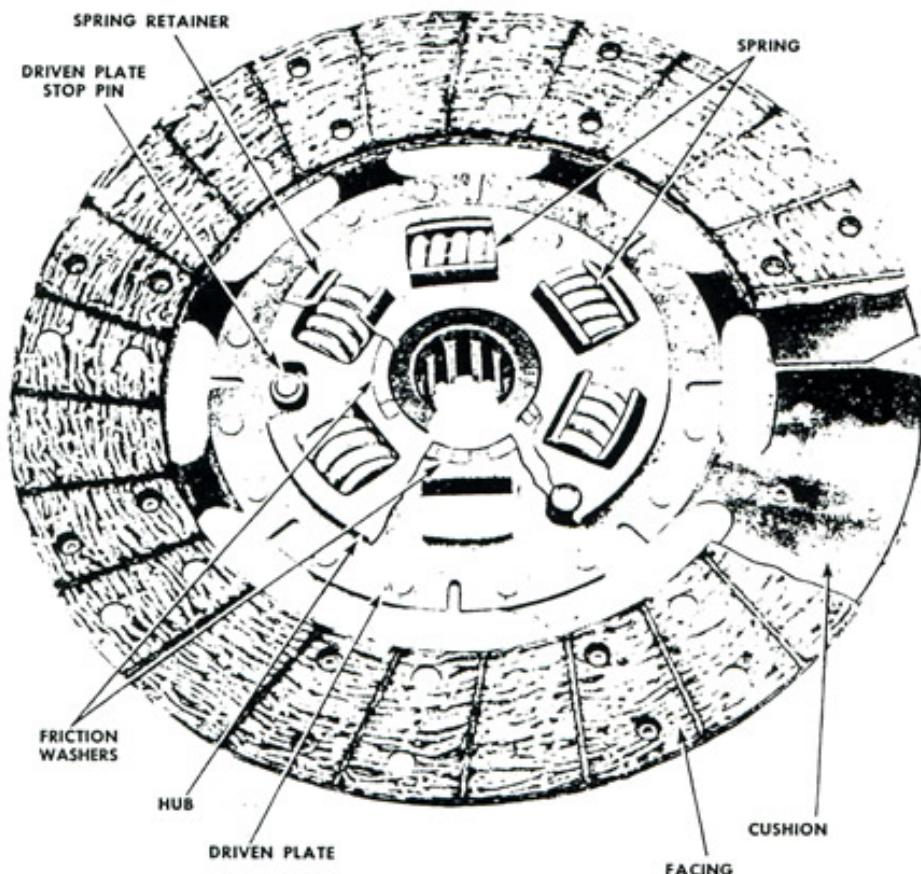
To control periodic vibration as outlined above, dampers are incorporated in the clutch disc assemblies, Figure 1 on page 2 shows cutout illustration of the construction of a clutch disc assembly. The number of coil springs, size, and other details, will vary in some discs; however, this is a typical example.

One-piece friction washers are also installed on both sides of the driven plate hub. These create friction between the moving parts of the assembly, this friction is predetermined and is maintained in production to make the assembly function properly.

It is important to keep transmission lubricant or any other lubricant out to prevent any variation in friction which will change the tuning characteristics of the assembly and permit periodic vibration.

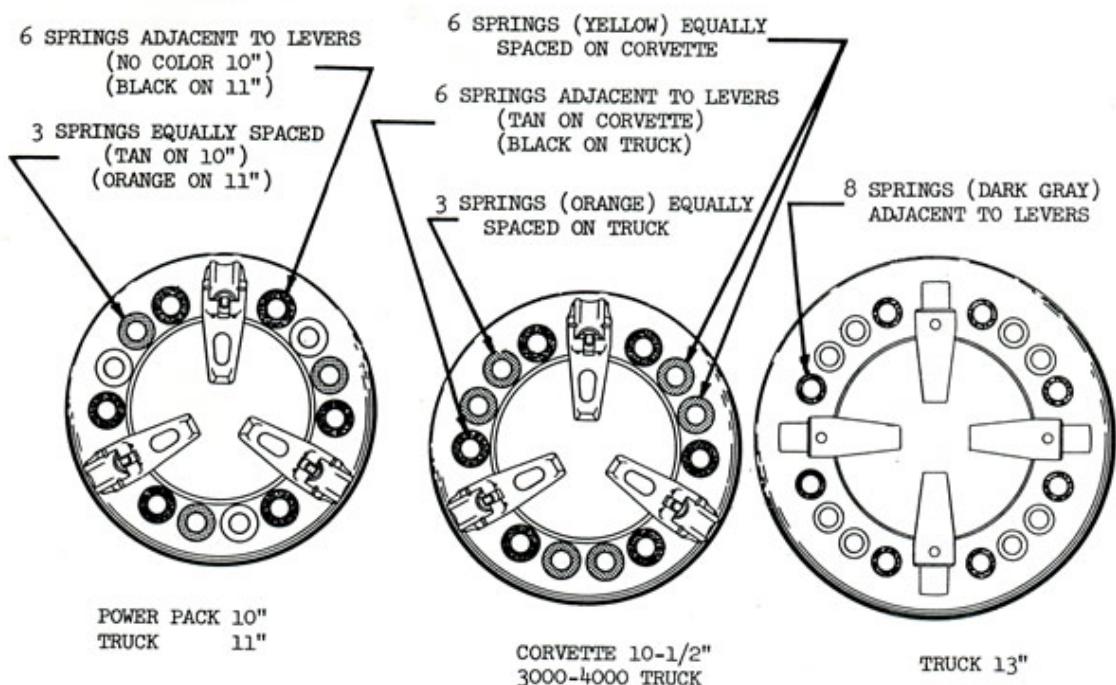
\* See illustration on page 4 for location of the various coil springs in the pressure plate.

In some cases early Power Pack Clutches, coil spring type (6 red and 3 lavender coil springs) were found to be low in capacity. Where this condition exists, they should be changed to "6 No Color" and "3 Tan" as covered in chart. For extreme use on high performance units "9 No Color" springs or Corvette clutch cover and pressure plate assembly is recommended, although a considerably higher pedal effort will result form use of such assemblies.
