# 1956 Corvette Service Bulletin: Clutch Disc - Springs - Periodic Vibration

**Source:** Chevrolet Technical Service Bulletin

**Bulletin No:** DR #266

**Date:** October 5, 1956

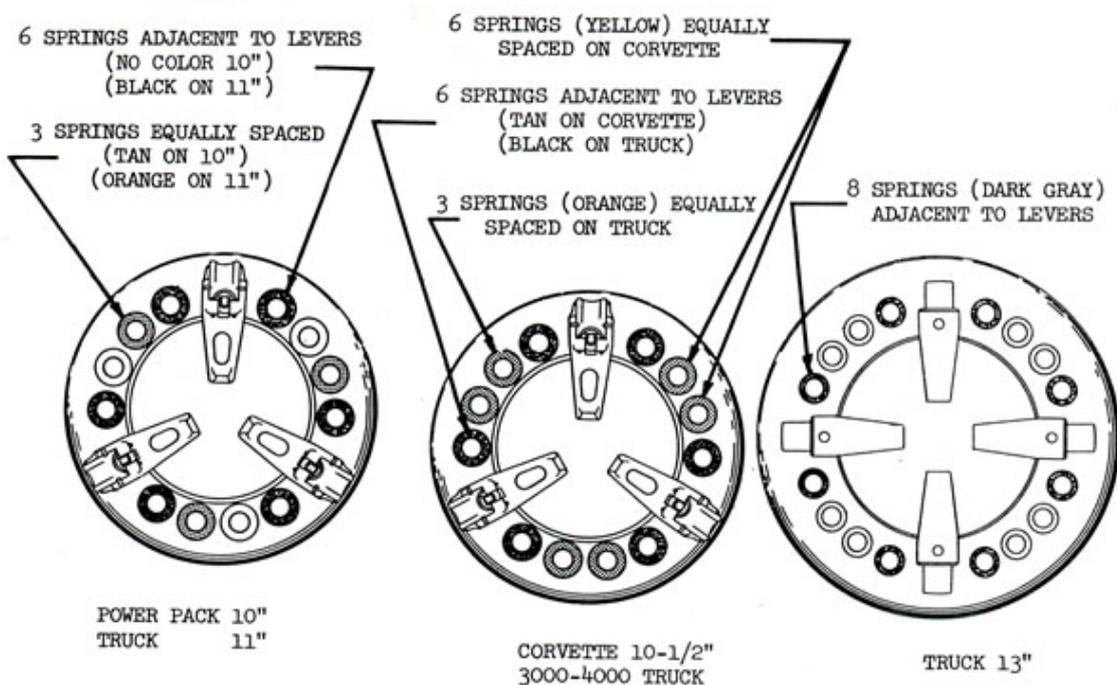
\* See illustration on page 4 for location of the various coil springs in the pressure plate.

In some cases early Power Pack Clutches, coil spring type (6 red and 3 lavender coil springs) were found to be low in capacity. Where this condition exists, they should be changed to "6 No Color" and "3 Tan" as covered in chart. For extreme use on high performance units "9 No Color" springs or Corvette clutch cover and pressure plate assembly is recommended, although a considerably higher pedal effort will result form use of such assemblies.
