1997 - 1998 Corvette: Service Bulletin: Hiss Type Noise Coming From Weatherstrip When Closing Right or Left Door

Subject: HISS TYPE NOISE COMING FROM WEATHERSTRIP WHEN CLOSING RIGHT AND/OR LEFT DOOR (ADD RELIEF HOLE)
Source: Chevrolet Dealer Technical Service Bulletin
Number: 83-15-07

Models: 1997-1998 Chevrolet Corvette Coupe and 1998 Chevrolet Corvette Convertible

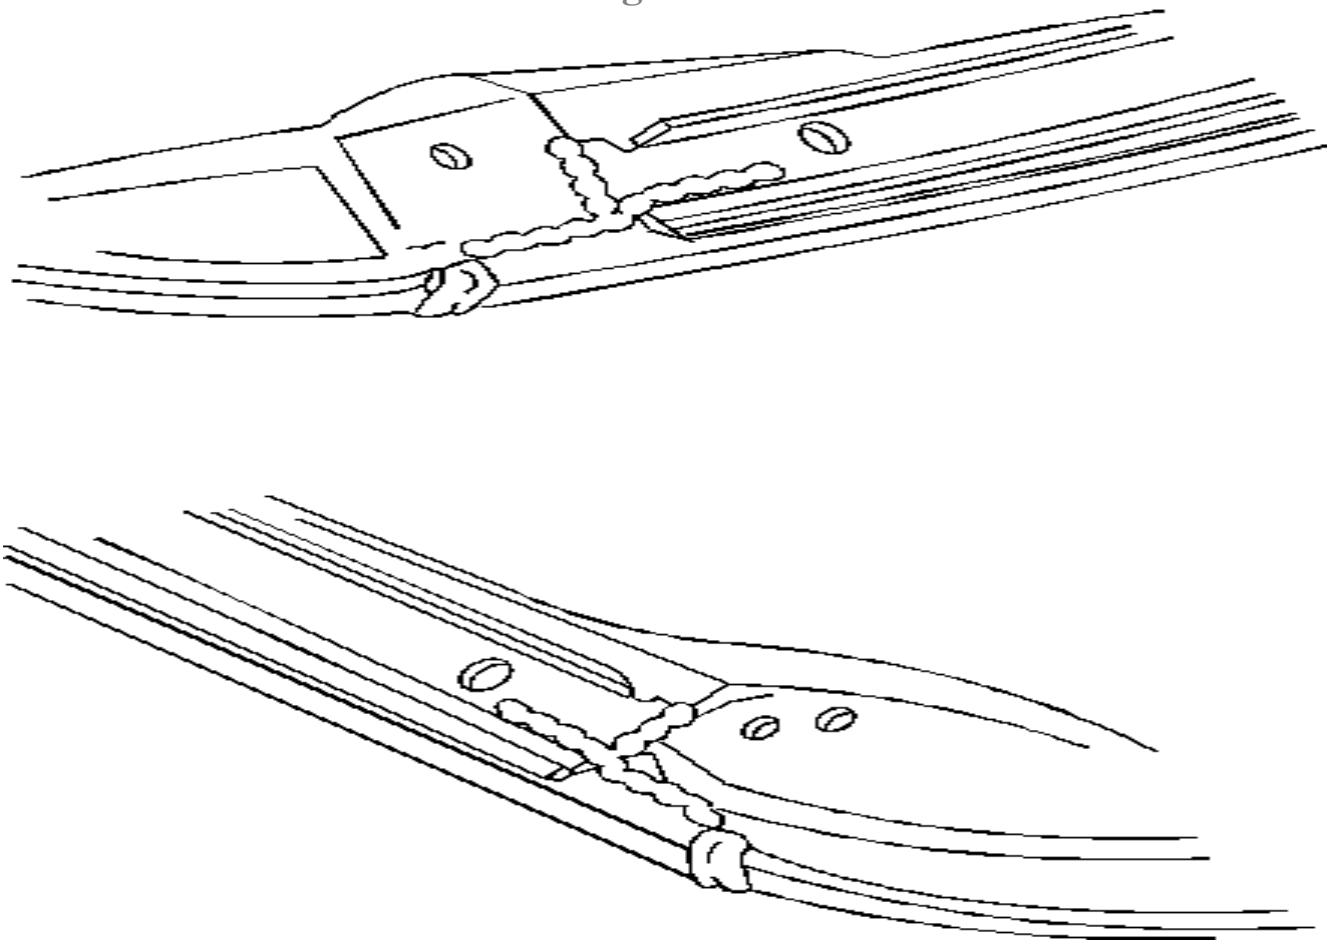
Figure 1

Condition: SOME CUSTOMERS MAY COMMENT ON A HISS TYPE NOISE COMING FROM THE WEATHERSTRIP WHEN CLOSING THE RIGHT AND/OR LEFT DOOR WITH THE GLASS IN THE FULL UP POSITION.

1. REMOVE THE WEATHERSTRIP ABOVE THE DOOR GLASS AND CUT AN AIR RELIEF HOLE 3MM WIDE (.12 IN) BY 10MM LONG (.4 IN) IN THE BACK OF THE WEATHERSTRIP.

2. RESEAL THE FRONT AND REAR CORNERS ON THE COUPE OR THE FRONT CORNER OF THE CONVERTIBLE WITH WEATHERSTRIP ADHESIVE; 3M(R) P/N 08011, OR EQUIVALENT. SEE FIGURE 1.

3. REINSTALL WEATHERSTRIP.
