1958 Corvette: Service Bulletin: Electric Windshield Wiper Information

Subject: Electric Windshield Wiper Information
Model and Year: 1958 Passenger Cars and Trucks
Source: Chevrolet Technical Service Bulletin
Bulletin No: DR #359
Section: I
Date: May 28, 1958

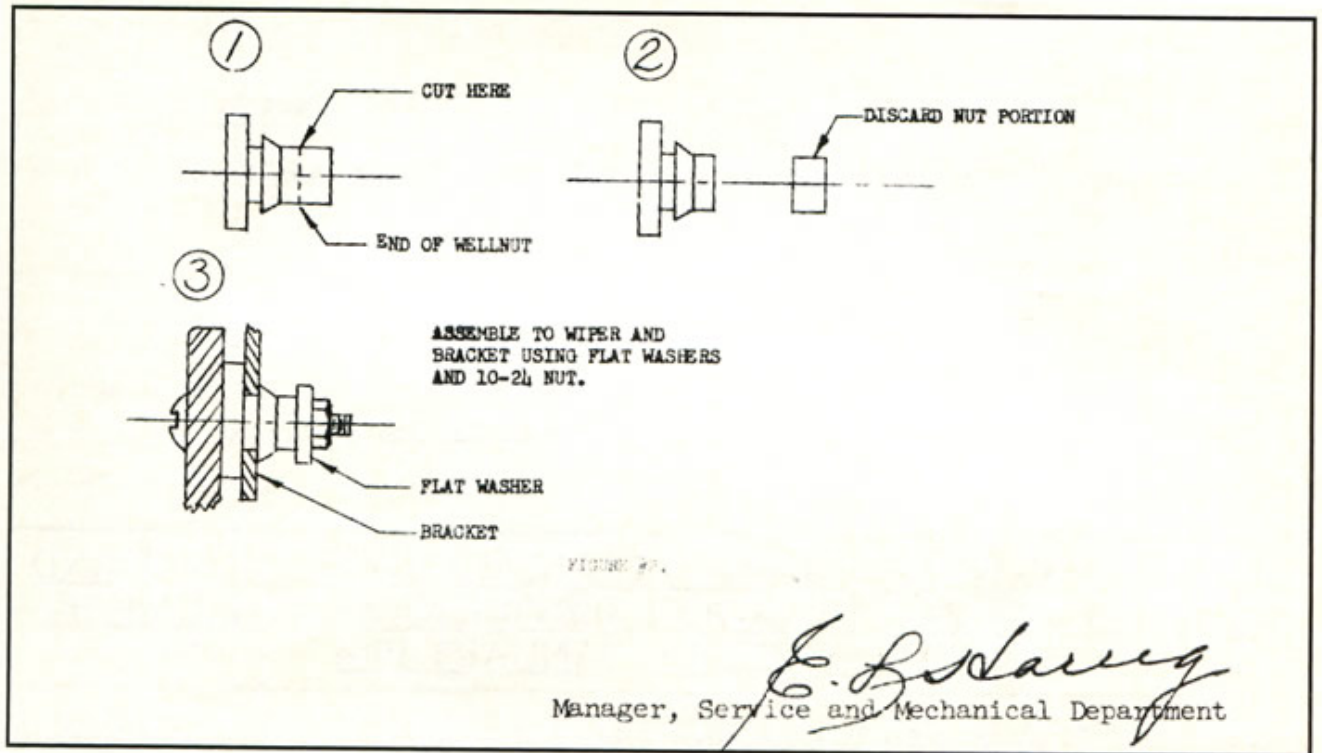
FIGURE #1.

In some cases the wiper motor, after being shut off, may over travel the effective length of the parking cam and continue to run in a reverse direction. This condition may occur even though the blades are properly positioned as covered in TSB #508, DR #359.

If the right hand blade slaps against the moulding excessively even though the blade is correctly positioned and parks properly, the upper cam stop is probably bent or broken. This damage can occur if the mechanism is coated with ice when the wiper is turned on.

A parking spring has been released for production and service which enables the motor to shut off without depending on the resistance of the wiper blades. The spring is designed to clear the revolving arm in the "ON" position and stop the arm in the "PARK" position when switch is turned off. Figure #1 shows installation of parking spring.

A more durable replacement cam stop is available for service. Figure #1 shows details of installation. The existing tab must be bent flat before installation of the new stop.
