1967 - 1975 Corvette: Service Bulletin: Fabric Roof Cover Repairs

Subject: Fabric Roof Cover Repairs

Source: Chevrolet Dealer Service Information Bulletin

Bulletin No: 69-I-2 (Supplement)

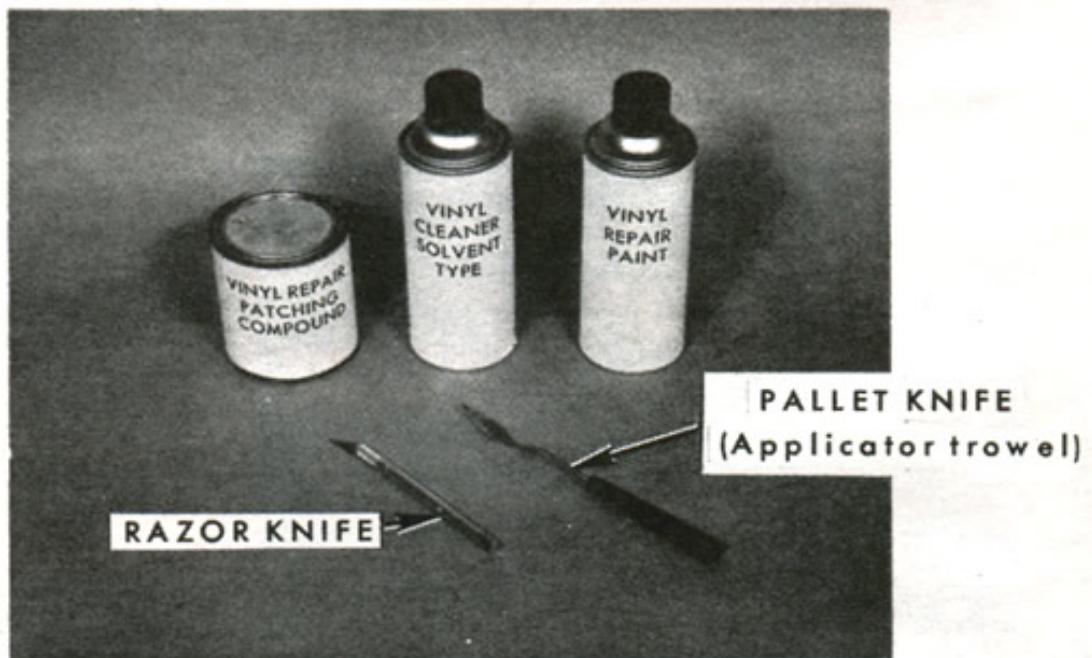
FIGURE 3

1. Fabric Roof Cover Repair Tool J-23091 (Figure 3) - for curing and graining vinyl repair patching compound.

FABRIC ROOF COVER TOOL - TOOL J 23091
(Consist of three pieces)

1. Pre-Heat Fabric Roof Cover Repair Tool J-23091 (Figure 3) - using a basic 72 setting (plus or minus two: 70-74 setting) on the variable heat control (Tool J-23091-3), pre-heat Tool J-23091 for a minimum of 15 minutes until the graining tool achieves an operating temperature of approximately 300 degrees.
